The Effects of Post-Processing on Mechanical Properties and Corrosion Behavior of AM 316L Stainless Steel

US Naval Research Laboratory
Codes 6350 and 6130

Objectives: Systematically determine the microstructure, corrosion behavior, and mechanical properties of AM 316L stainless steel in the as-built and post-processed conditions

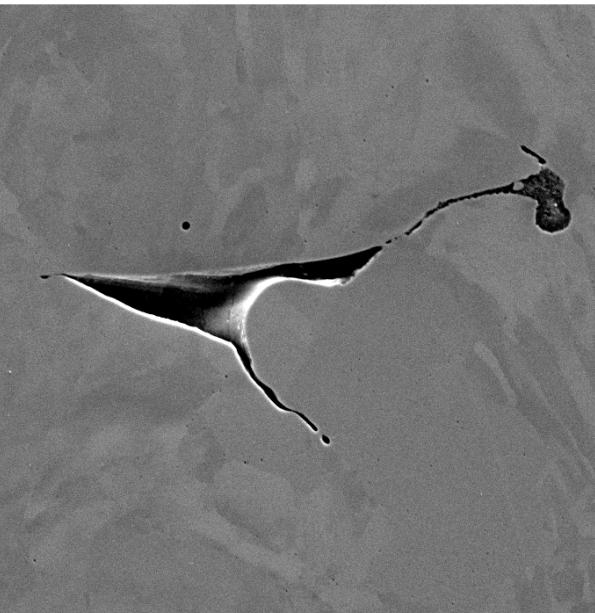
Effect of HT on Pore Morphology

- No effects at <1000 °C
- Initial rounding of pore corners at 1100 °C
- No gross changes in pore shape <1300 °C
- Follows recrystallization behavior

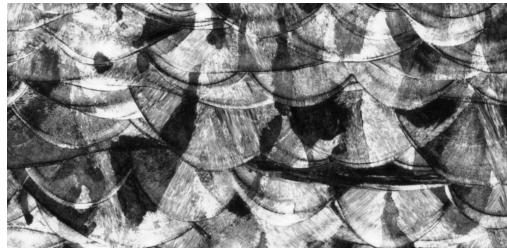
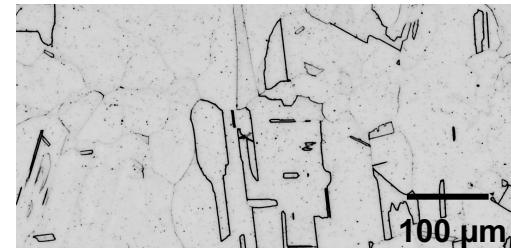
Characteristic Microstructures

Fine cell structure

As-built grain
structure

**70% recrystallized
grain structure**

**Fully recrystallized
grain structure**

Few precipitates

Fine precipitates
