Data Base for Radioactive Waste Management
Review of Low-Level Radioactive Waste
Disposal History

Data Base for Radioactive Waste Management

Review of Low-Level Radioactive Waste Disposal History

Dames and Moore, Inc.

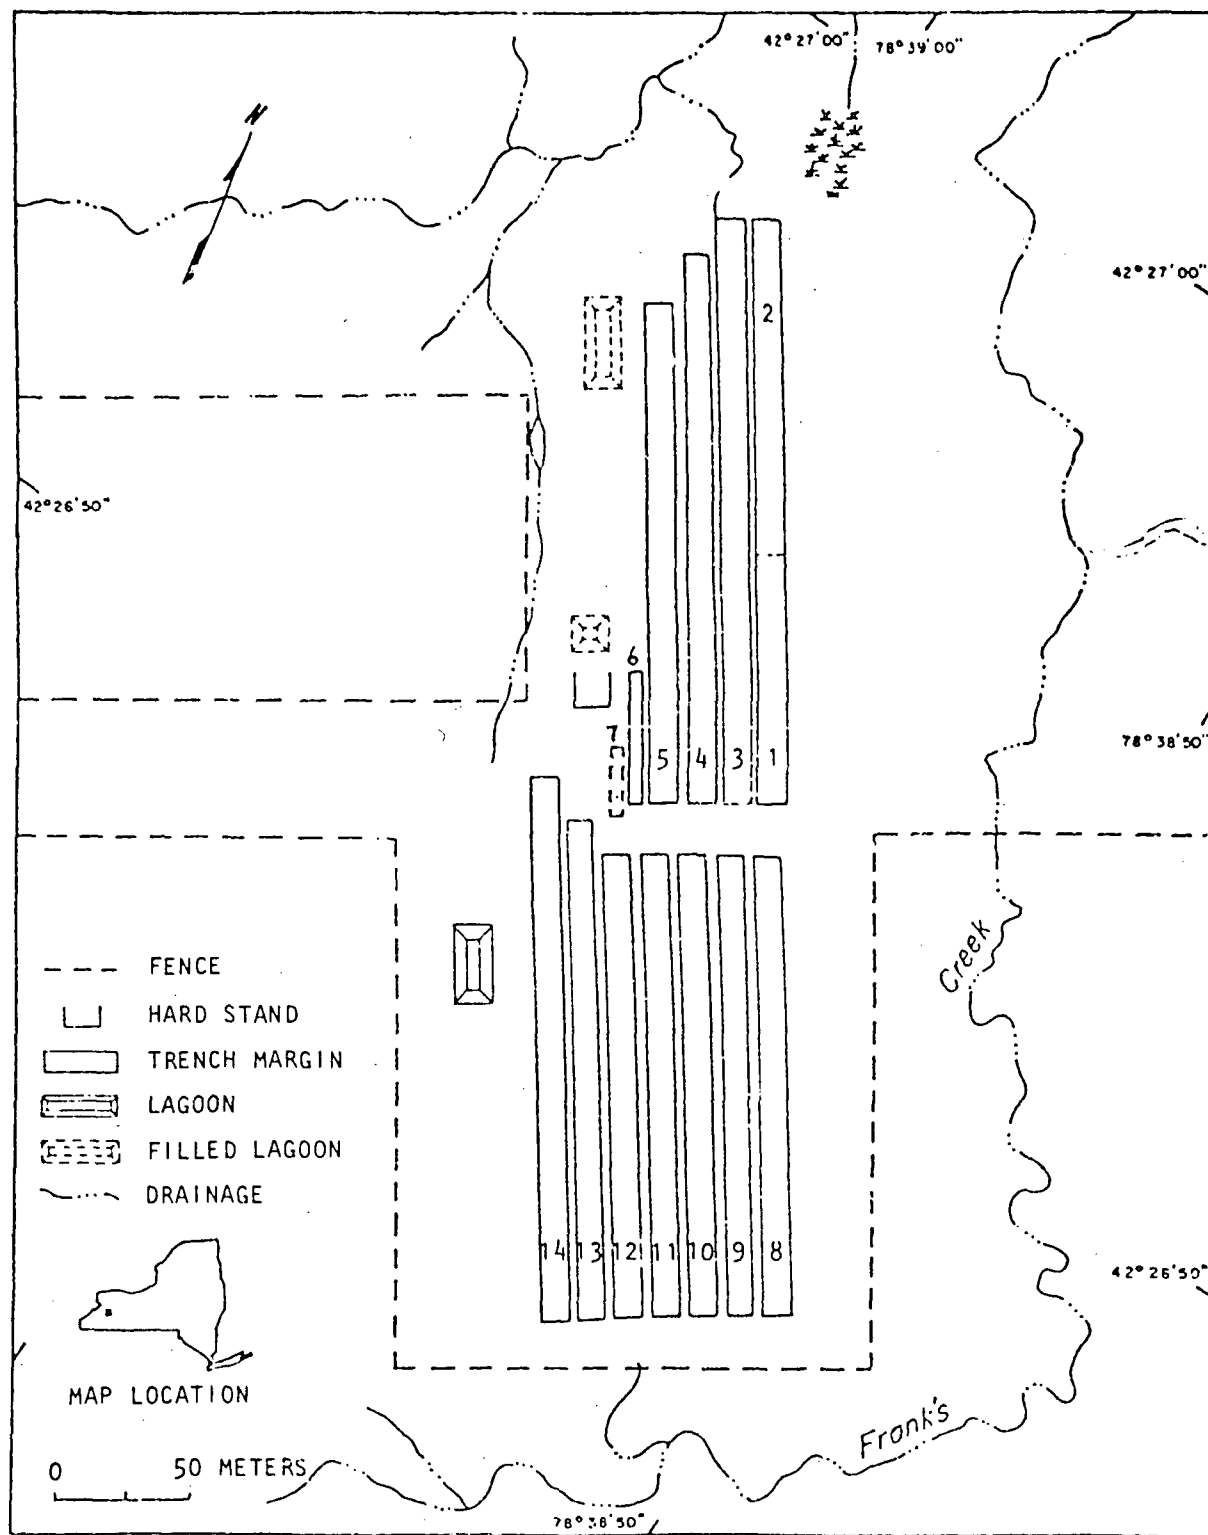
WEST VALLEY LOW-LEVEL WASTE DISPOSAL SITE

As shown in Figure 3-4, the disposal site consists of 14 shallow land burial trenches. Seven trenches were constructed in the northern area of the site between 1969 and 1975. Three of these trenches (trenches 3, 4, and 5) are relatively long and narrow and measure about 180 to

240 m (792 ft) in length, about 10 m (33 ft) in width, and about 6 m (20 ft) in depth. It was once thought that trenches 1 and 2 were one long continuous trench; however, trench water (leachate) differences suggest that one trench is hydrologically disconnected from the other. Trench 6 is not a true trench but rather a series of individual bore holes for waste with high external exposure rates. Trench 7 is actually a narrow and shallow concrete vault. The spacing between the trenches in the northern area was typically between 1.5 and 2.0 m (4 and 7 ft).

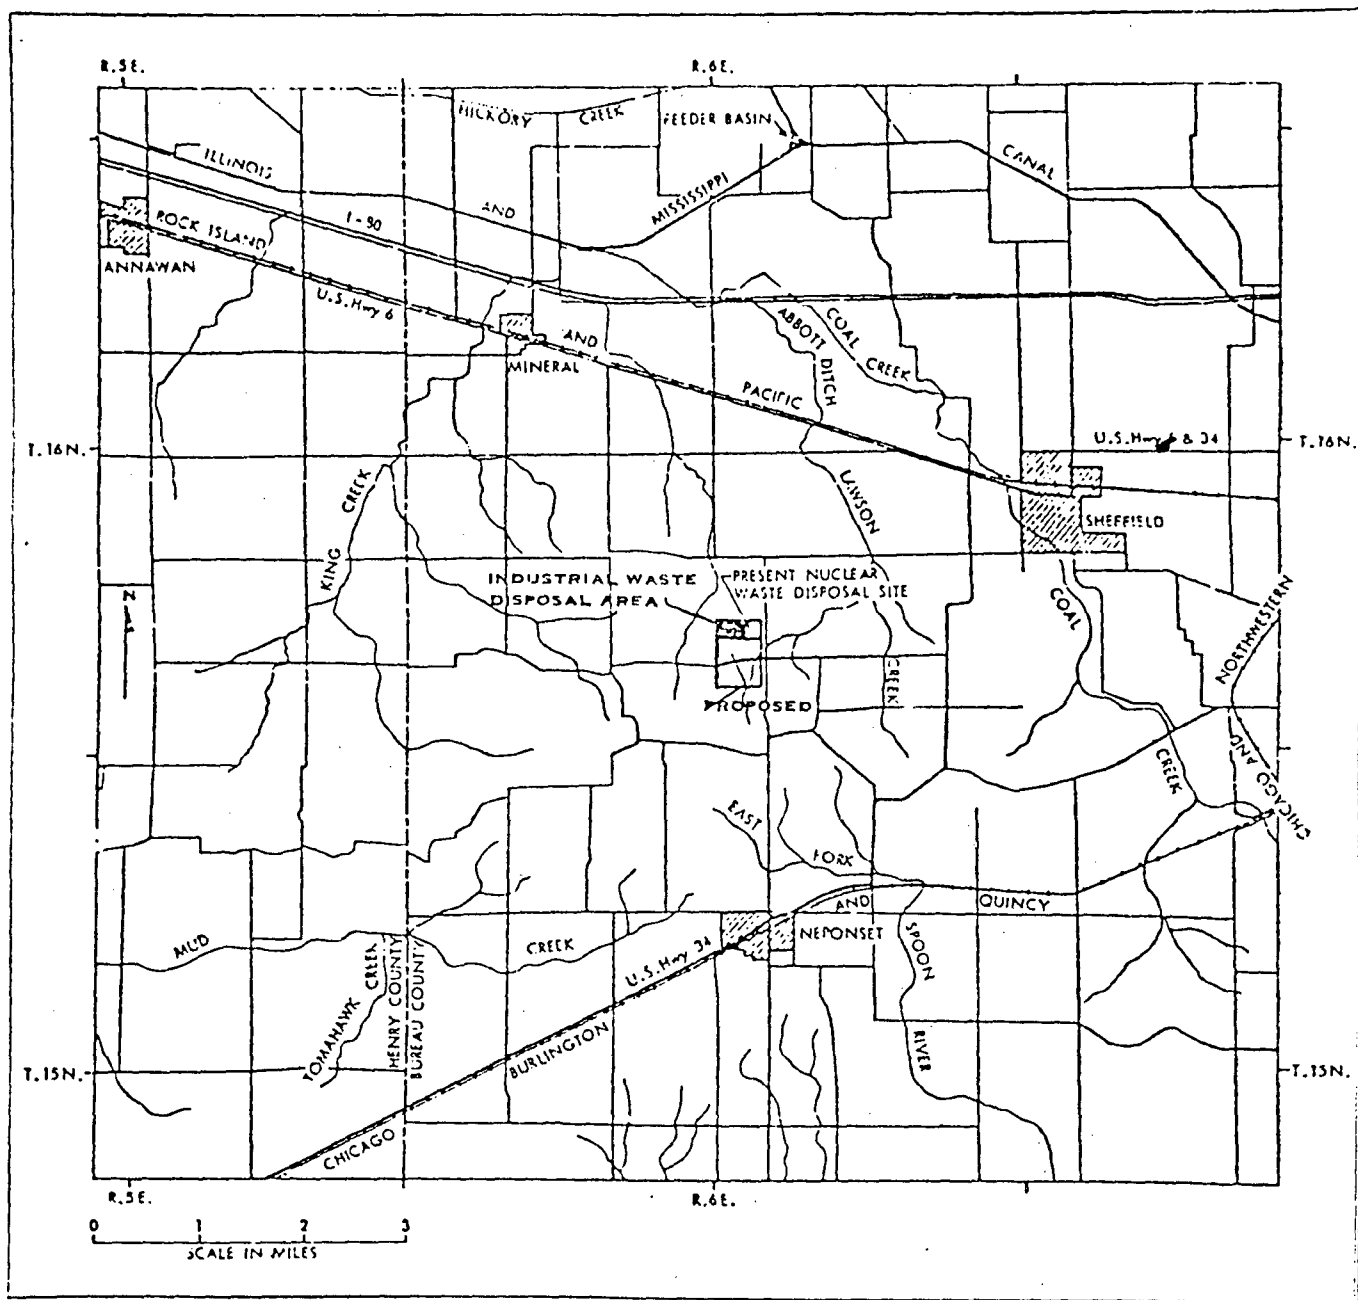
FIGURE 3-6
VICINITY OF SHEFFIELD SITE

The Sheffield disposal site, which is shown in Figure 3-6, is located in northwestern Illinois about 5 km (3 miles) west to southwest of the town of Sheffield. The State-owned area which comprises the disposal site is 8.3 ha (20.5 acres). The surrounding 68 ha (168 acres) are owned by the site operator and are predominantly used for industrial waste disposal (16 ha or 39.5 acres) and farm leases (48.8 ha or 120 acres). Land nearby the site is used for farming (crops and pasture), and has also been used for strip mining of coal.⁽³⁸⁾

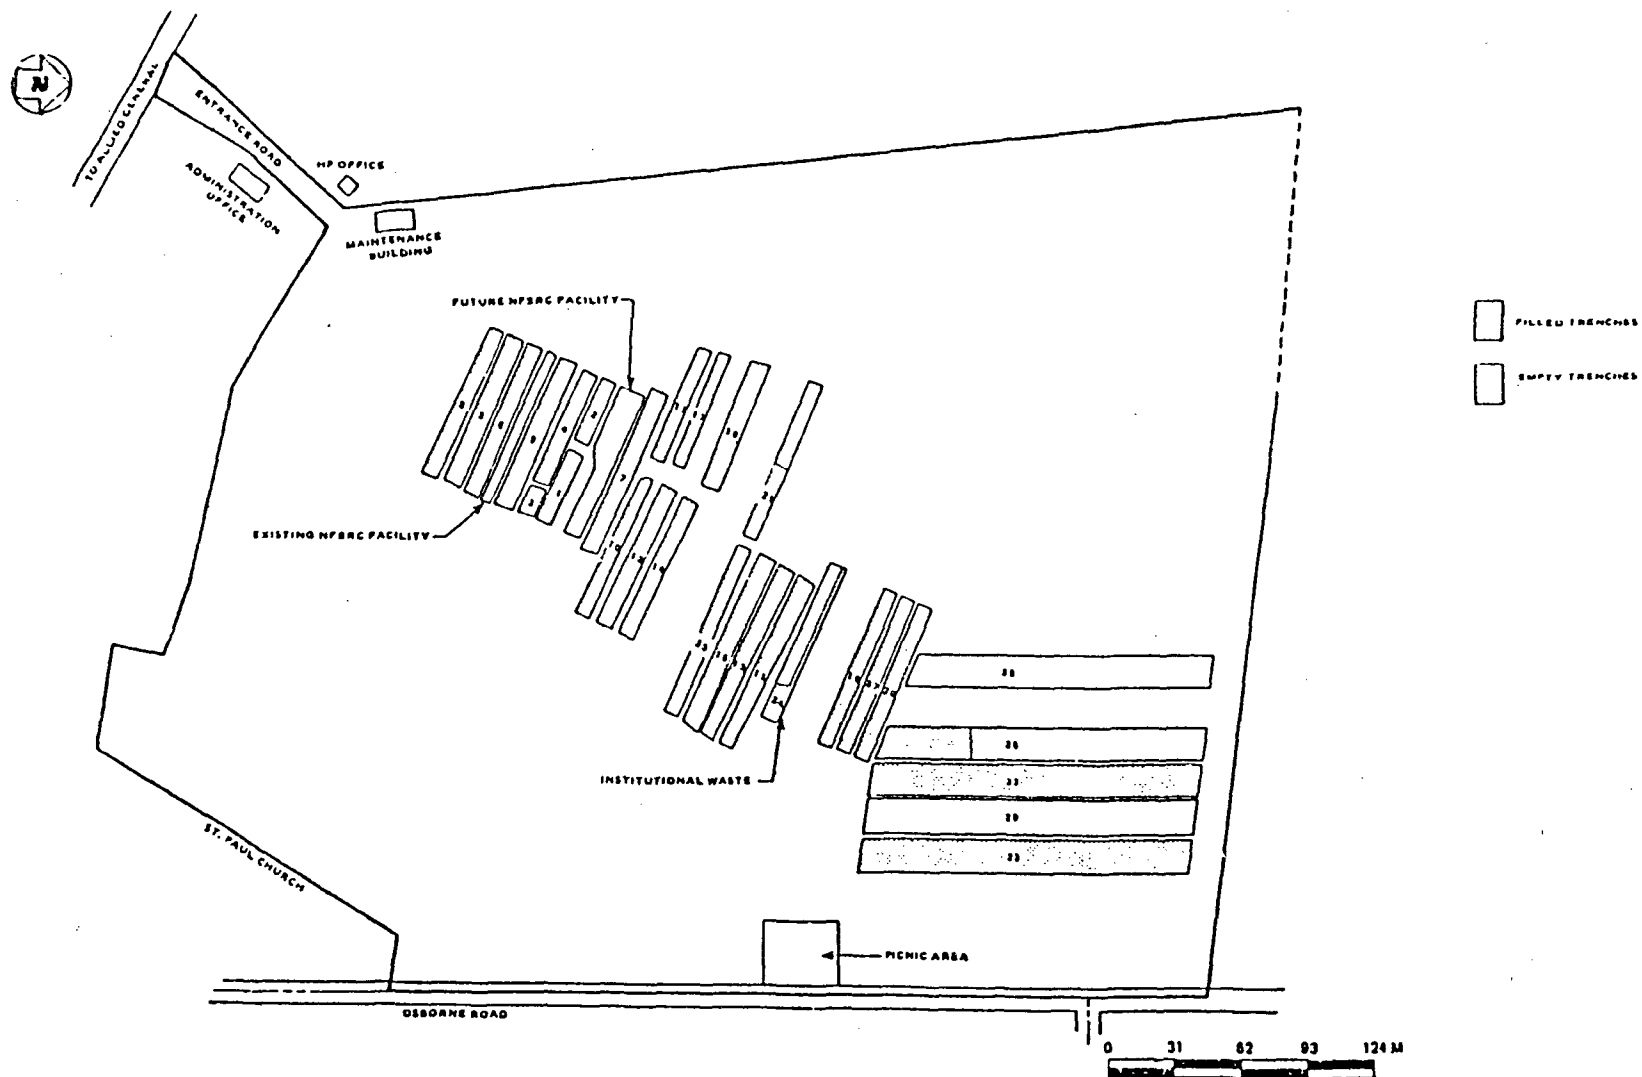
BARNWELL LOW-LEVEL WASTE DISPOSAL SITE

Two types of disposal trenches have been employed at the Barnwell facility: slit trenches and "standard" shallow land burial trenches. Each of the two slit trenches that have been constructed at the site measure about 76 to 152 m (250 to 500 ft) long, 1 m (3 ft) wide, and 6 m (20 ft) deep. A map of the disposal area is shown in Figure 3-10.

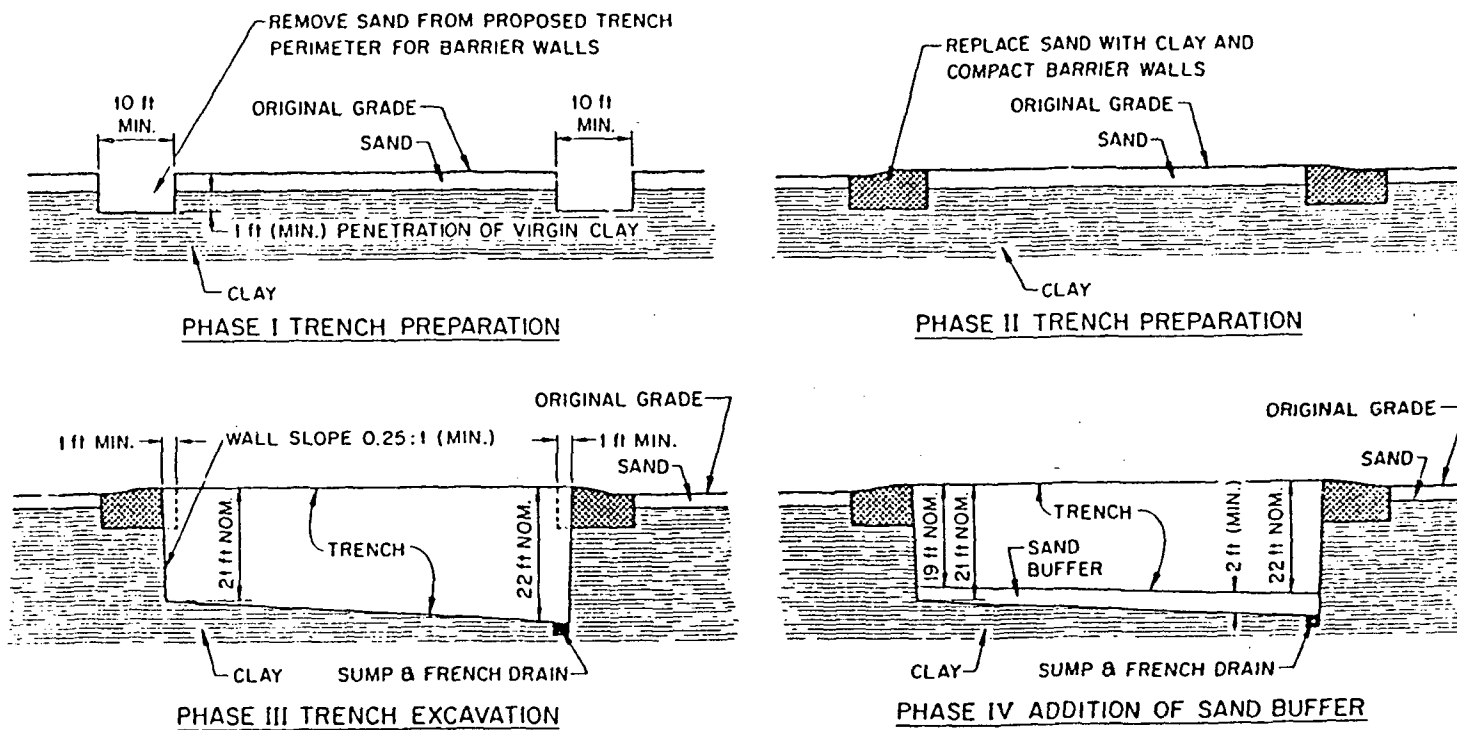
BARNWELL DISPOSAL TRENCH CONSTRUCTION TECHNIQUE

typically measuring 305 m (1000) ft long by 30 m (100 ft) wide.⁽⁴⁴⁾ Somewhat smaller trenches (500 ft by 50 ft) are also occasionally used. A diagram of a typical trench construction sequence is provided as Figure 3.11.

Prior to waste emplacement, two or three feet of pervious sand is placed on the bottom of the operational trench. This is to ensure drainage of water away from the bottom layer of disposed waste packages, to allow unimpeded drainage to the French drain, and to provide a smooth working foundation for waste emplacement.⁽⁴⁵⁾ Waste emplacement then commences at the high end of the trench floor, allowing rainwater to drain away from the emplaced waste packages. License conditions prohibit emplacement of waste more than 100 ft beyond the backfilled portion of the trench, and also prohibit emplacement of waste in standing water.⁽⁴⁷⁾ Small berms around the edges of the trenches are used to prevent surface water flow into open trenches.

In practice, waste emplacement is a combination of stacked and random disposal. Boxes and ion exchange liners are typically stacked while

drums and other small waste packages are typically dumped into the spaces alongside the stacked waste. The disposal facility operators impose economic penalties on waste packages that do not conform to standardized sizes and dimensions.⁽⁴⁸⁾ The use of standardized waste packages helps to improve efficient use of trench volume reduces waste container handling times and helps to reduce voids between waste packages. Stacked disposal also helps to reduce voids between waste packages.

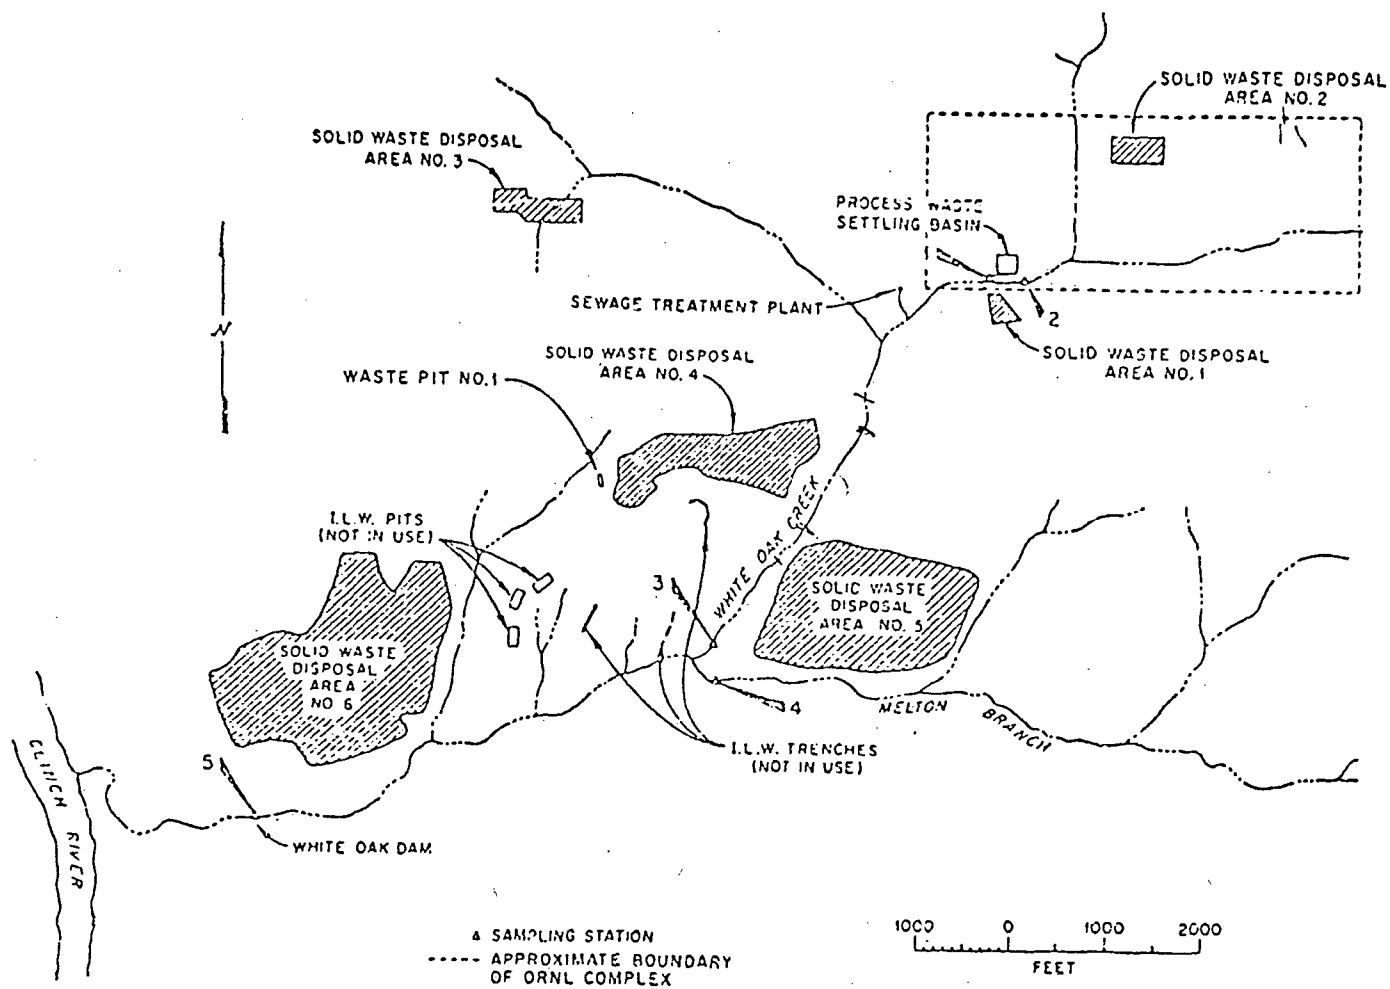
OAK RIDGE NATIONAL LABORATORY SOLID WASTE DISPOSAL AREAS

Radioactive solid waste at ORNL is disposed in trenches, pits, and shafts (Figure 4-1).^(2,3,5,6) Typical trench dimensions at ORNL are

3 m (10 ft) wide, 3 to 4.5 m (10 to 15 ft) deep, and 15 m (50 ft) long. Significantly longer trenches were excavated in the past; however, this was later found to be undesirable for the existing environment at ORNL. The total volume of waste accumulated at ORNL through the end of 1979 was 192,400 m³. This waste is either stored or disposed at the site.

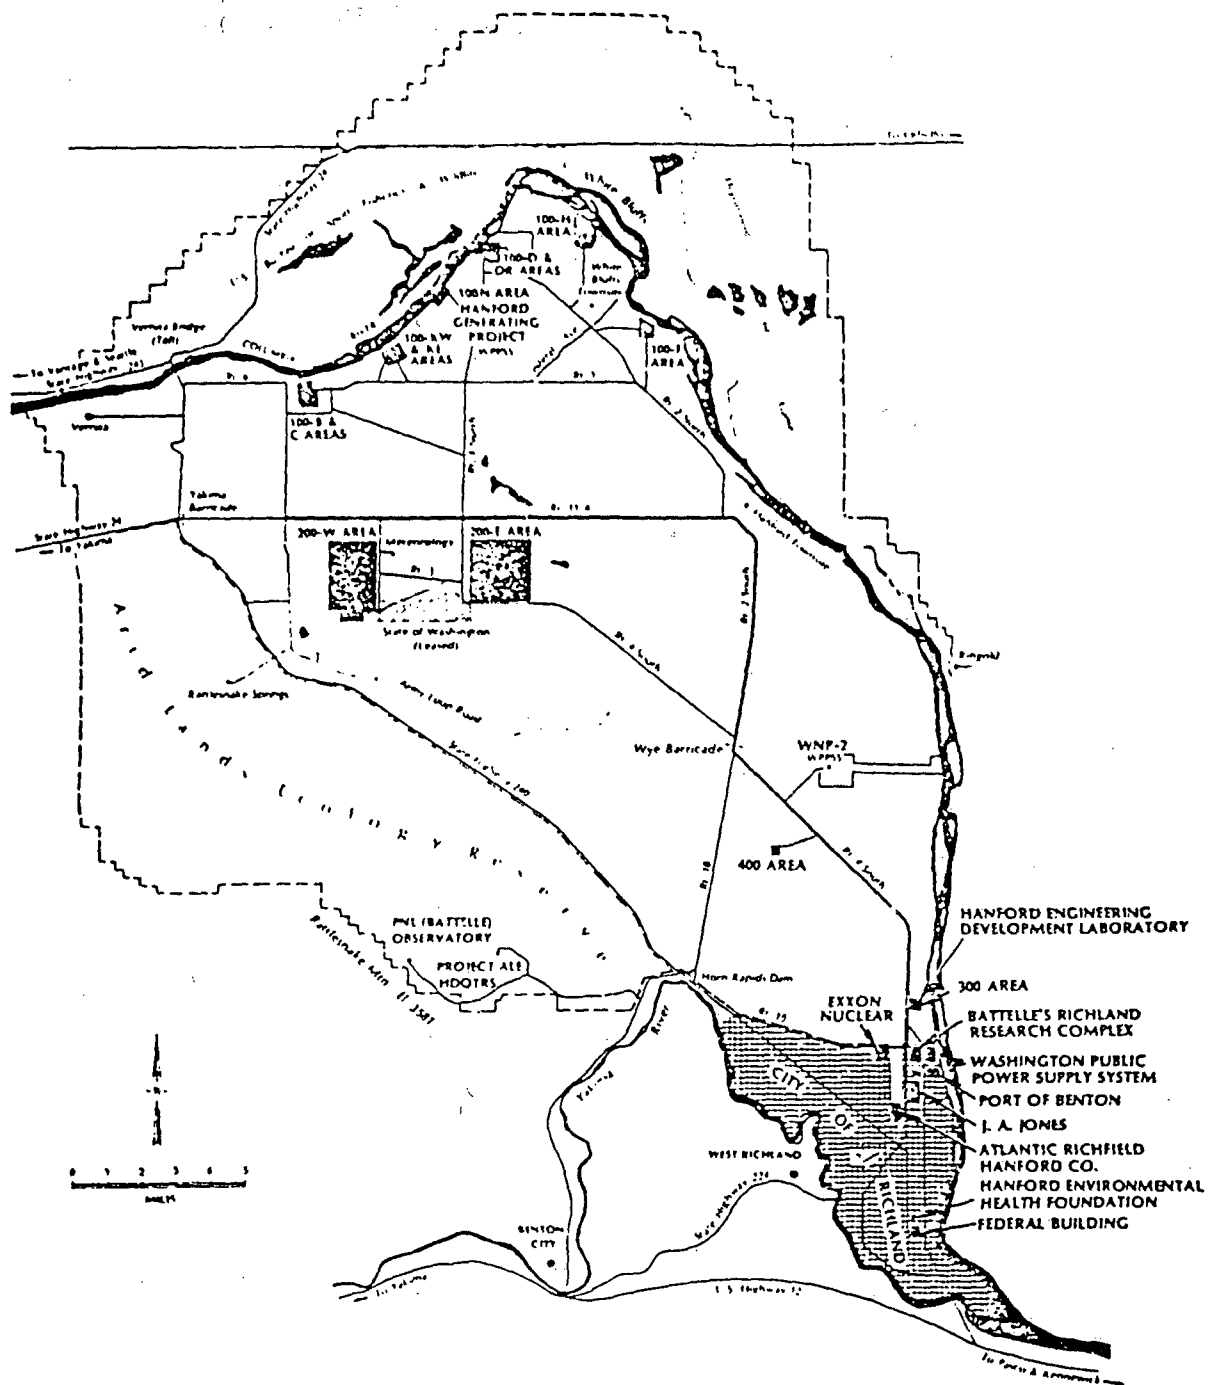
HANFORD RESERVATION

Radioactive waste generation at the HR occurs at several separate complexes within the site (Figure 4-3). Research, development, and production work at HR is performed by several DOE contractors. The principal contractors at HR are the Rockwell Hanford Company, Battelle Memorial Institute (Pacific Northwest Laboratories), and United Nuclear Industries. Work activities at HR are performed within

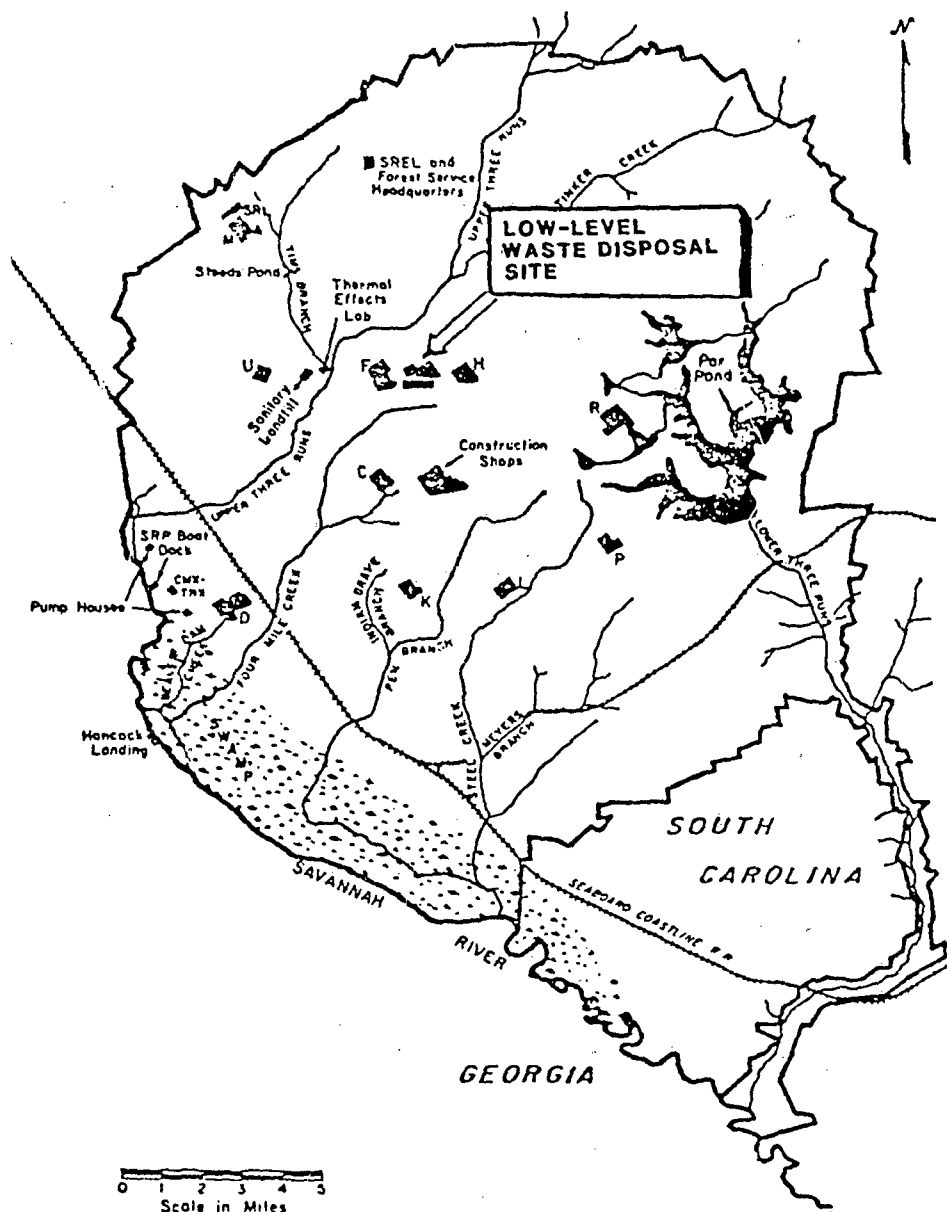
SAVANNAH RIVER PLANT

Waste disposal and storage operations have been carried out at SRP since 1953 (Figure 4-5).^(6,19,21,24) The types of waste stored and disposed at the SRP are quite variable and include such items as:⁽²¹⁾ (1) contaminated equipment (obsolete or failed tanks, pipes, process equipment), (2) laboratory and operating waste (e.g., gloves, protective apparel, analytical waste, decontamination residues, glassware), (3) non-fuel reactor hardware, (4) spent lithium-aluminum targets (5) contaminated oil (from pumps in tritium facilities), (6) spent ion-exchange resins, and (7) "special shipments." Included in the "special" waste category are ²³⁸Pu process waste from the Mound facility and LASL, and debris (including soil) from two U.S. airplane accidents involving nuclear weapons.

The disposal and storage areas at SRP occupy about 78.9 ha (195 acres) of land. Disposal activities have been performed at two contiguous sites. The first site encompasses about 31 ha (76 acres) and was filled in 1972. More recently, waste disposal and storage has been carried out at an adjacent site encompassing about 48 ha (119 acres). Typical disposal trenches at the SRP disposal area are 215 m (700 ft) long, 6 m (20 ft) wide, and 6 m (20 ft) deep. Waste is placed into segregated trenches according to the surface radiation levels of the

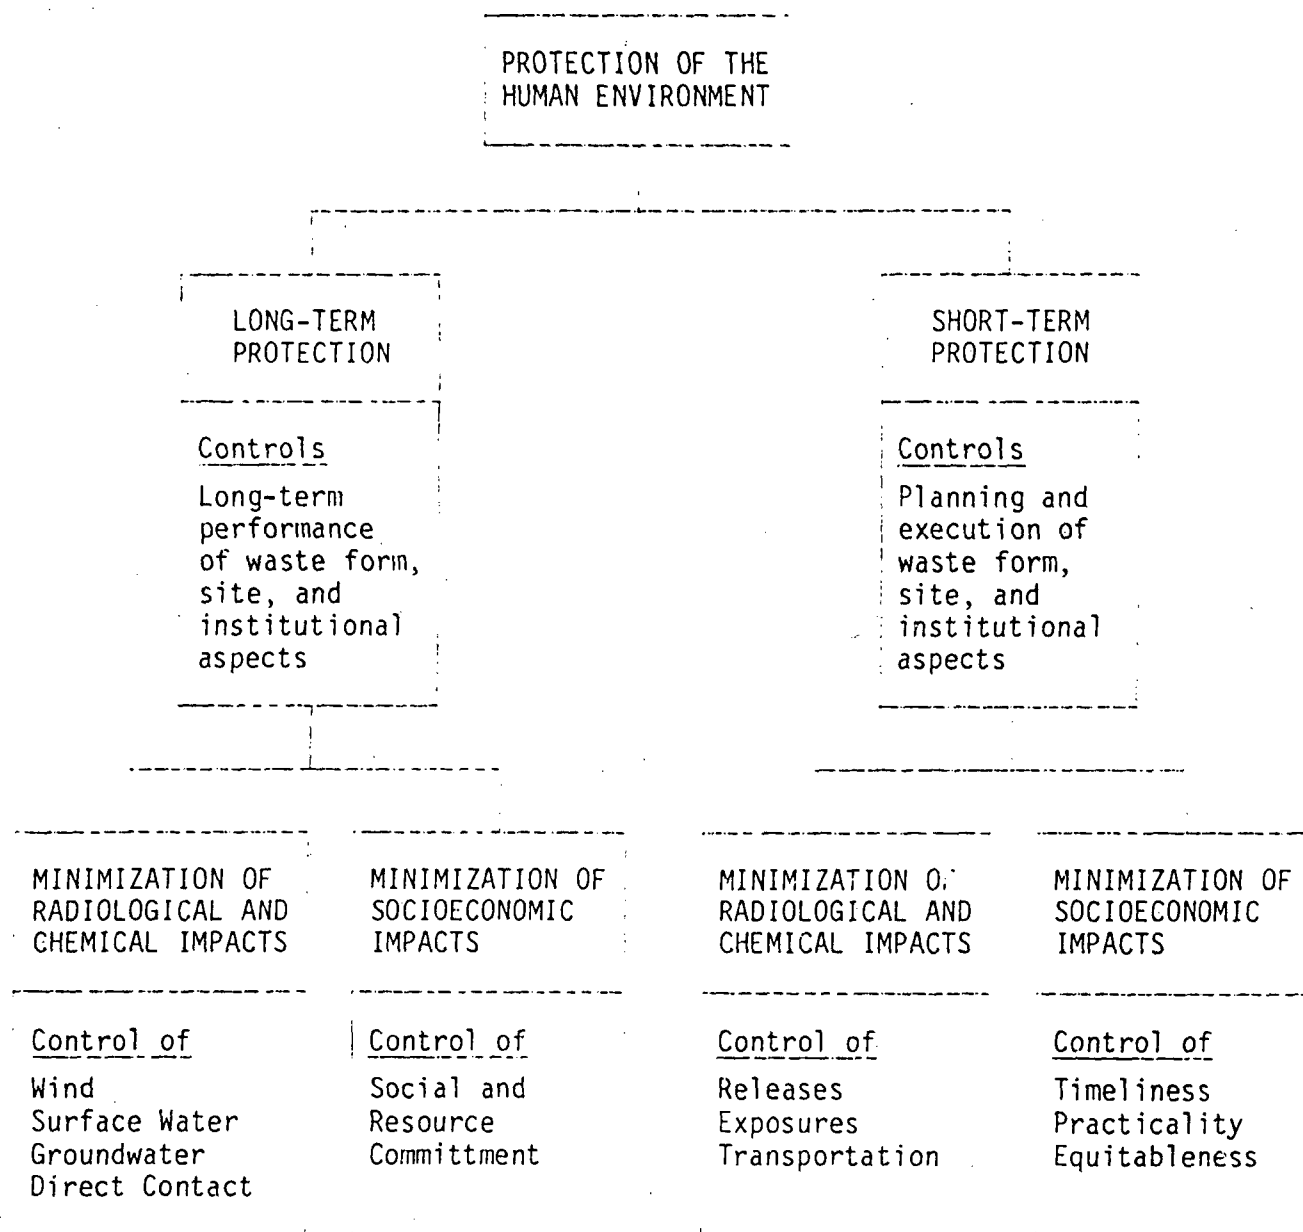
Figure 5.1 . Overview of Disposal Principles

The long-term protection of the human environment can be accomplished through controlling the long-term performance of (1) the waste form, (2) the disposal site (including site selection, design, and operations), and (3) the institutional aspects of the disposal system. In order to minimize the long-term radiological and chemical impacts, these controls may be applied in the form of barriers to minimize the interaction between the waste and transfer agents -- e.g., wind and groundwater -- that may transport the harmful constituents to

the human environment. These barriers can be physical, such as site selection factors (distance to groundwater, low flooding potential, etc.), site design factors (special disposal cell covers, etc.), or site operational factors (waste emplacement procedures, operational drainage systems, etc.). The barriers can also be chemical such as waste form factors (solidification, incineration, etc.), or they can be administrative such as institutional barriers (land ownership, restricted land use, funding, etc.).
