**WETLAND MITIGATION PLAN  
FOR THE  
PROGRESS ENERGY  
LEVY NUCLEAR PLANT and  
ASSOCIATED TRANSMISSION LINES**

Progress Energy, Florida  
St. Petersburg, FL 33701

Florida Department of Environmental Protection

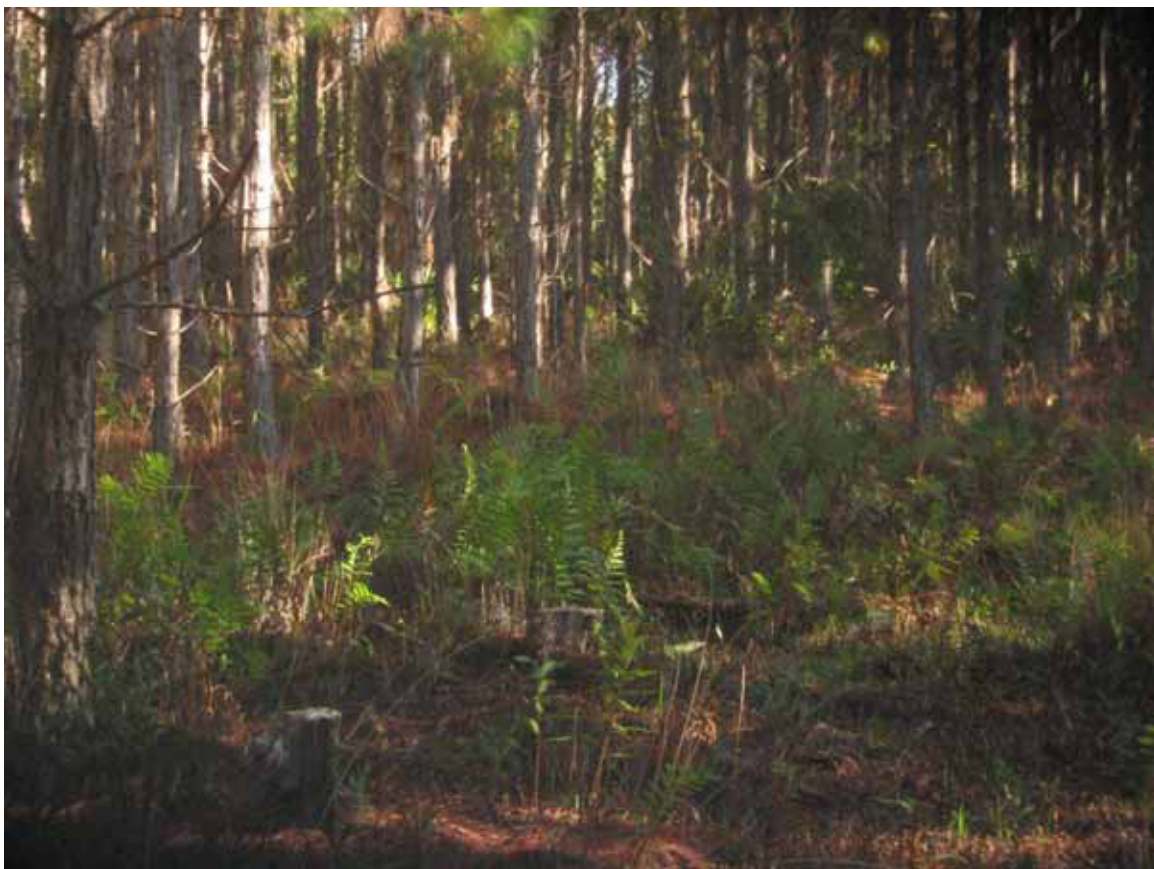
Wet Planted Pine (Reticulate wetlands) – FLUCFCS 6290

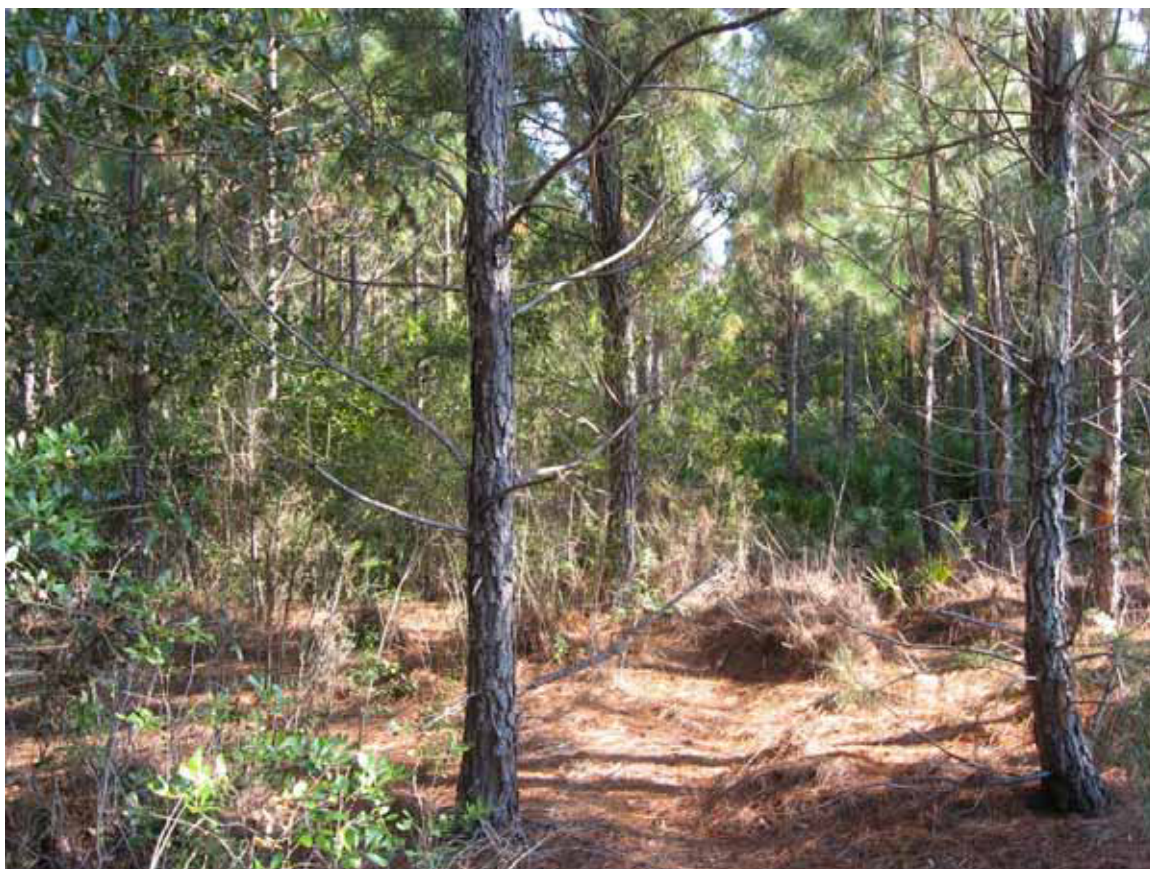
Pine Plantation – FLUCFCS 4400

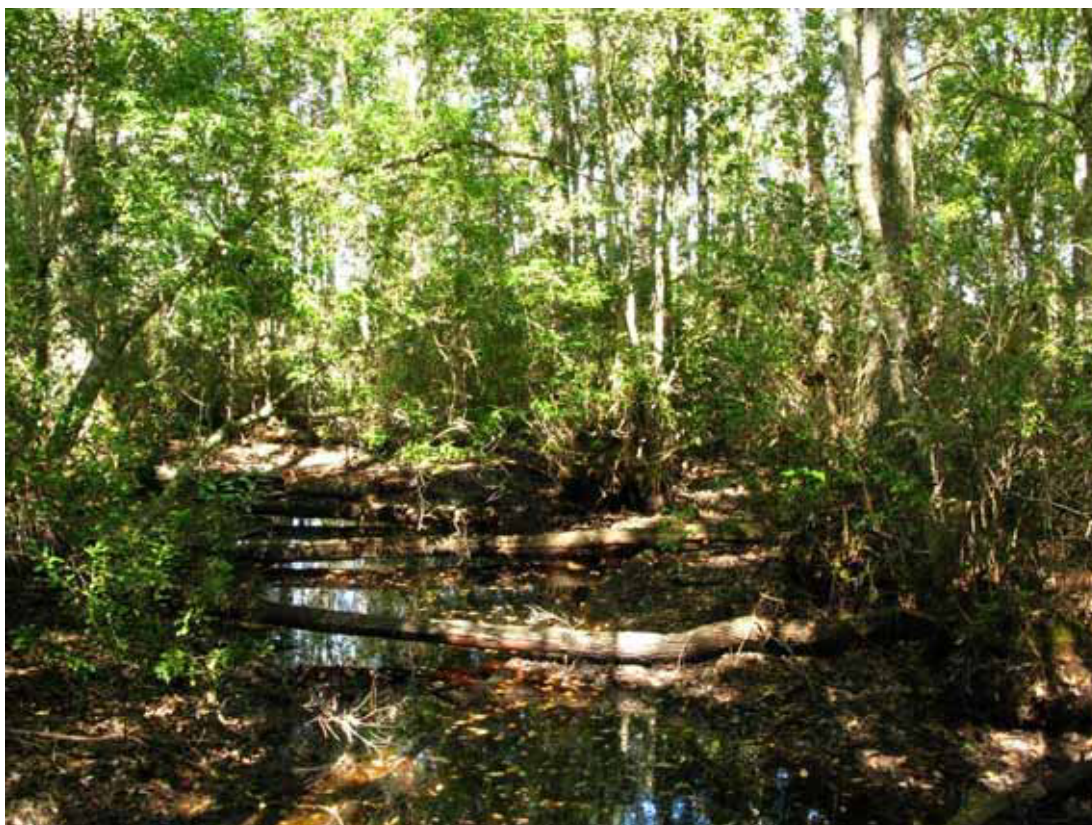
Mixed Wetland Hardwood – FLUCFCS 6170

These are forested wetland areas which have not been recently logged. The majority of these community types are located on the LNP site but can also be found on the Lybass and Robinson sites. The canopy stratum consists of a mixture hardwood and some conifer species. The most common species present are blackgum (*Nyssa sylvatica*), red maple, and cypress. Other species dominant in some areas include laurel oak, sweetgum, popash (*Fraxinus caroliniana*) and slash pine.

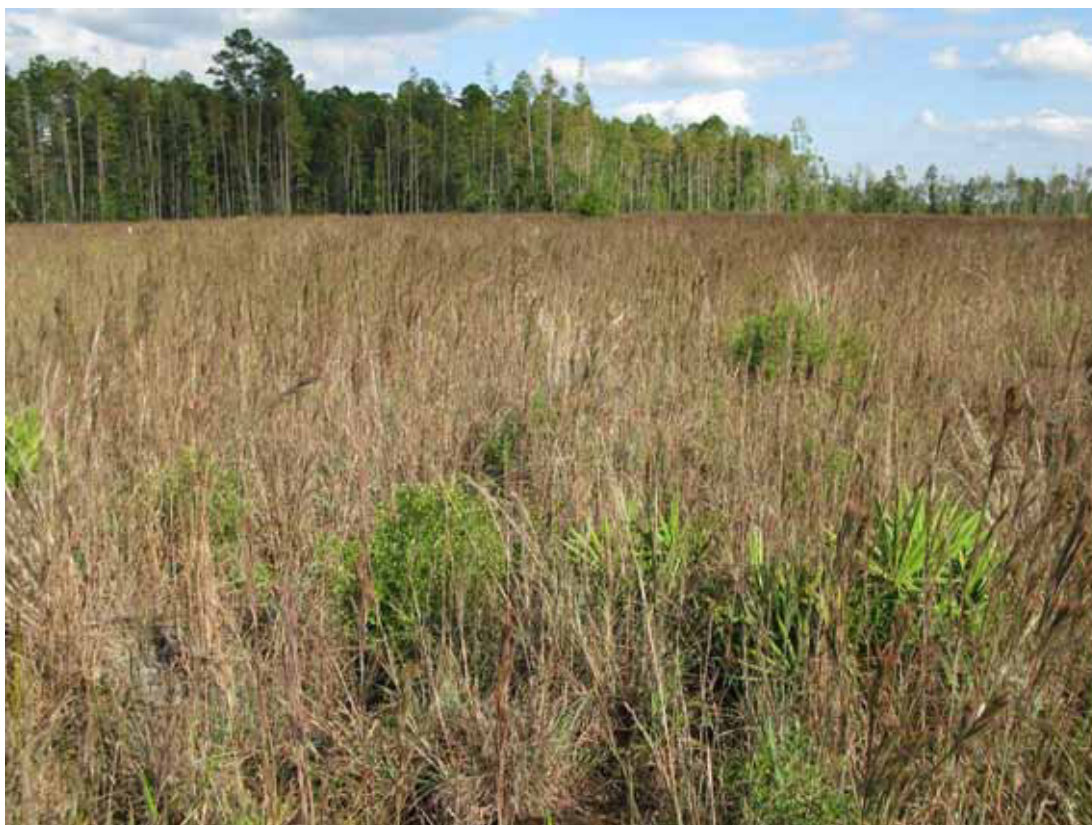
Wet Prairie – FLUCFCS 6430

Wet Prairie occurs on low, relatively flat, poorly drained terrain of the coastal plain. Soils typically consist of sands often with a substantial clay or organic component. The most important physical factors are hydrology and fire. Wet Prairie is seasonally inundated or saturated for 50 to 100 days each year and burns every two to four years. Wax myrtle quickly invades and will dominate Wet Prairies with longer fire intervals. Generally, Wet Prairies have a much shorter hydroperiod than other herbaceous wetlands and are subject to regular and prolonged desiccation during the dry season due to their flat topography.

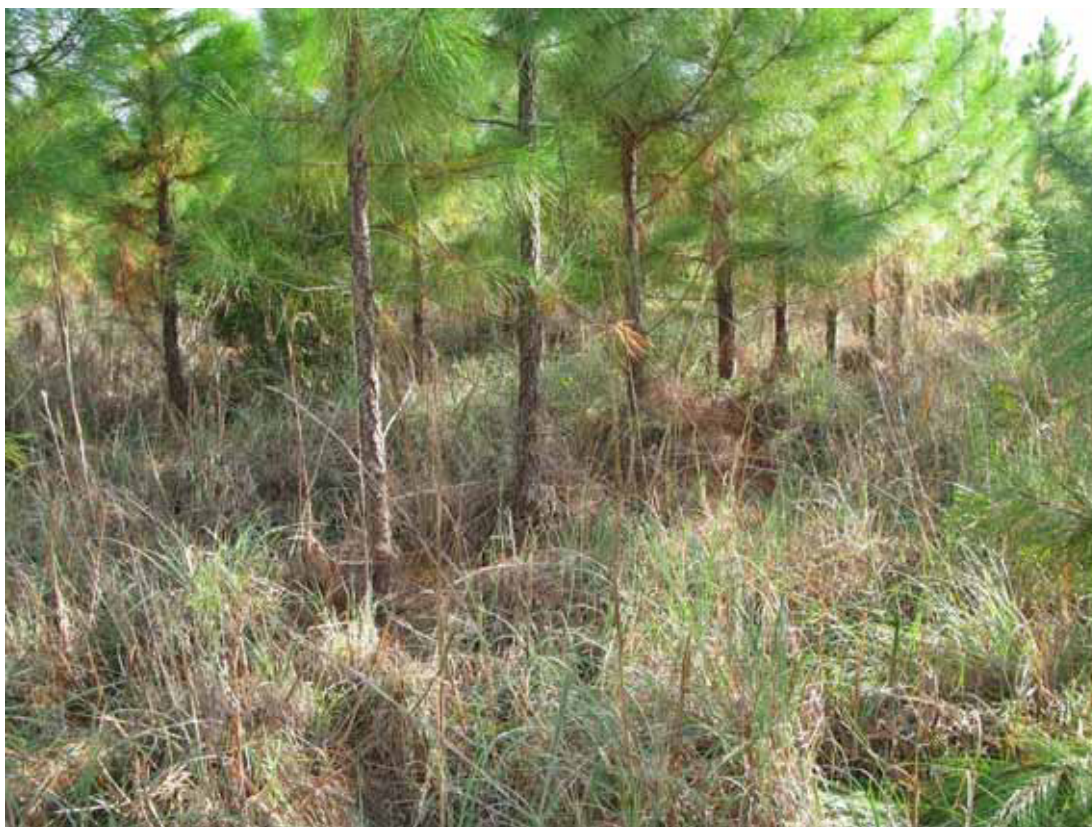
Wet Planted Pine – FLUCFCS 6290

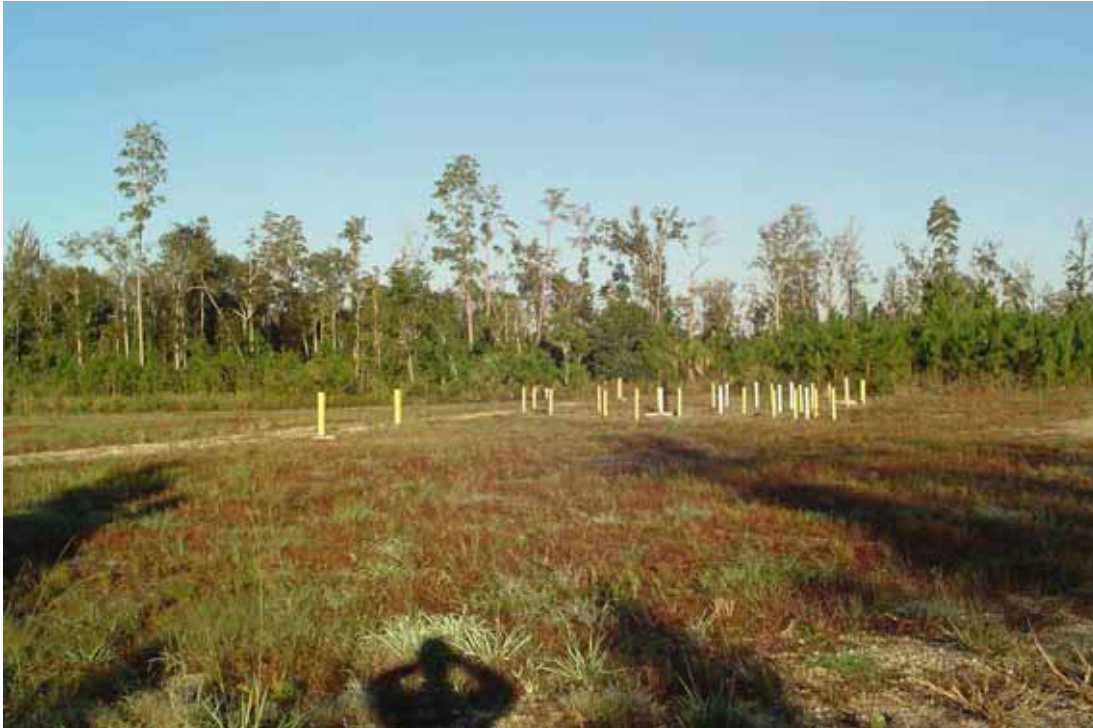
Other Open Lands – FLUFCS 2600/Utilities – FLUCFCS 8300(Well Monitoring Station)

This land use type is found solely on the LNP site and is a cleared portion of land where transmission lines and a 30-inch natural gas pipeline bisect a portion of the property. The land under the transmission lines is maintained by mowing and herbicide to allow for proper access and safe maintenance of these facilities.

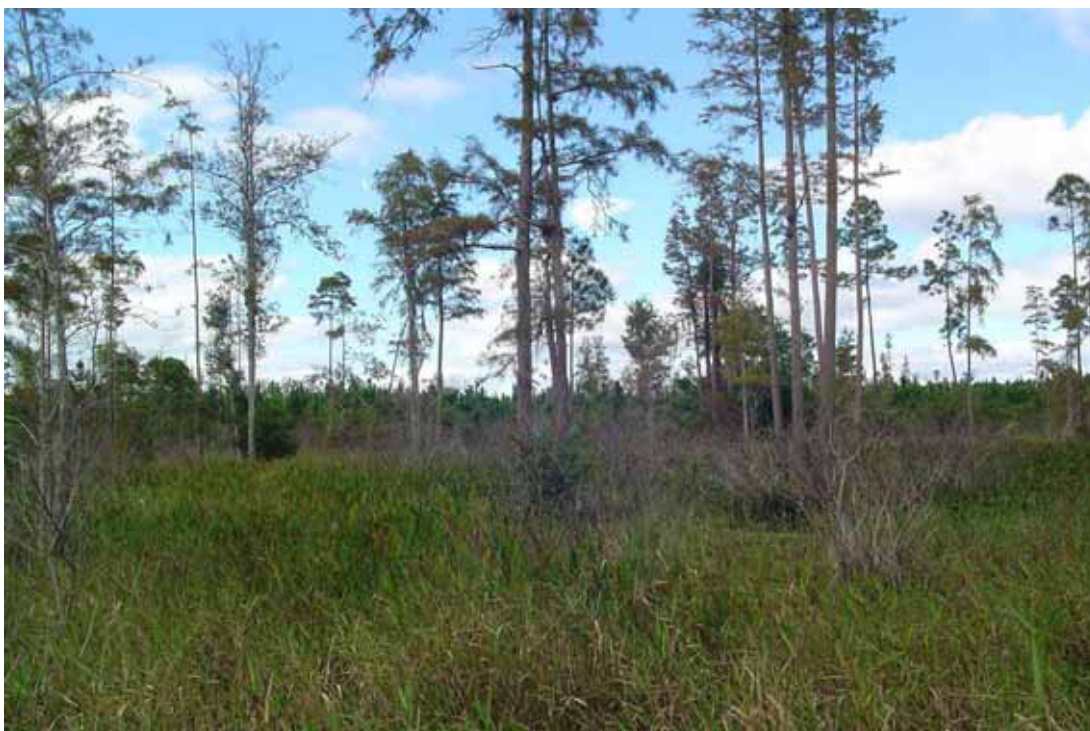
Cypress Wetland (Logged) – FLUCFCS 6210

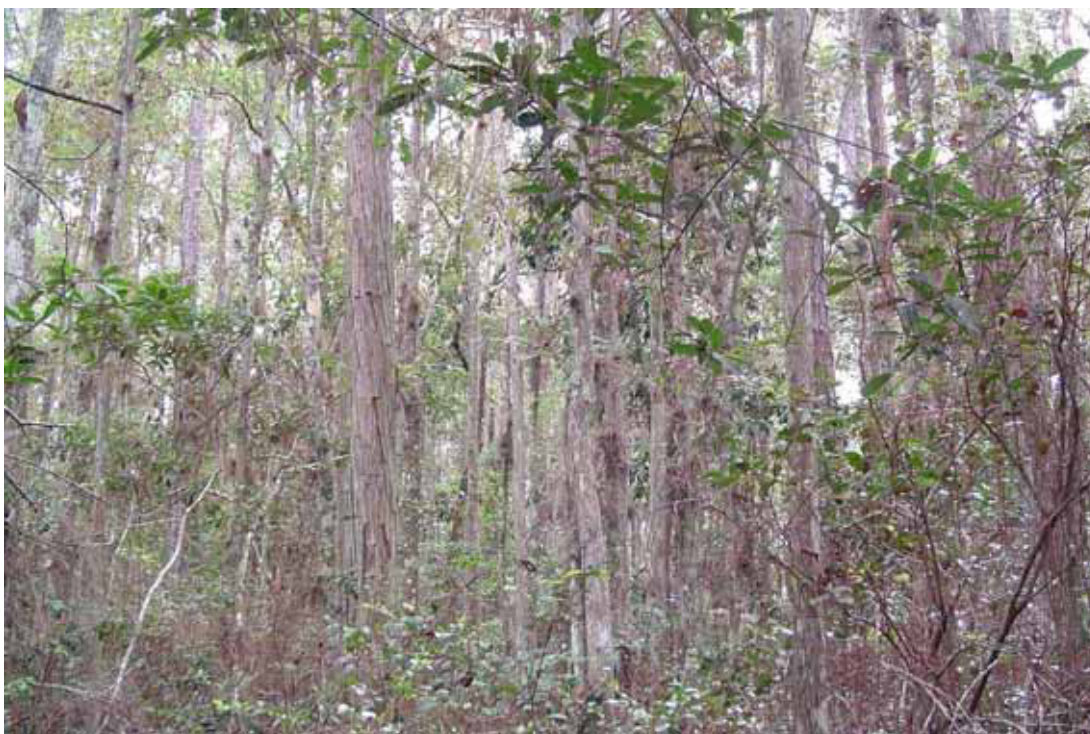
Cypress Wetland – FLUCFCS 6210

This habitat type occurs on all four sites, and is the only land use within the GSF mitigation areas. This land use type is dominated by pond cypress (*Taxodium ascendens*) or pond cypress (*Taxodium ascendens*) in the canopy with lance-leaved arrowhead (*Sagittaria lancifolia*), maidencane (*Panicum hemitomon*), pickerelweed and sawgrass (*Cladium jamaicense*) dominating the understory. Many of these systems suffer from the same condition described above for the mixed hardwood forests in that they have become, as a result of fire suppression, impenetrable thickets of fetterbush. Slightly more than half of the isolated wetlands are dome swamps dominated by pond cypress in various stages of regeneration.

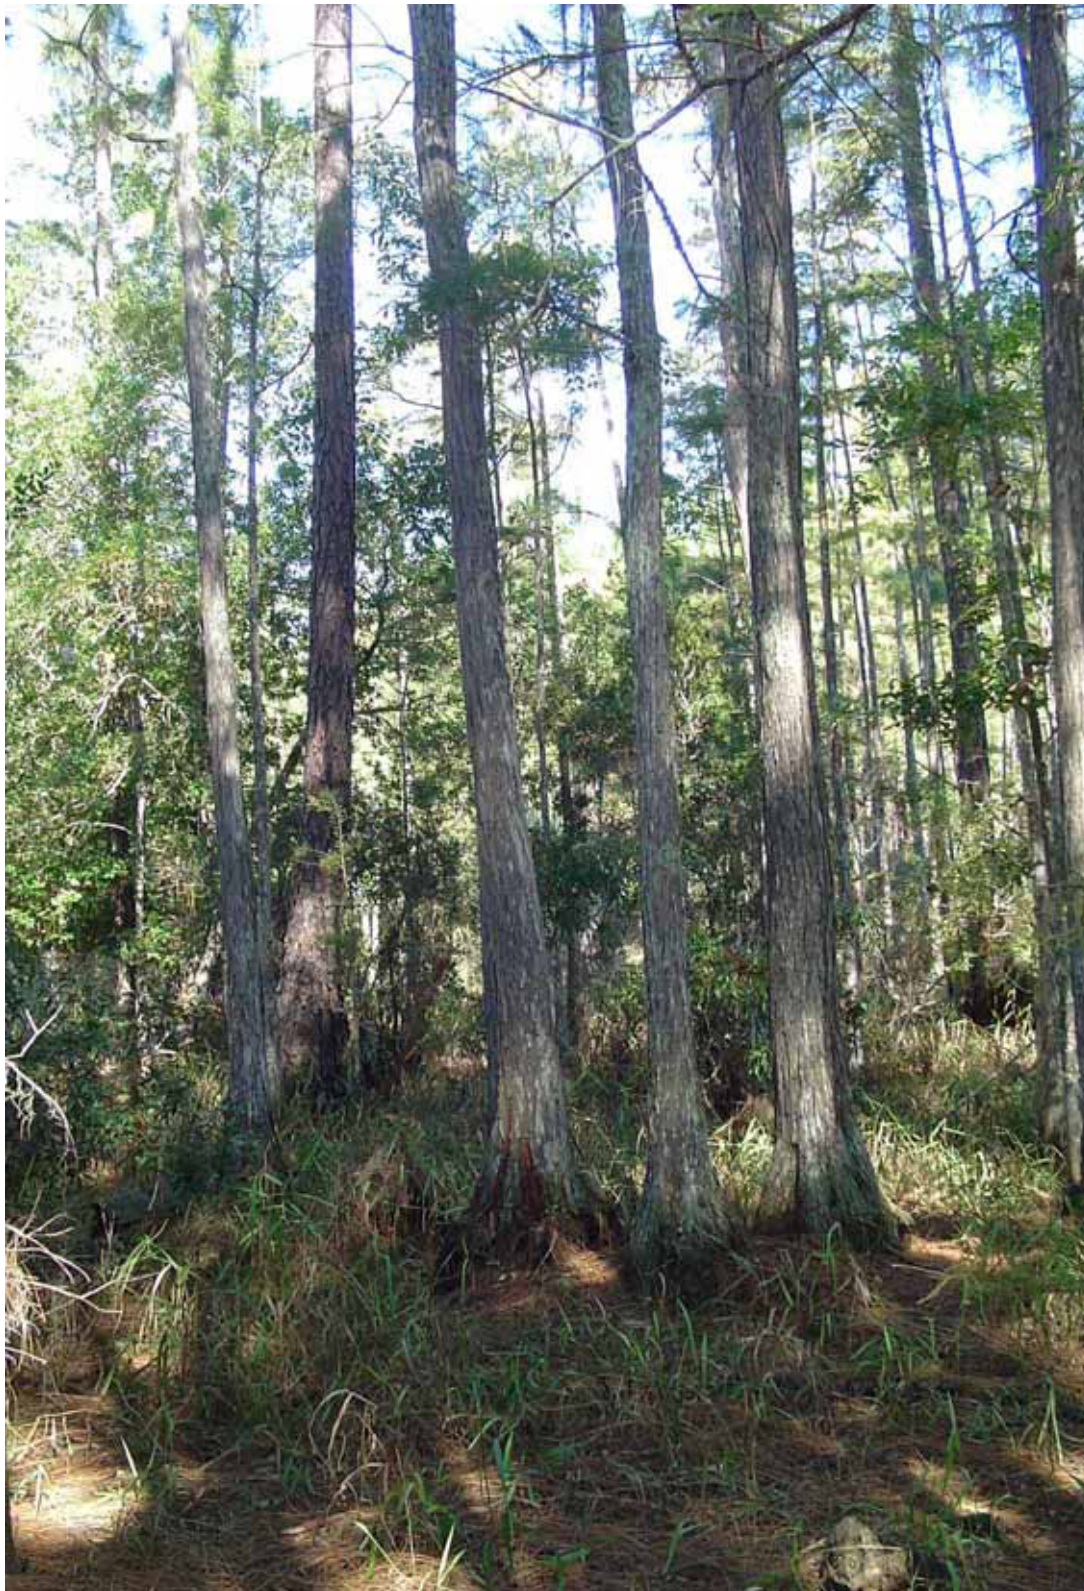
Wetland Forested Mixed – FLUCFCS 6300

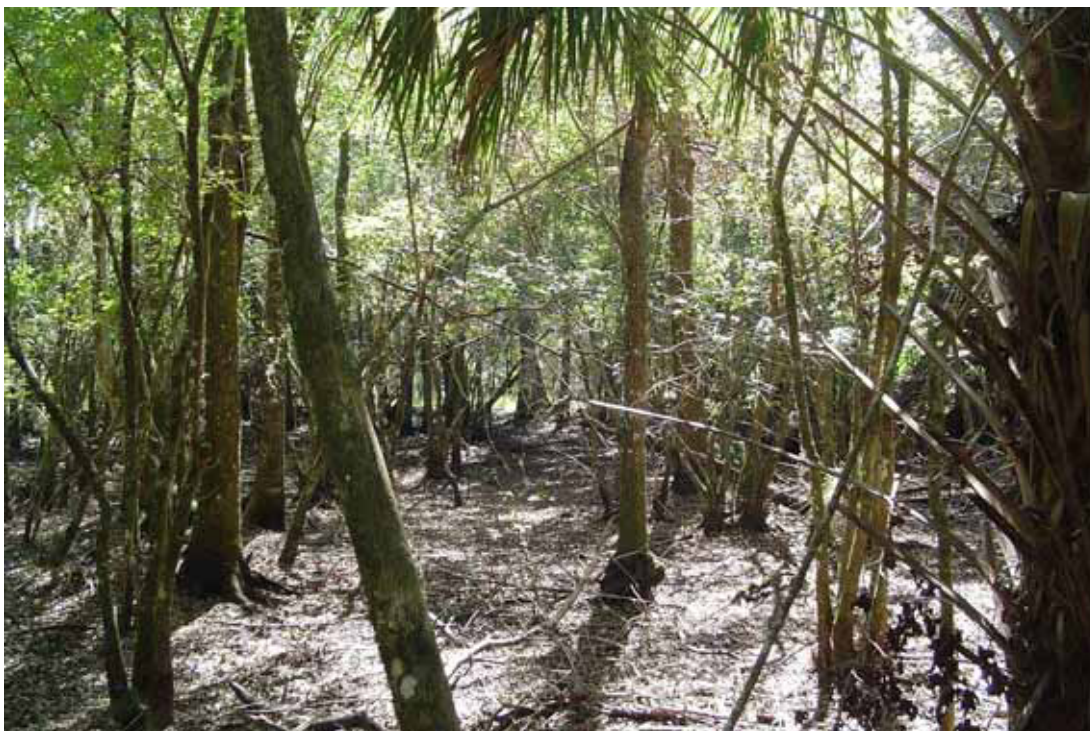
Mixed Wetland Hardwoods – FLUCFCS 6170

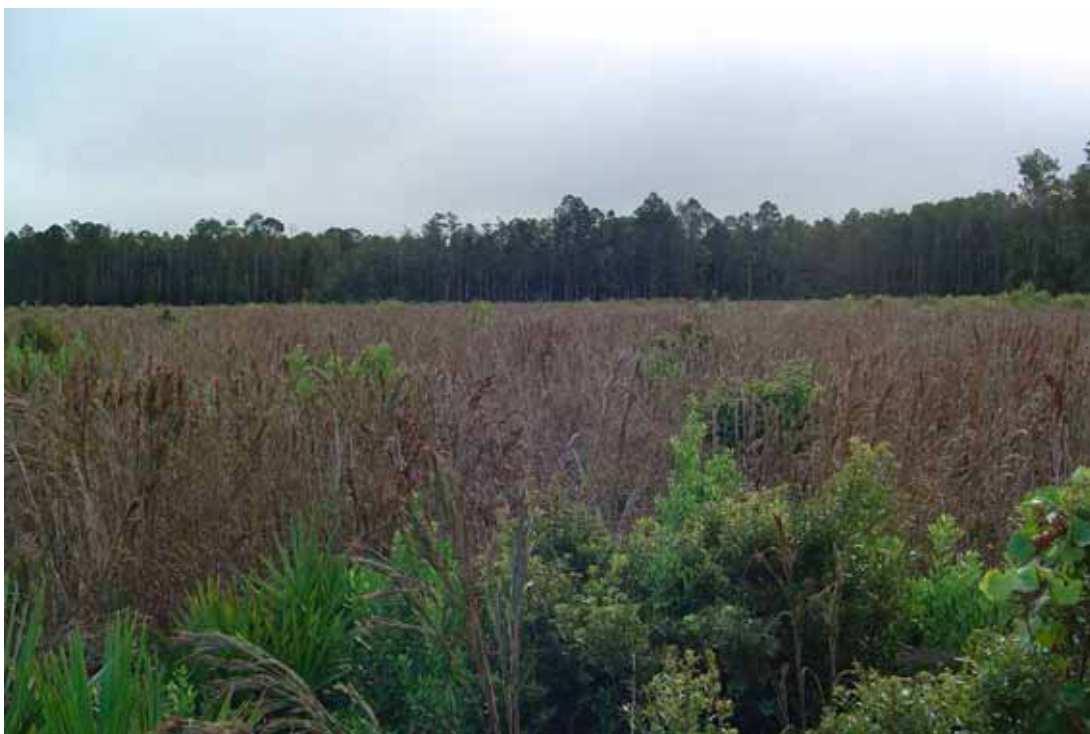
Treeless Hydric Savanna – FLUCFCS 6460

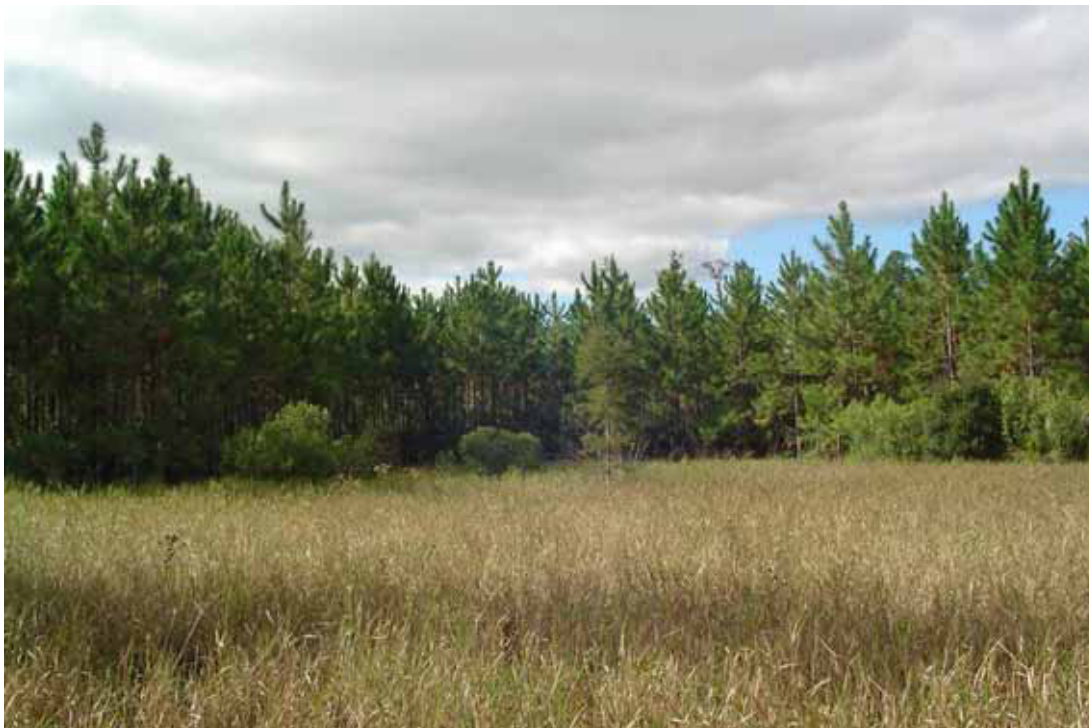
Herbaceous Wetland – FLUCFCS 6410
