**Comanche Peak Nuclear Power Plant, Units 3 & 4  
COL Application  
Part 2, FSAR**

**Figure 2.5.1-226 Photos of Roadcuts along Highway 56**

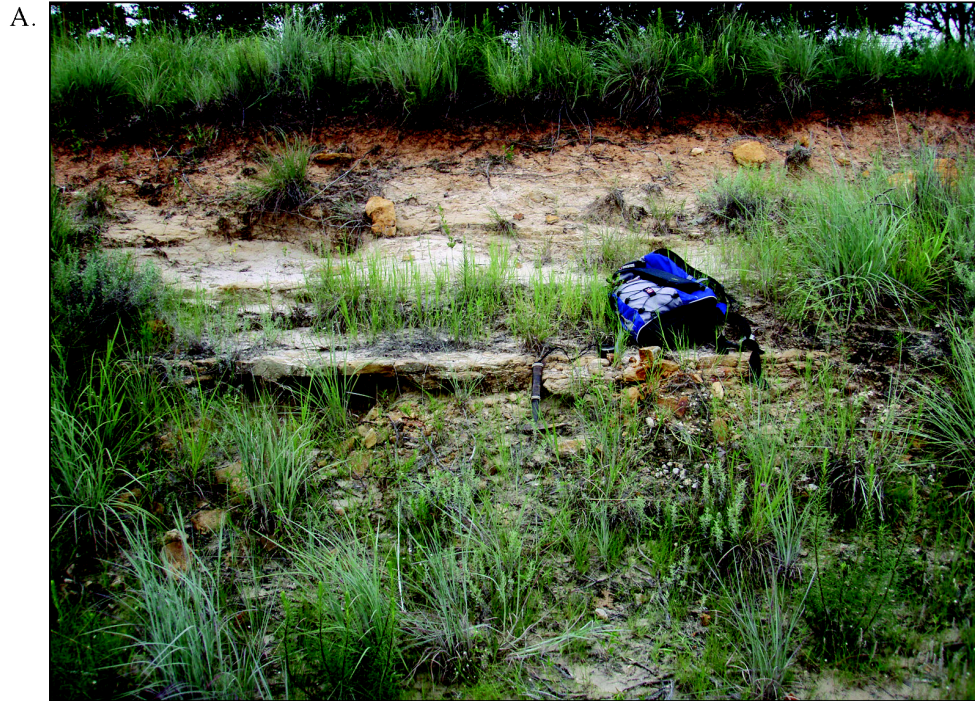
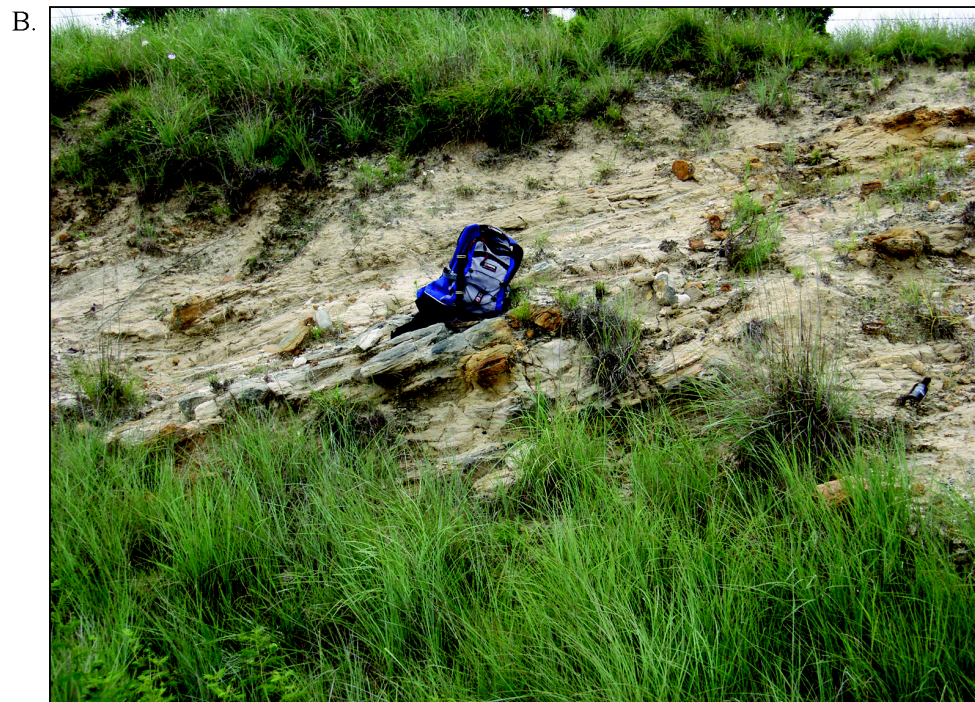
Field photos of (A) typical bedding in the Paluxy Formation and (B) more steeply dipping bedding associated with feature along Highway 56
