Figure 3E.1-14—Reinforcement Pattern for Section 3-3 of the Equipment Hatch Area

Figure 3E.1-15—Elevation View of the Entire RCB

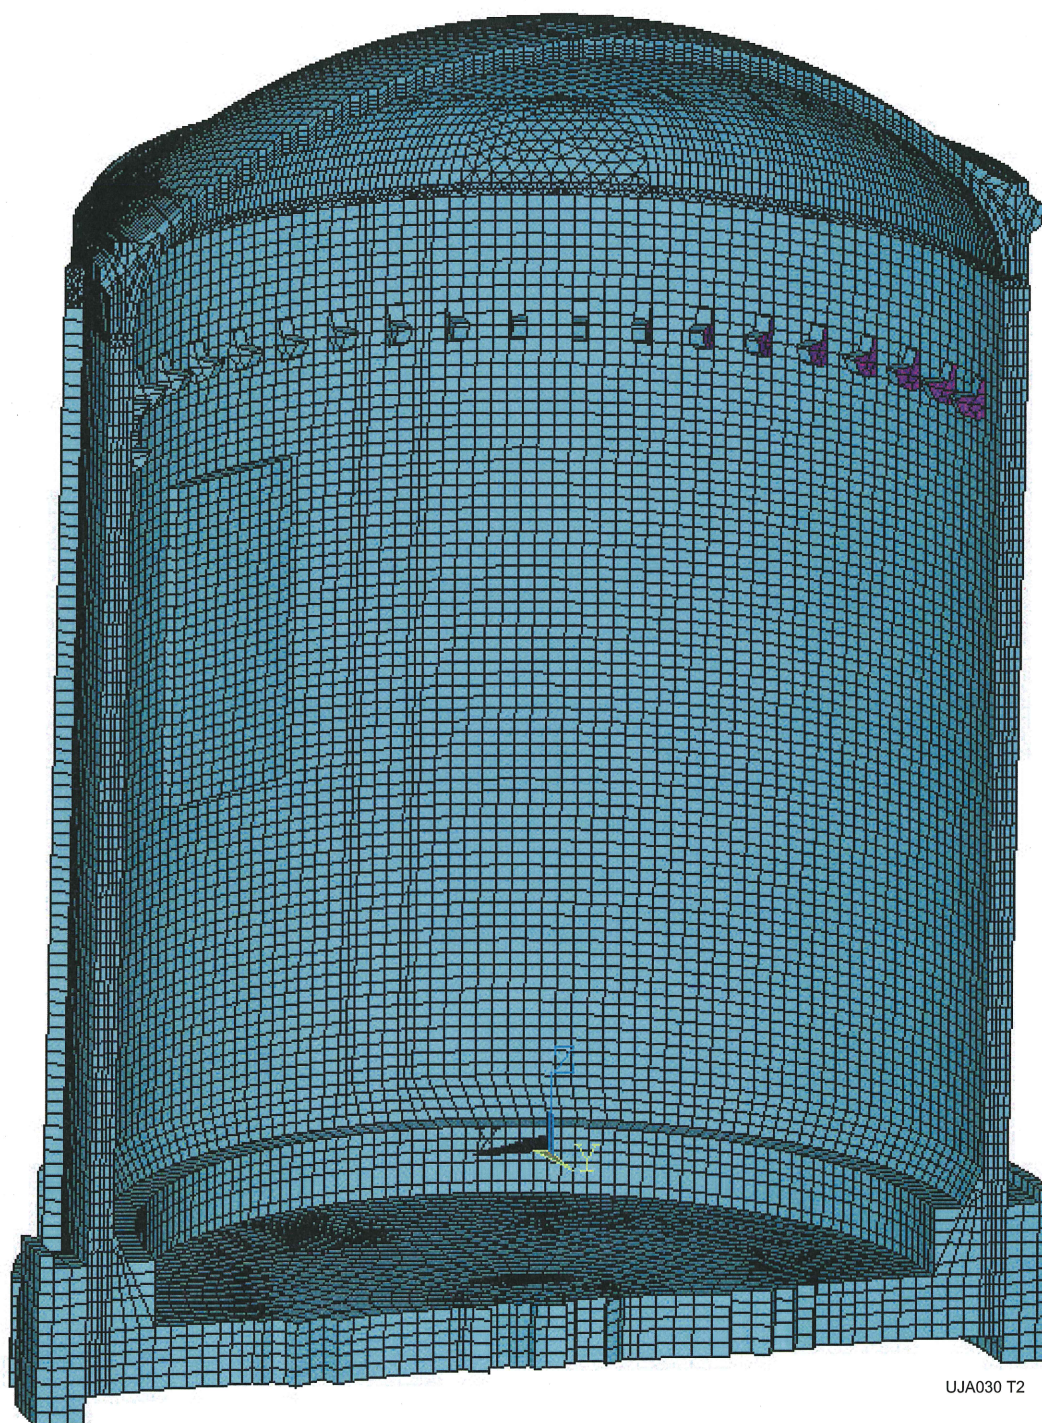
**Figure 3E.1-16—Section Cut Through Entire RCB**

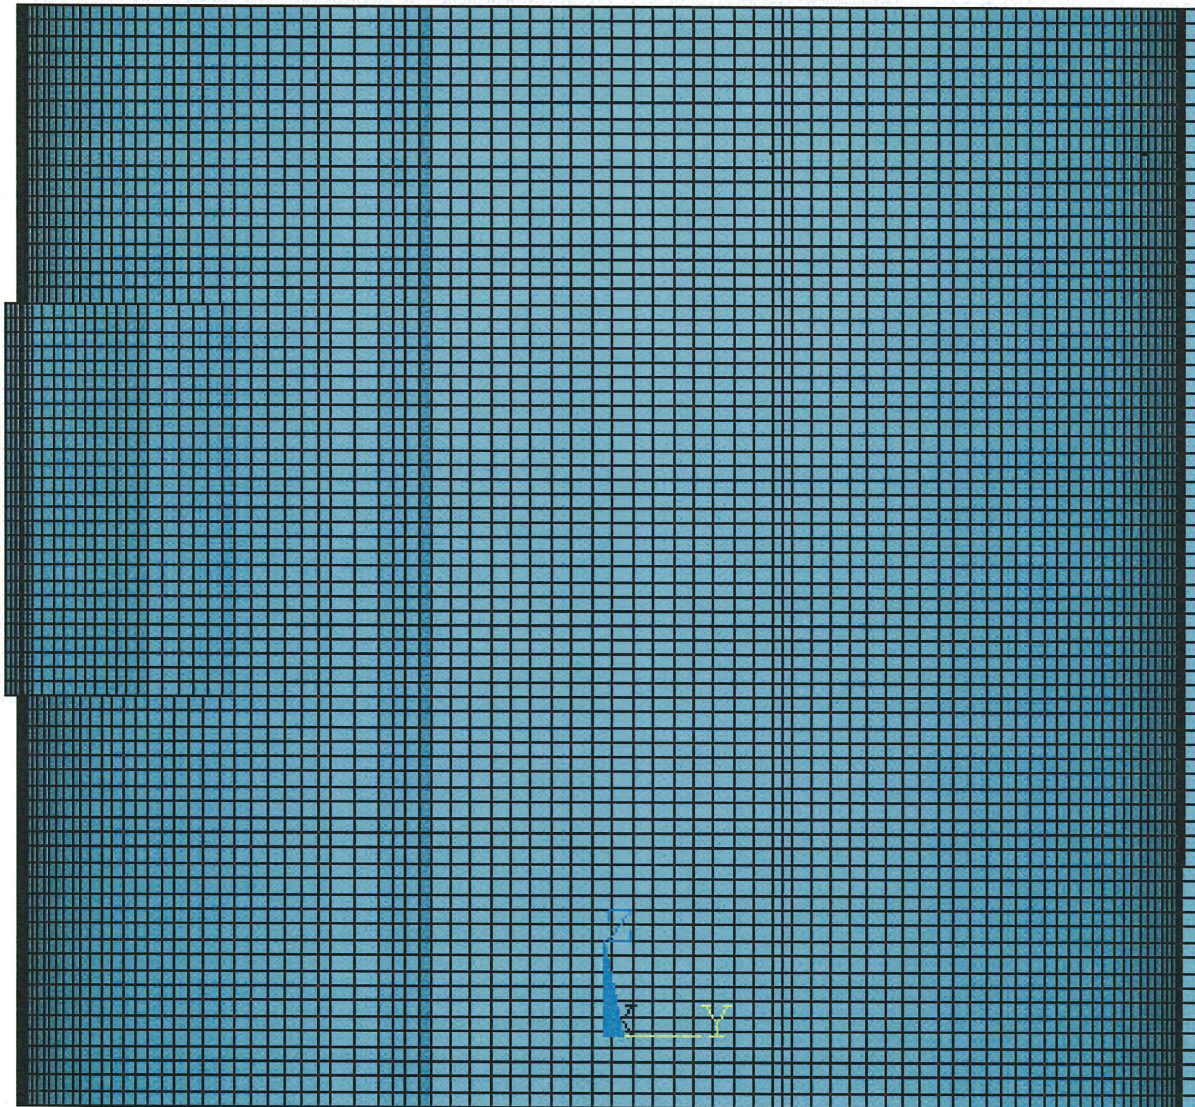
Figure 3E.1-17—Elevation View of Critical Section
