PSEG Power, LLC  
PSEG Site ESPA  
Part 2, Site Safety Analysis Report

FIGURE 2.4.6-14

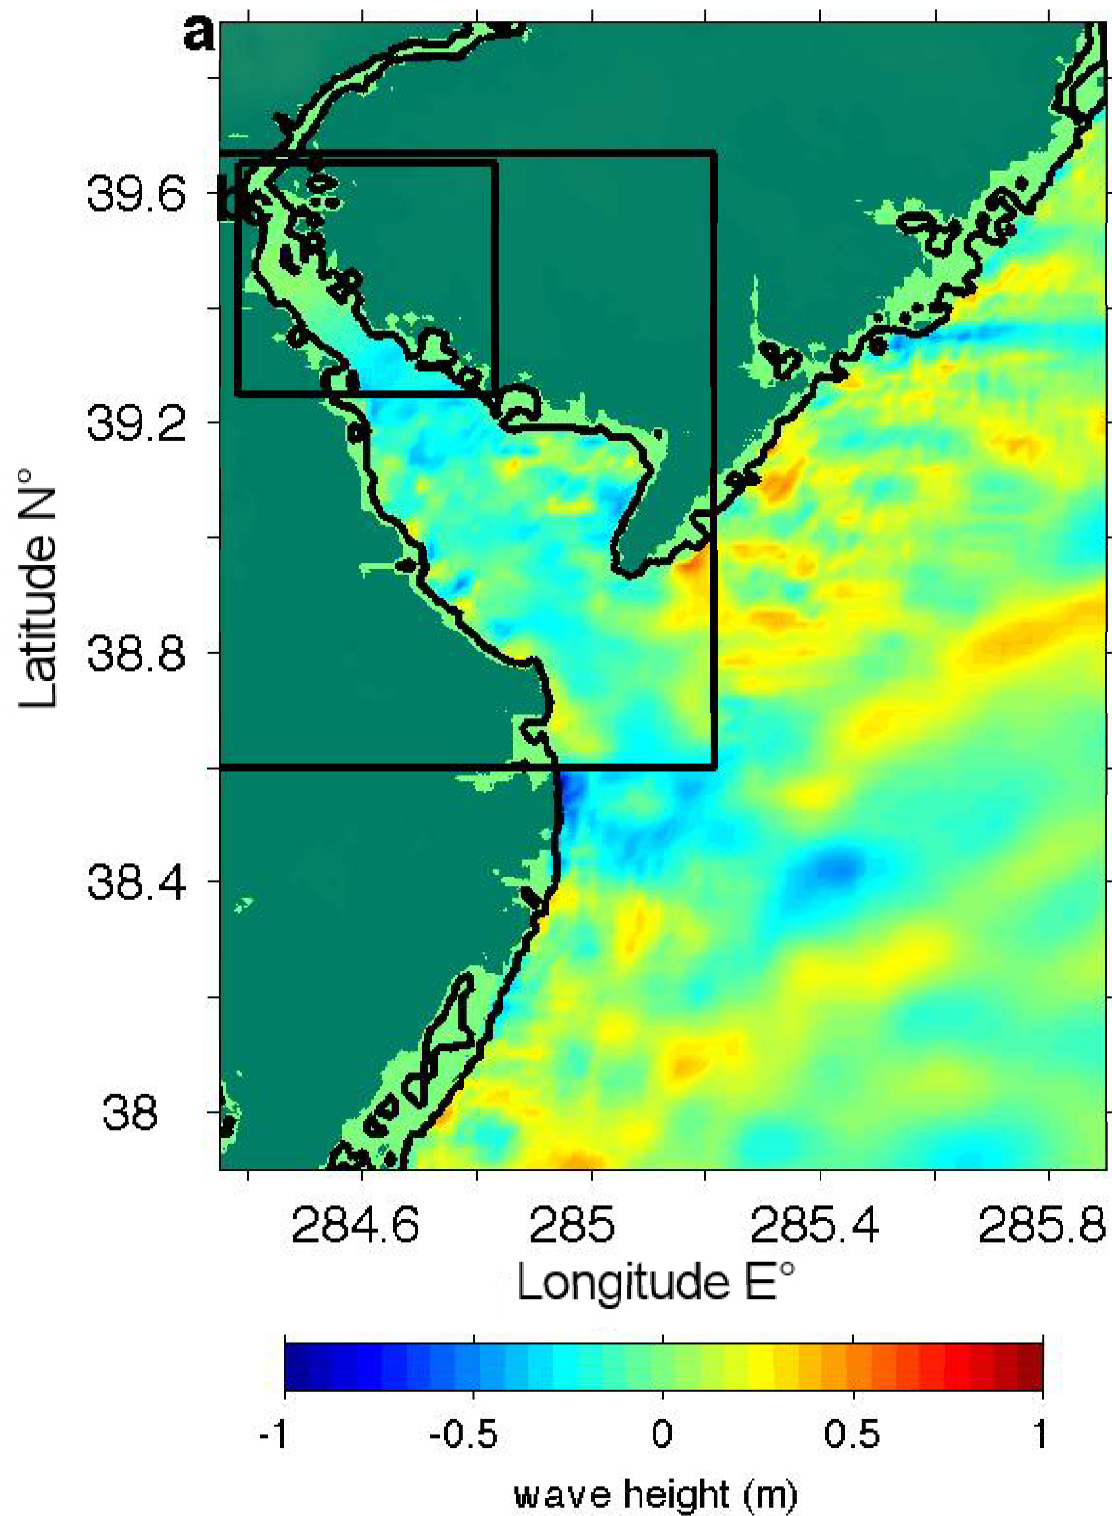
2-D Image for Currituck Slide  
at 05 hours
