PSEG Power, LLC  
PSEG Site ESPA  
Part 2, Site Safety Analysis Report

FIGURE 2.4.6-24

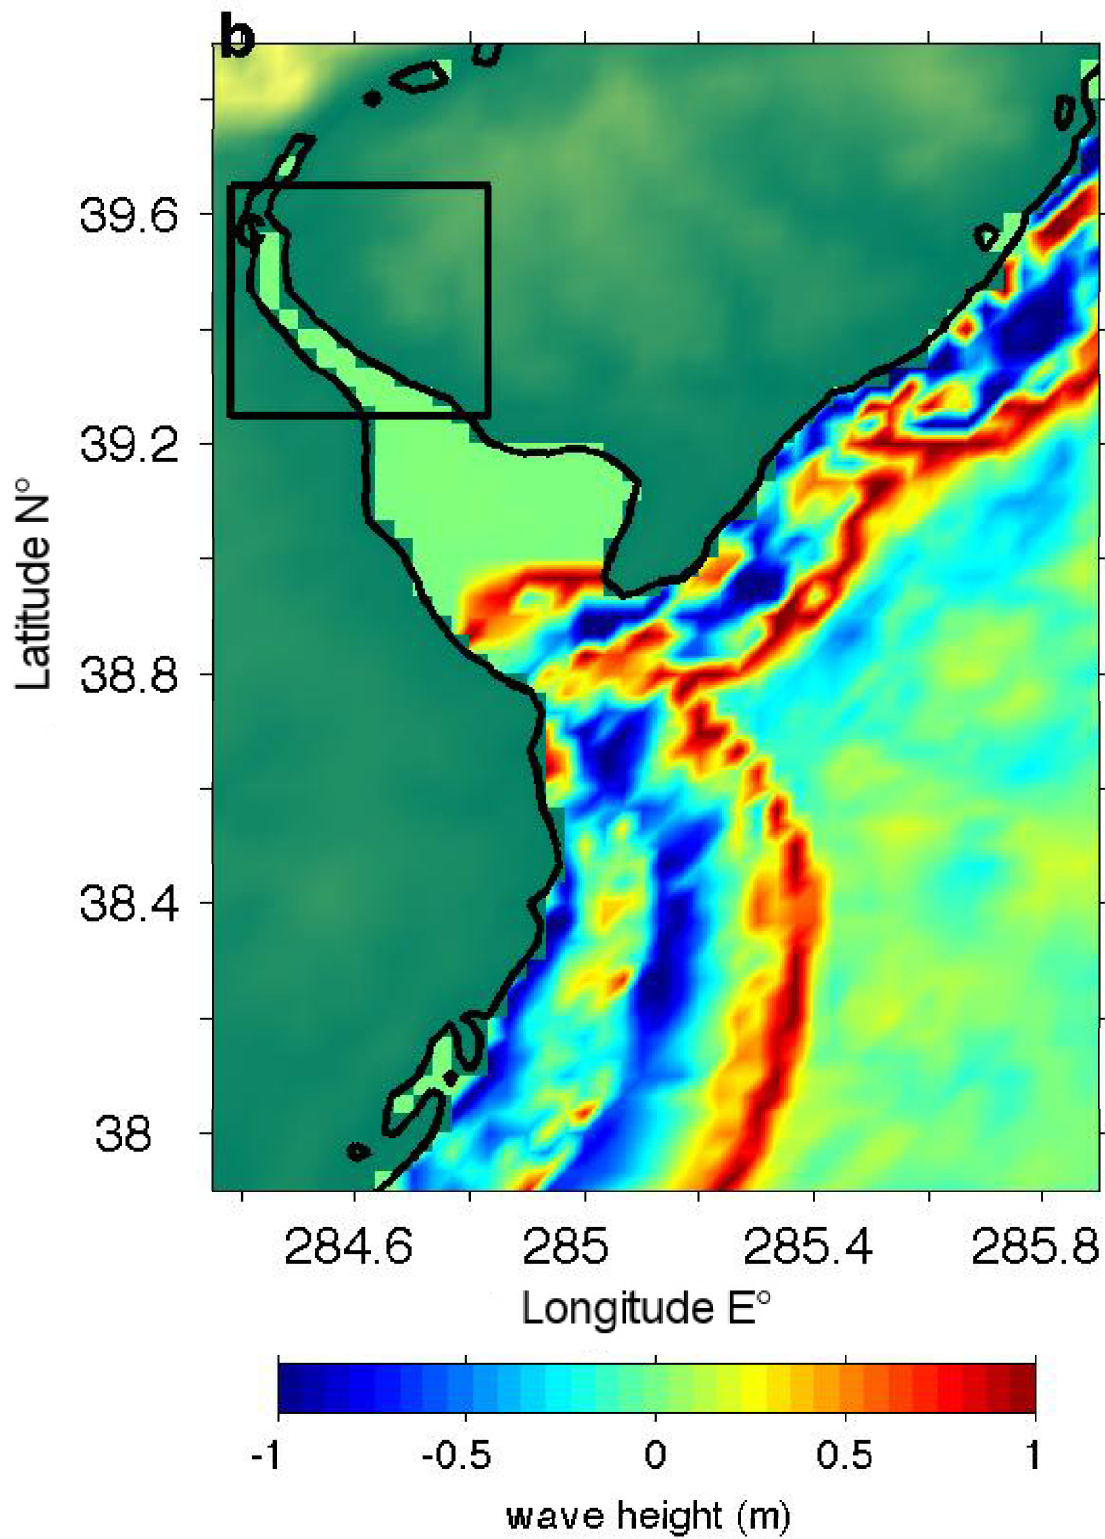
2-D Image for Hispaniola Trench  
Earthquake at 05 hours
