PSEG Power, LLC

PSEG Site ESPA

Part 2, Site Safety Analysis Report

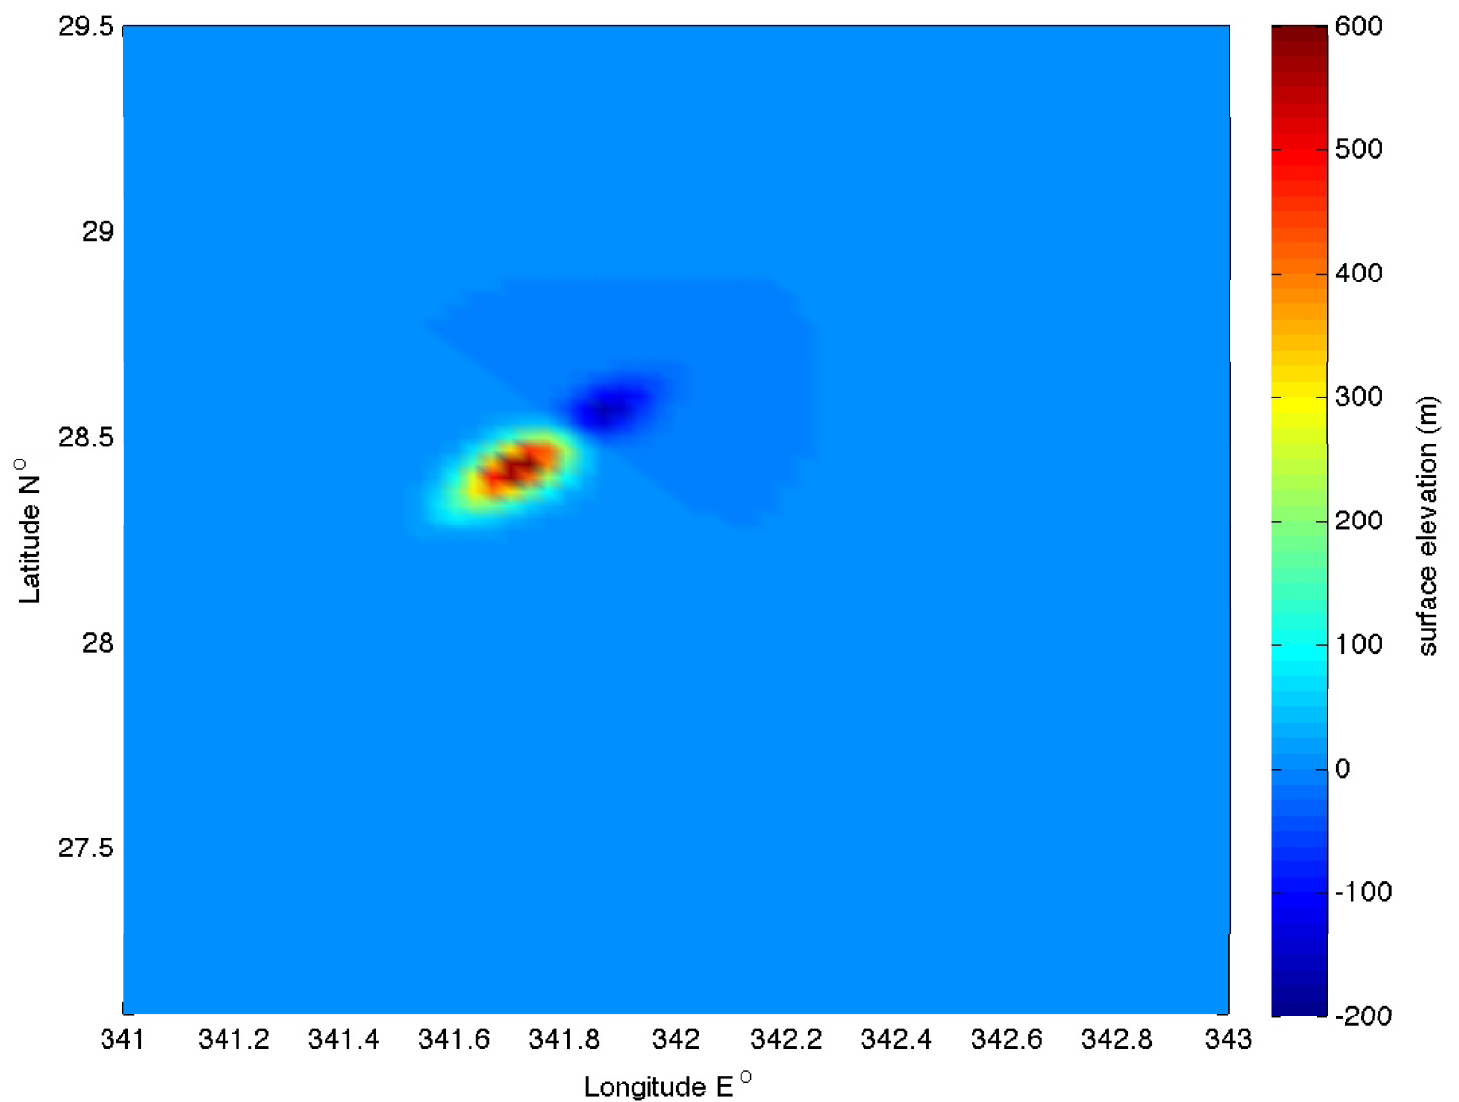
FIGURE 2.4.6-16

Initial Water Surface Elevations at
Source La Palma Slide Case
