## **APPENDIX A**

### **GYPSUM IN REDBEDS AT THE WCS SITE**

## **APPENDIX A FIGURES**

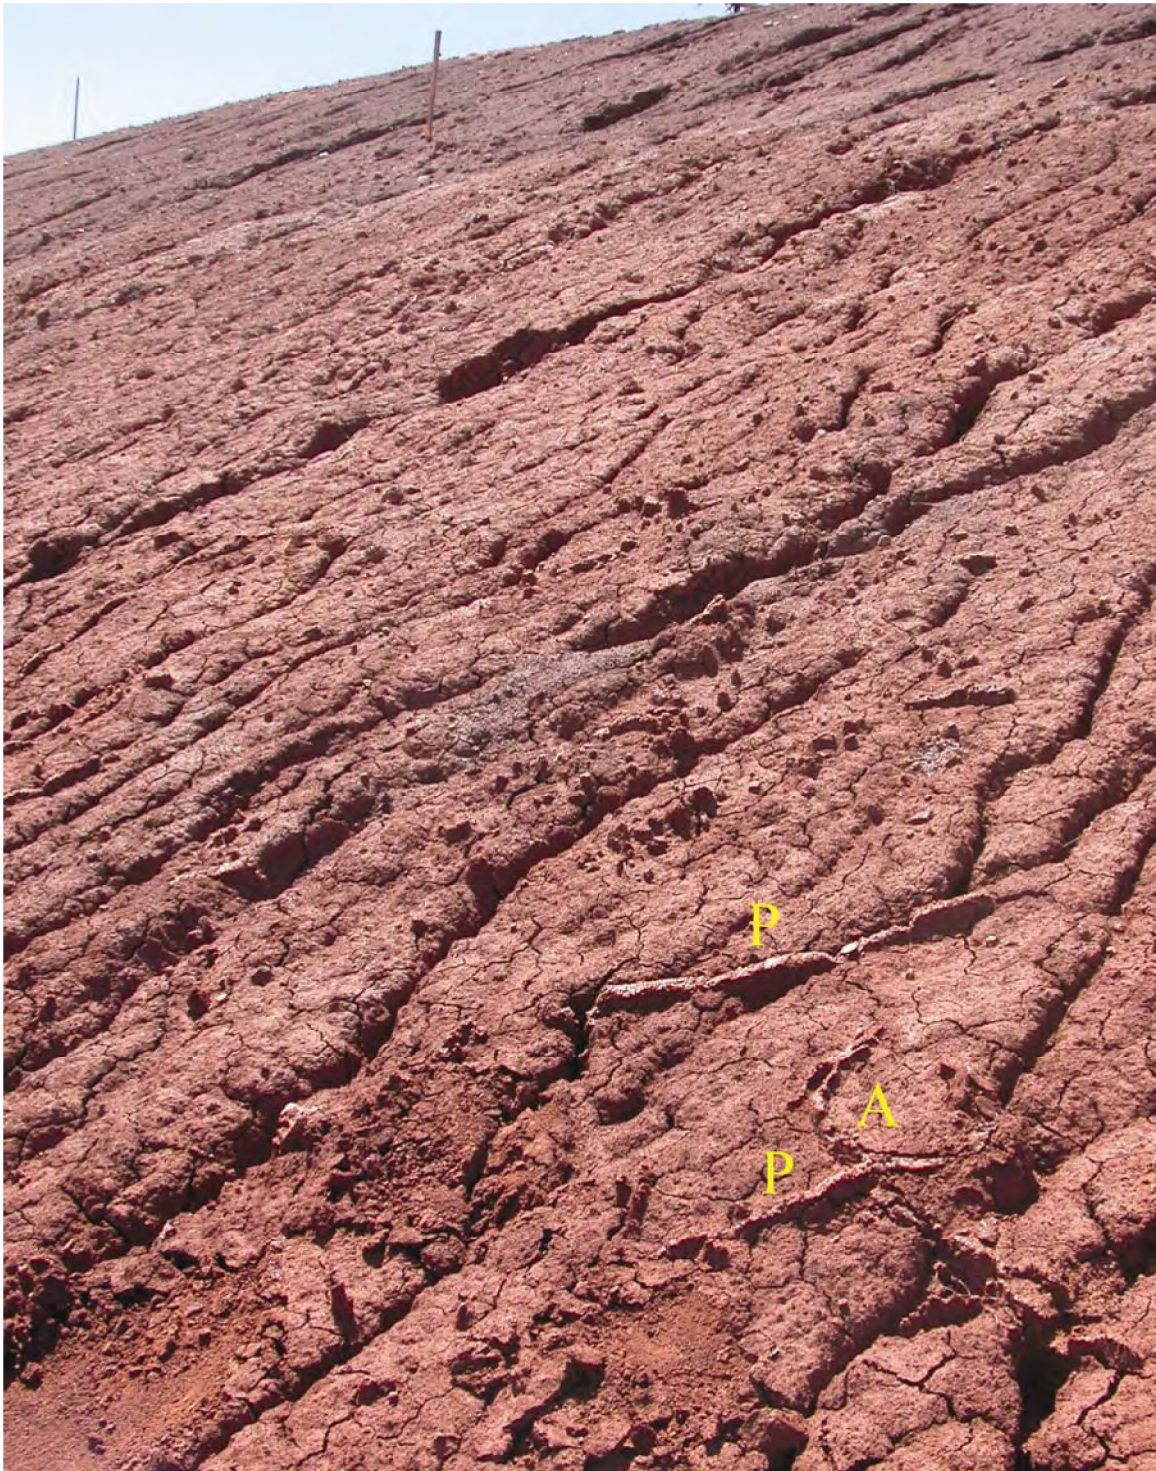
Figure 1. Antitaxial gypsum veins found in the WCS RCRA landfill are discontinuous and display planar (P) and arcuate (A) morphologies.

Poorly preserved, discontinuous, arcuate to planar, subvertical to subhorizontal, antitaxial gypsum-filled veins occur within the gypsum-bearing interval at the WCS site (Figure 1). Crystals within the veins are blocky and are primarily oriented perpendicular to the edge of the vein, indicating that minimum principle stresses were oriented subvertically when the veins formed (e.g., Durney and Ramsay, 1973; Ramsay, 1980). Gypsum crystals within the veins appear to be partly corroded or fluted and may show local overgrowths or recrystallization (Figure 2), indicating a complex fluid history since the veins first formed. Medial lines,

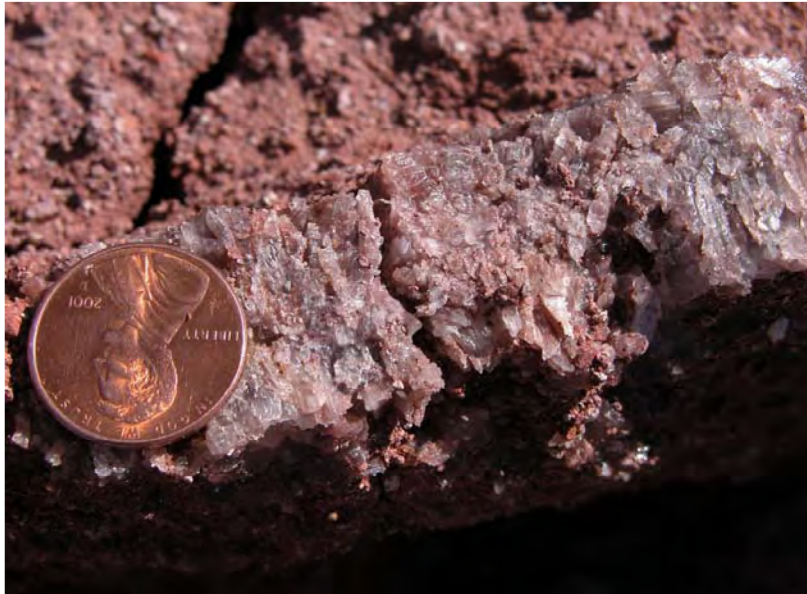
Figure 2. Gypsum crystals within antitaxial veins appear to be partly corroded or fluted and show local overgrowths and possible recrystallization.

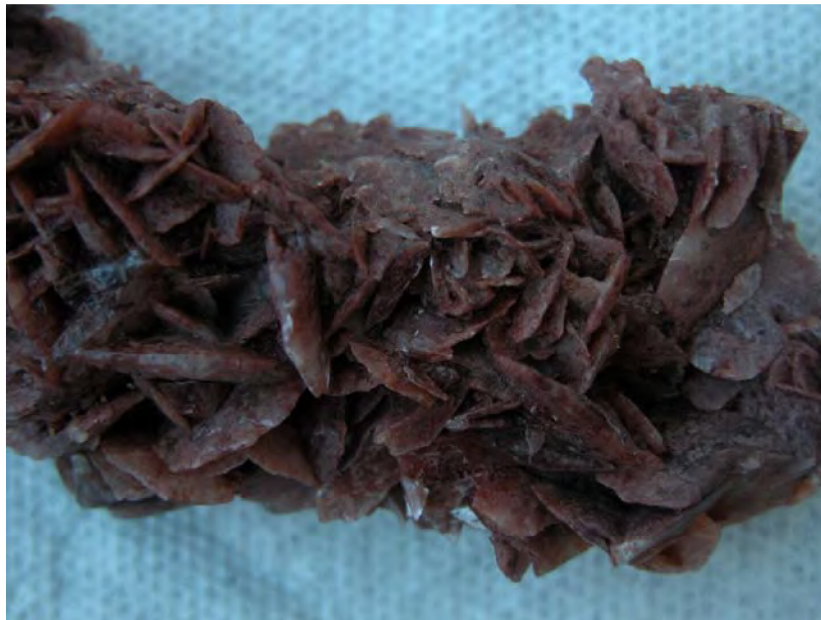
Figure 3. Rosettes of gypsum crystals display lenticular crystal habits. This example occurs in a roughly cylindrical zone and could be a rizolith.

At the WCS site, lenticular gypsum rosettes occur in elongated zones along some fractures, in cylindrical zones (possible rizoliths) (Figure 3), and as irregular masses (Figure 4). Gypsum crystals range up to ~1 cm and contain inclusions of the mudstone host rock. The morphology of the gypsum crystals provides some information about their origin. Lenticular gypsum crystals form from alkaline fluids (pH >7.5) in the presence of soluble organic materials at relatively high temperatures (greater than ~ 35° C) (e.g., Cody, 1979; Cody and Cody, 1988). Lenticular penetration twins observed at the WCS site also require the presence of high concentrations of terrestrial humic substances in the pore fluids (Cody and Cody, 1988).

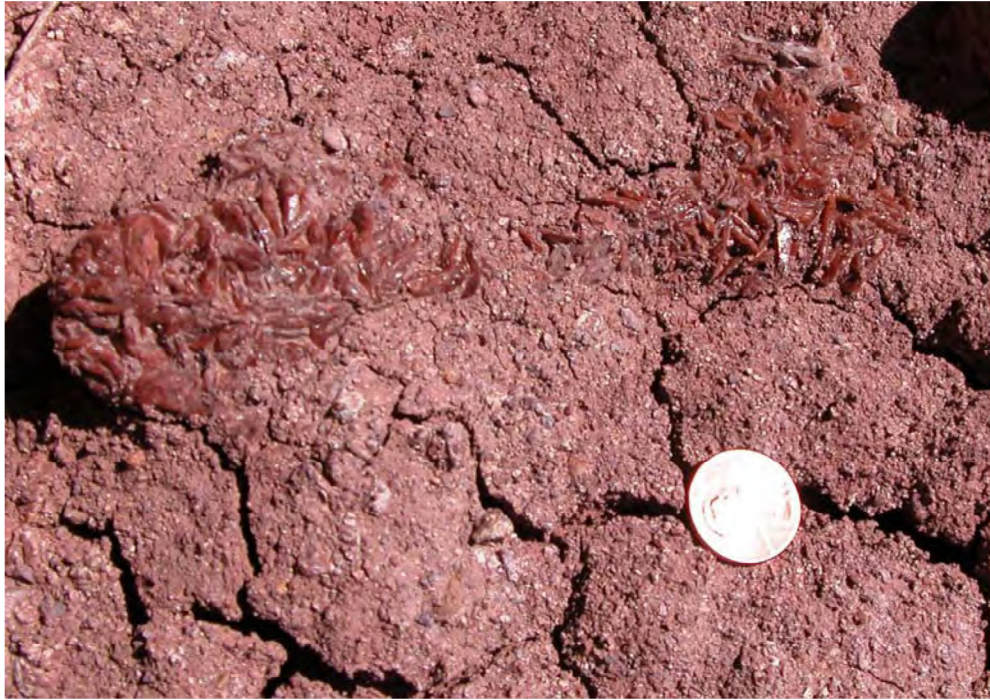
Figure 4. Some lenticular gypsum rosettes occur in irregular masses within the host mudstone.

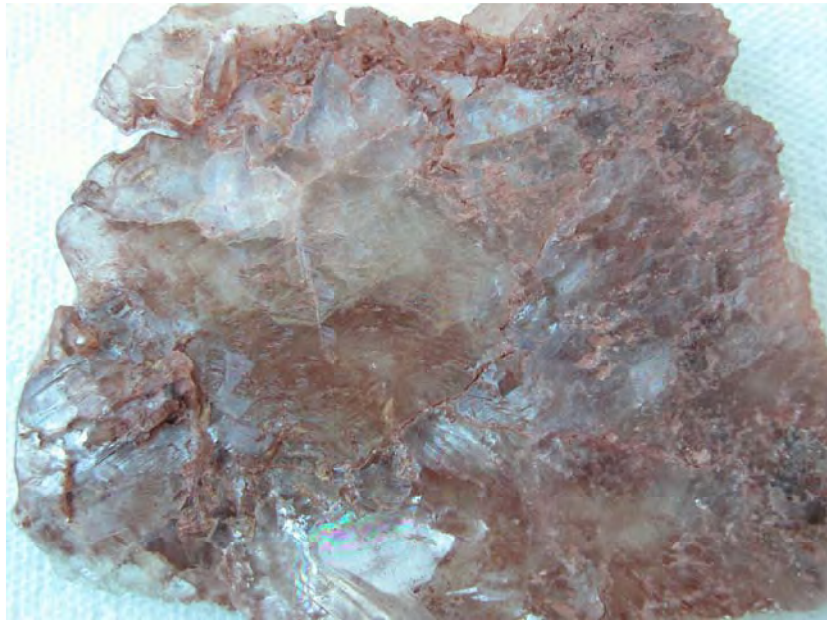
Figure 5. This gypsum fracture filling from the WCS site displays large interlocking crystals with lenticular surfaces. Note that some wall rock mudstone has been incorporated within the crystals, especially along crystal boundaries.

Large (several cm), interlocking gypsum crystals occupy some fractures at the WCS site (Figure 5). Some crystals contain small inclusions of mudstone, while the surfaces of other crystals are lenticular. The large crystal size indicates that most of this gypsum grew passively into and filled existing void space associated with fractures. Limited displacive and incorporative growth may have occurred as the crystals began to encroach on the boundary of previously open fractures.
