NUREG/CR-7246
PNNL-27003

Reliability Assessment of Remote Visual Examination

Remote visual testing (RVT) is a commonly used nondestructive examination method for inservice inspection (ISI) of reactor internals to detect cracking and gross component failures. Despite widespread use, the detection reliability of RVT and the factors that impact overall RVT performance have been unresolved issues. This report describes the results from an assessment sponsored by the U.S. Nuclear Regulatory Commission and conducted by the Pacific Northwest National Laboratory, in cooperation with the Electric Power Research Institute, for evaluating the reliability of RVT methods currently being used for [reactor] in-vessel visual inspection.

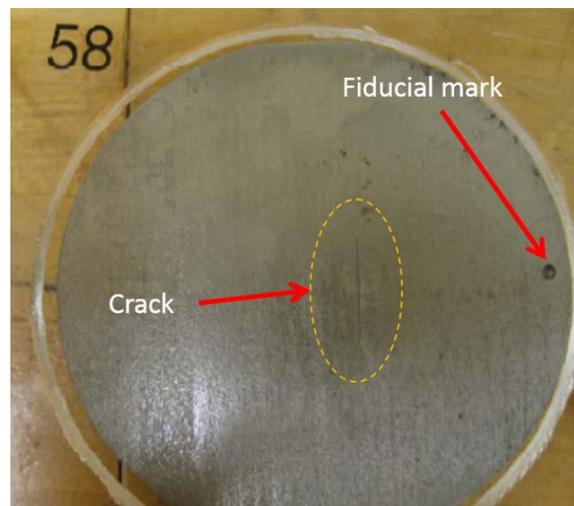
Figure 4-1 Example of Specimen Used for Phase I Mini-RRT

The specimens used for the mini-RRT were designed to identify variables that may affect the performance of remote visual examination techniques for detecting flaws in test specimens. The specimens used for the mini-RRT had a fiducial mark indicating the 0° location (Figure 4-1). Specimens could be rotated so that the fiducial was located at 0°, 90°, 180°, or 270° from the vertical. This allowed the physical location and orientation of the cracks to vary relative to the observer and tested the effect of flaw orientation on detection performance.

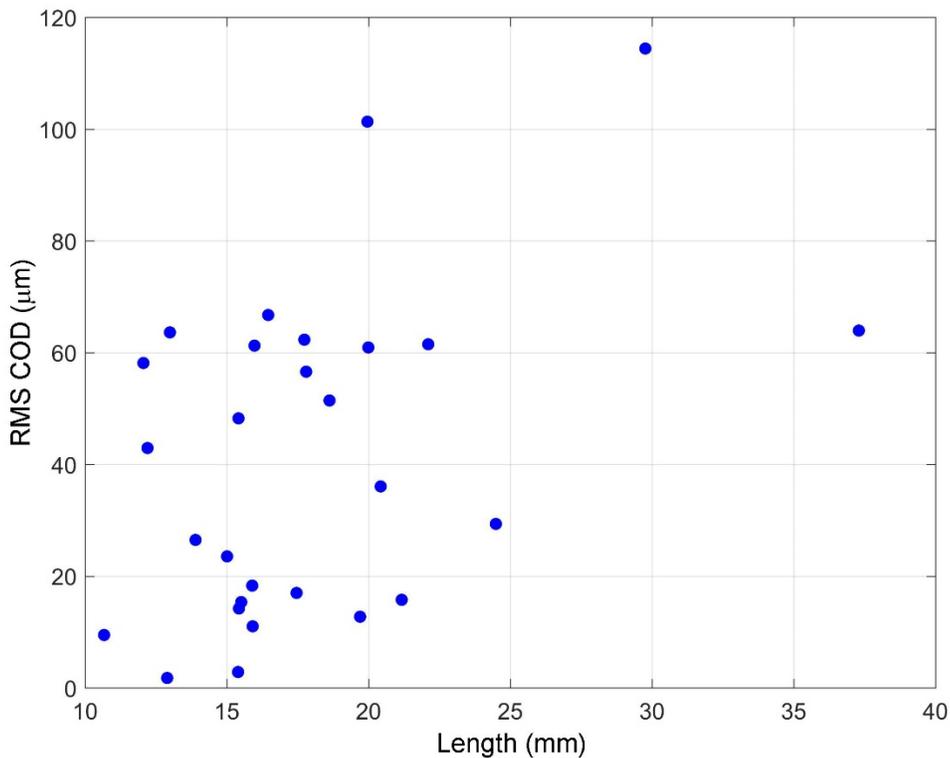
Figure 4-2 Distribution of Crack Lengths and COD for Phase I Mini-RRT Specimens

Two fundamental parameters (crack length and COD) were used in the specimen and RRT design process. For the mini-RRT, the distribution of COD and lengths is shown in Figure 4-2. Table 4-2 shows a summary of the COD and length ranges for flaws used in the parametric study. Section 4.1.2 describes the COD quantification procedure in greater detail.

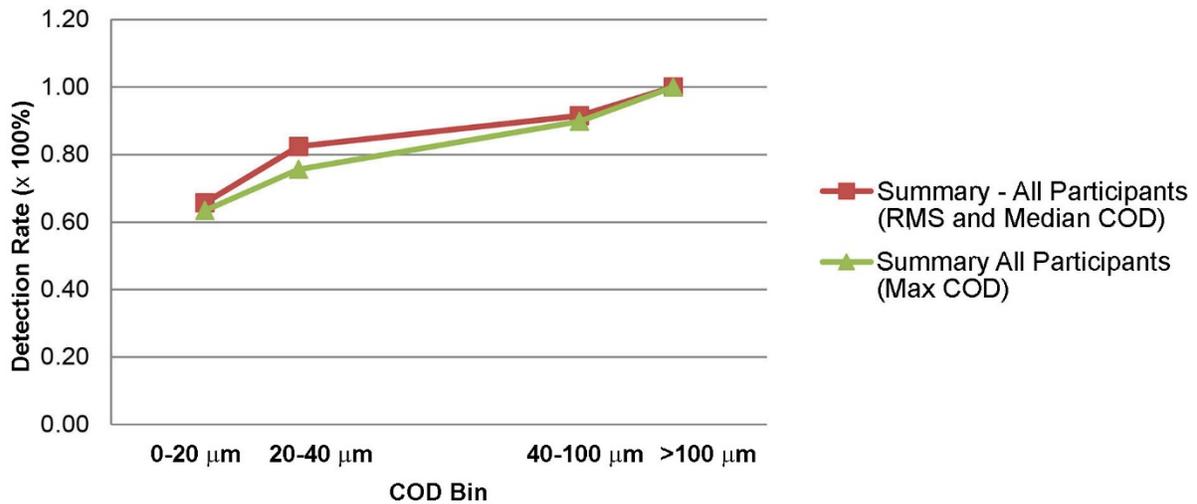
Figure 4-3 Detection Rate (total, over all trials) as a Function of COD. Detection rates as a function of RMS and median COD are identical.

Figure 4-3 summarizes the overall detection rate from the mini-RRT, averaged over all trials and all participants, as a function of the COD. As seen from this graphic, the overall detection rate increases as the COD increases and there is no significant difference in detection rate between the various computation methods (RMS, median, maximum). Note the detection rates when using RMS and median to compute COD are the same.

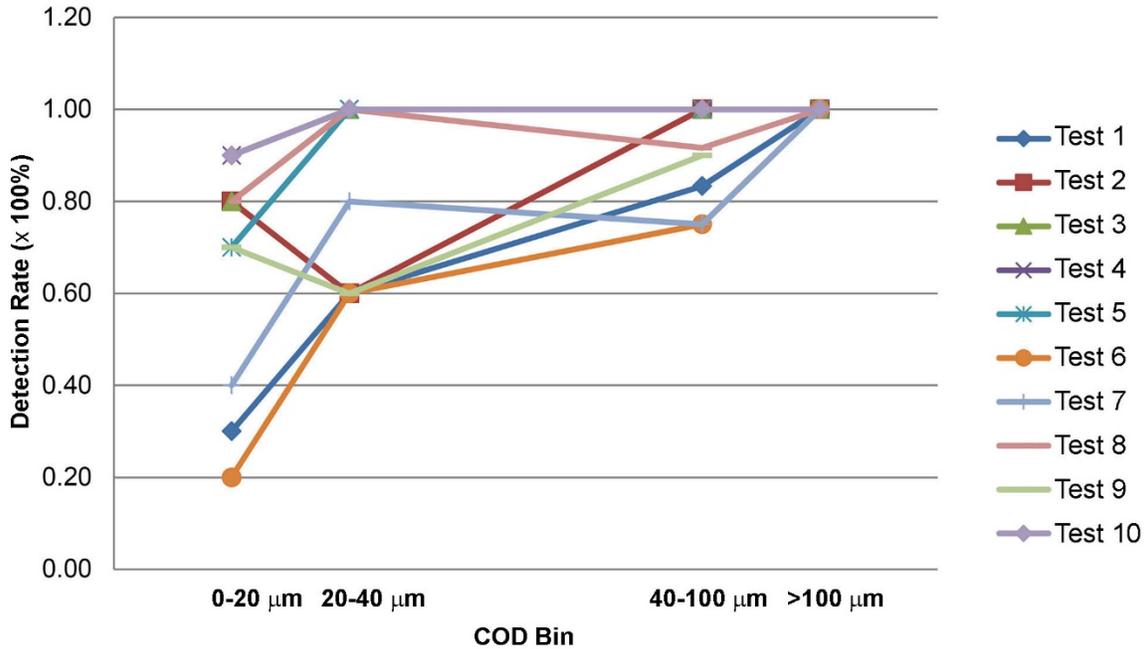
Figure 4-4 Detection Rate as a Function of RMS COD for Each of the Ten Tests (Trials). Data from some of the tests are identical and the corresponding data plots are hidden by the data from other tests.

Figure 4-4 shows the detection rate for each trial, where a trial consisted of a single test administered as part of the mini-RRT, as a function of the same COD ranges. This breakdown by trial shows interesting variations, particularly for the smaller COD cracks. An evaluation of the underlying data indicates that potential factors influencing this result include participant experience as well as a potential learning effect that may have occurred as a result of participants being allowed to take the test multiple times.

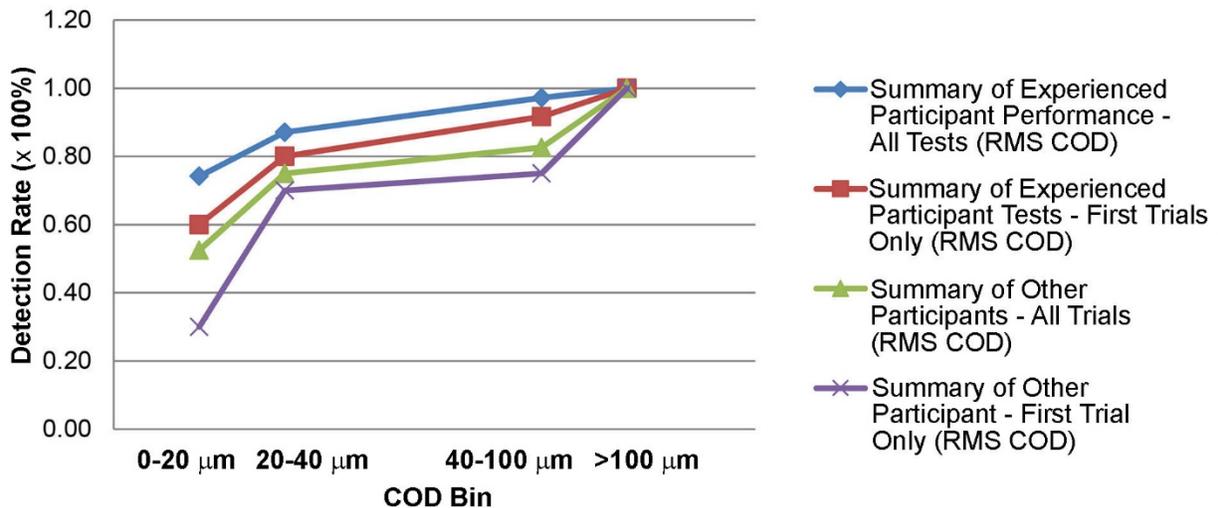
Figure 4-5 Detection Rate (organized by participant experience) as a Function of RMS COD. Because some participants took the test multiple times (although using different cameras), the results are further separated by combining only the first trials for each participant vs. all trials for the participants.

Figure 4-5 shows clear differences in the average detection rate between experienced participants vs. other participants. The detection rate, when accounting for repeated trials, also shows an improvement. Anecdotally, during debriefing, participants indicated that their familiarity with the specimens increased as they were given multiple opportunities to go through the tests, and that they were better able to adjust to the surface condition and lighting needs to detect cracks.

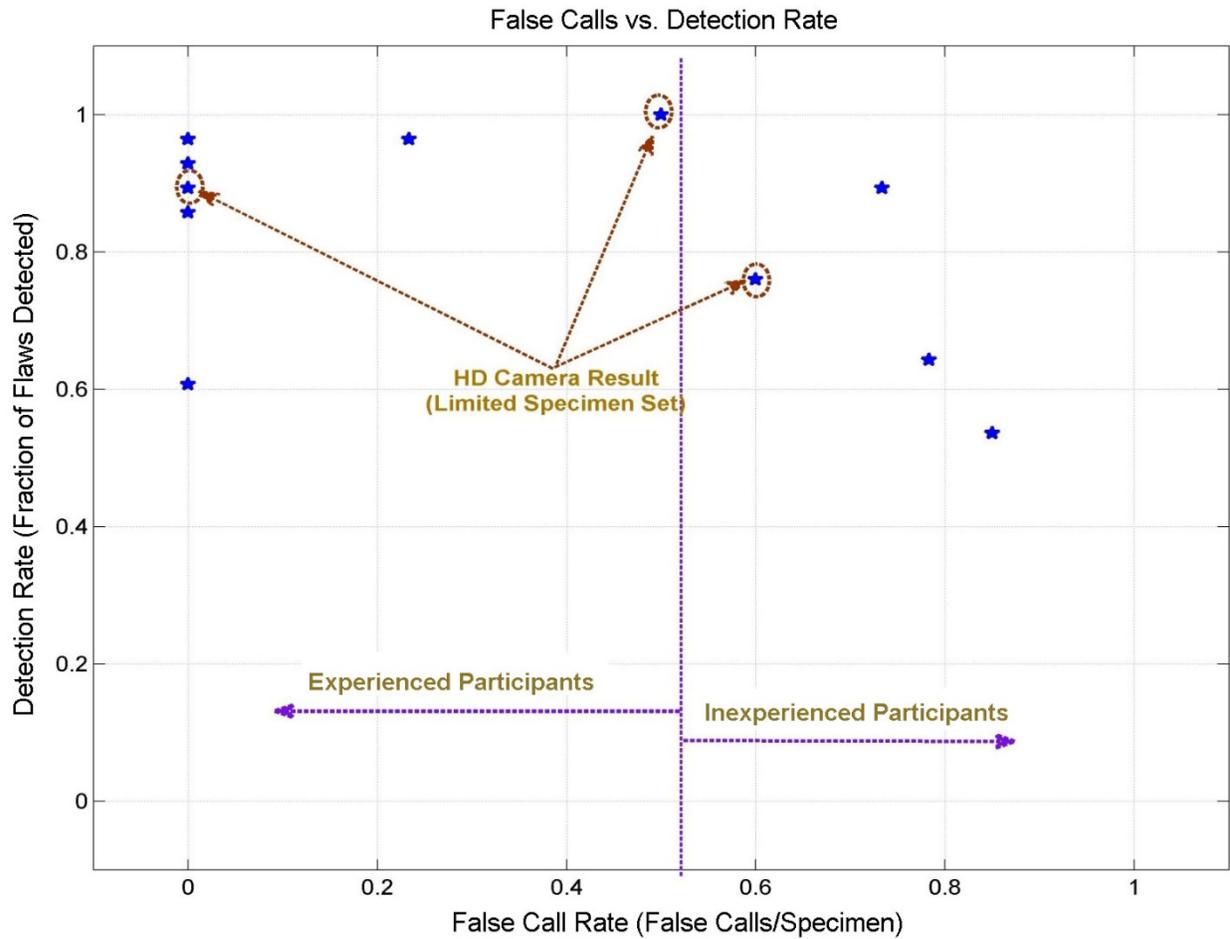
Figure 4-6 Detection vs. FCRs for Each Test

Analysis indicated the overall FCR was low when measured in false calls per specimen. However, there was again a quantifiable difference in the FCR based on the participant's experience, with the experienced participants who perform RVT examinations routinely having fewer false calls overall. This is illustrated in Figure 4-6, along with the detection rates. A possible cause of this result is that experienced participants are trained to assess an indication possibly using multiple viewing angles, and adjusting the camera zoom and lighting, enabling them to more effectively discriminate between flaws and other non-reportable indications such as surface features. In practice, this may mean a lower FCR in field examinations.

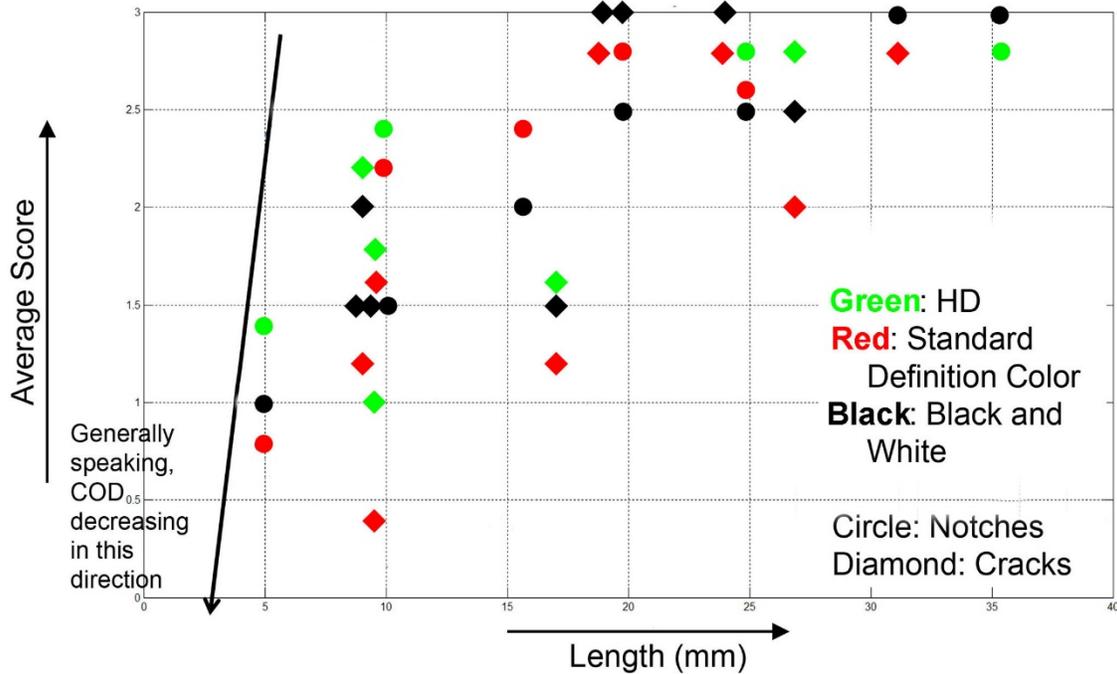
Figure 4-7 Average Detection Score vs. Length for Cracks and Notches in Stainless Steel

The results overall seemed to indicate correlation of detection performance with both COD and length, with little to no variation among cameras.

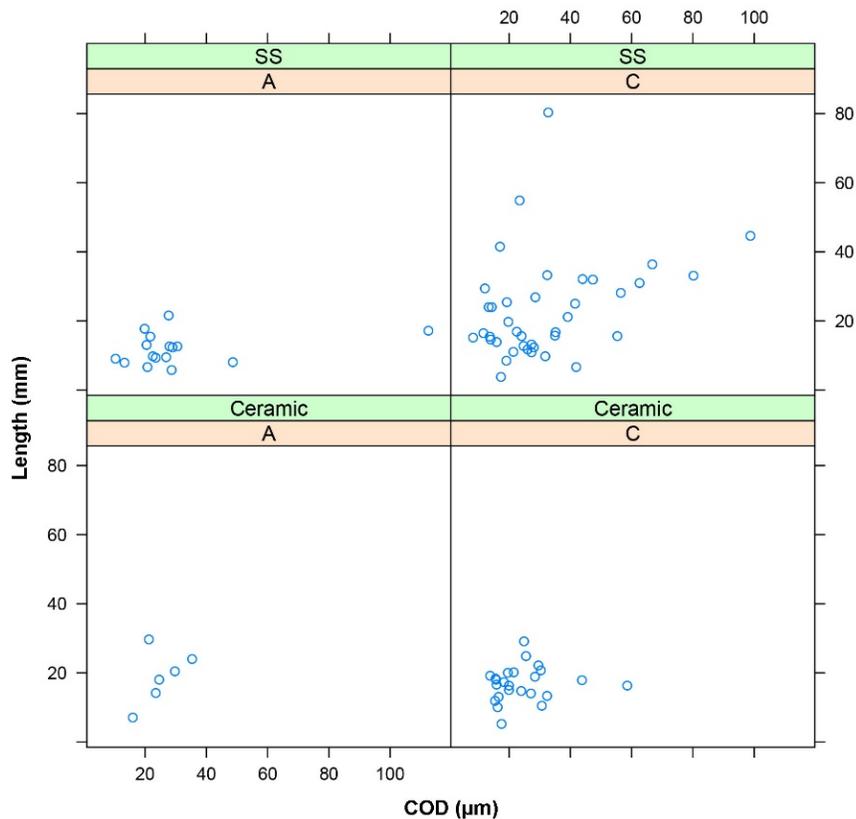
Figure 5-1 Flaw Dimensions Organized by Orientation (Axial, Circumferential) and Specimen Type (Ceramic, Stainless Steel)

Figure 5-1 shows the distribution of crack sizes (COD vs. length) for the various types of cracks in ceramic and stainless steel specimens. Note that the axis labels for all four sub-plots in Figure 5-1 are the same, and the labels from two of the four plots have been dropped to avoid cluttering the plots. The values for data points in these plots may be determined by examining the axis labels in adjacent plots. The distribution indicates a correlation between COD and length (chiefly associated with the extreme values). However, determining which of these two factors influences the POD should still be possible if the effect is strong.

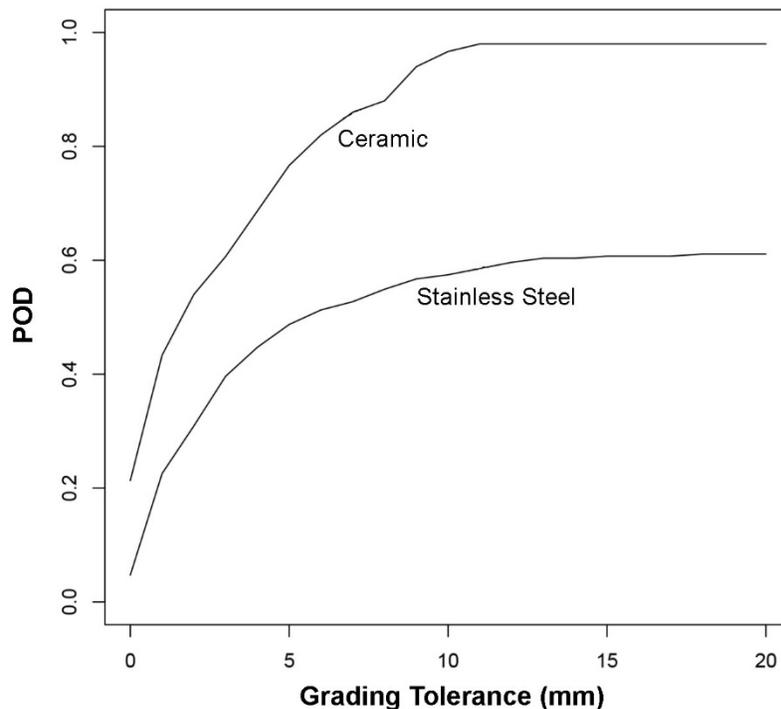
Figure 5-2 Plot of POD vs. Grading Tolerance

The grading tolerance was applied to account for minor errors in reported location. Figure 5-2 displays the relationship between grading tolerance and POD for the data from Phase II. The figure shows that a grading tolerance of 10 mm (0.39 in.) accounts for minor location errors in the data, with the POD in ceramic and stainless steel specimens becoming relatively stable beyond this value.

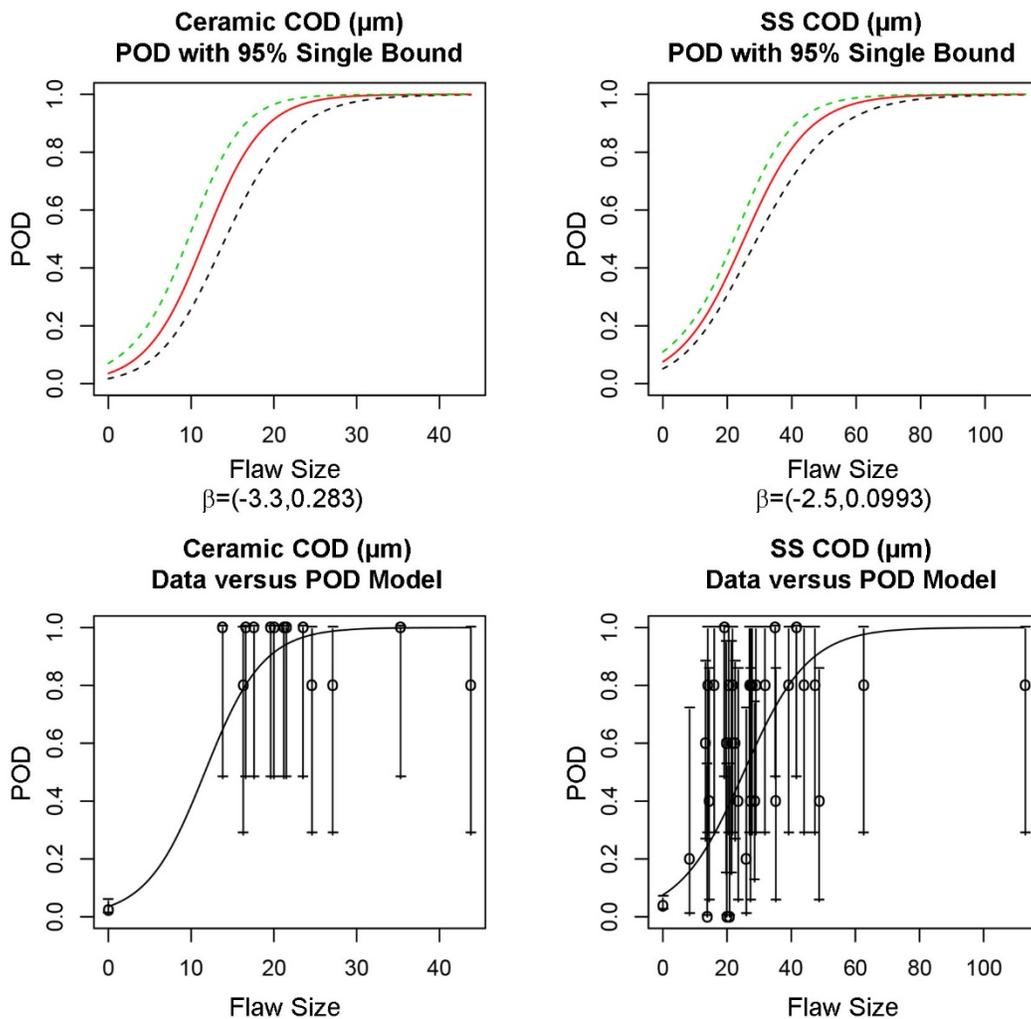
Figure 5-3 POD vs. COD for Ceramic (left) and Stainless Steel (right) Specimens

Additional analysis (described further in Appendix F) indicated that, for the data from Phase II, COD appeared to have a stronger effect on detection performance for cracks in the stainless steel specimens. While this seems intuitive (cracks with larger COD may present a greater contrast with the background), crack length may be more relevant for component safety calculations.

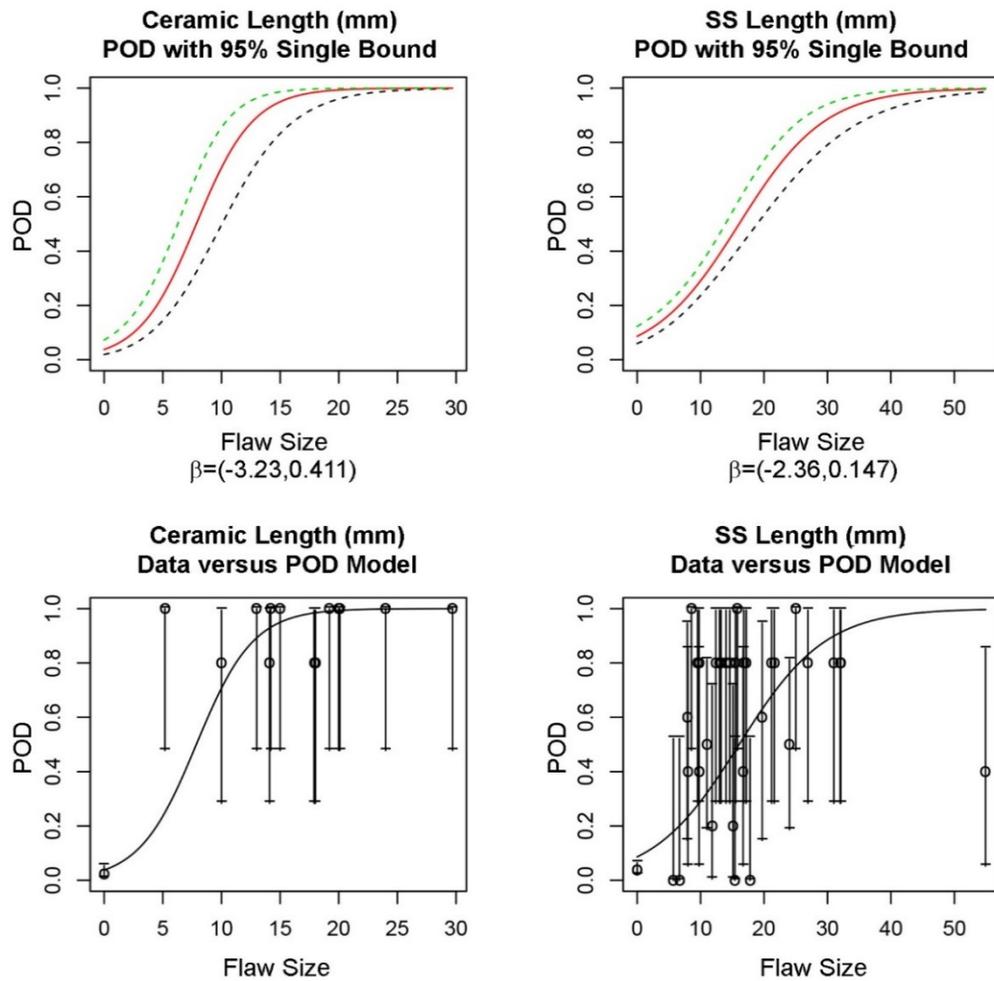
Figure 5-4 POD vs. Length Using All Detections and False Calls in Clean Material. 80 mm (3.15 in.) long crack, along the weld toe in a stainless steel specimen, is not shown.

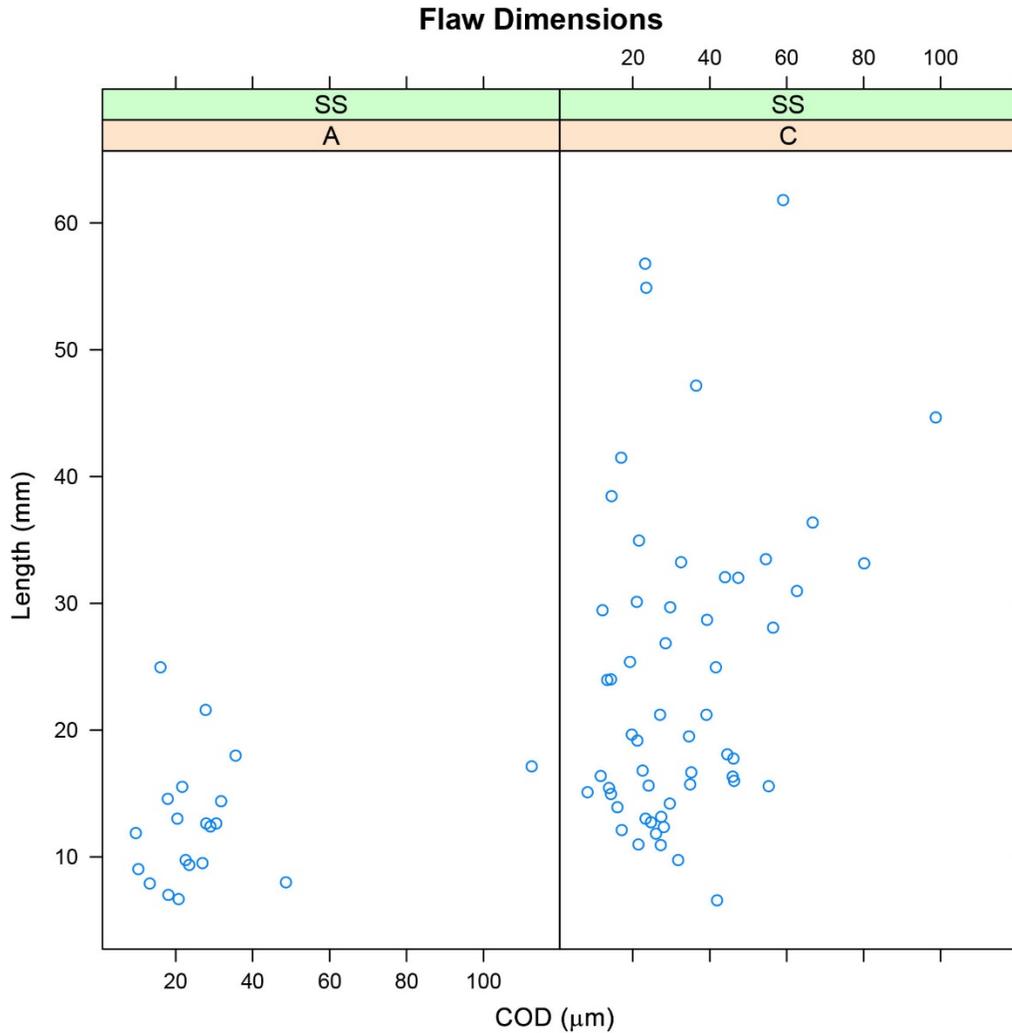
Figure 6-1 Plot of Flaw Dimensions Organized by Orientation (Axial, Circumferential)

Figure 6-1 displays flaw size (COD vs. length) for the various types of cracks used in Phase III. As in Phase II, the distribution indicates some correlation between COD and length (chiefly associated with the extreme values). Determining which of these two factors influences the POD should still be possible if the effect is strong. For cracks in the field, we might expect a higher correlation between COD and length, based on other studies (Wåle 2006). Figure 6-1 also indicates that the size range for circumferential cracks is greater than that for axial cracks, likely because the length of the axial cracks was limited to the width of the weld. Table 6-6 provides a summary of the distribution of crack COD and length.

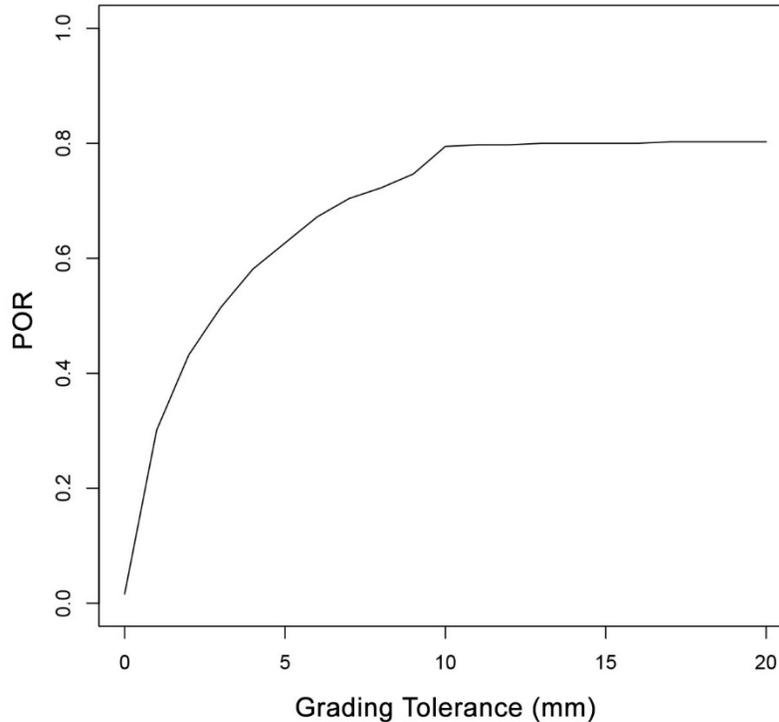
Figure 6-2 Plot of POR vs. Grading Tolerance in the Circumferential Direction. The grading tolerance in the transverse direction is 1.5 times that in the circumferential direction.

As in Phase II, a manual review of the automated grading results was necessary to correct for any large errors in the location of reported indications. In addition, about 60 reported indications (total over all inspection teams) were assigned by the automated grading procedure to more than one grading unit. This was a consequence of the larger grading tolerance, where indications located between two cracks result in more than one detection when using the automated grading procedure. Almost all of these multiple associations involved a crack and a surface feature, with one exception that was associated with two cracked grading units. All instances of such multiple detection were flagged by the automated detection algorithm and were manually corrected.

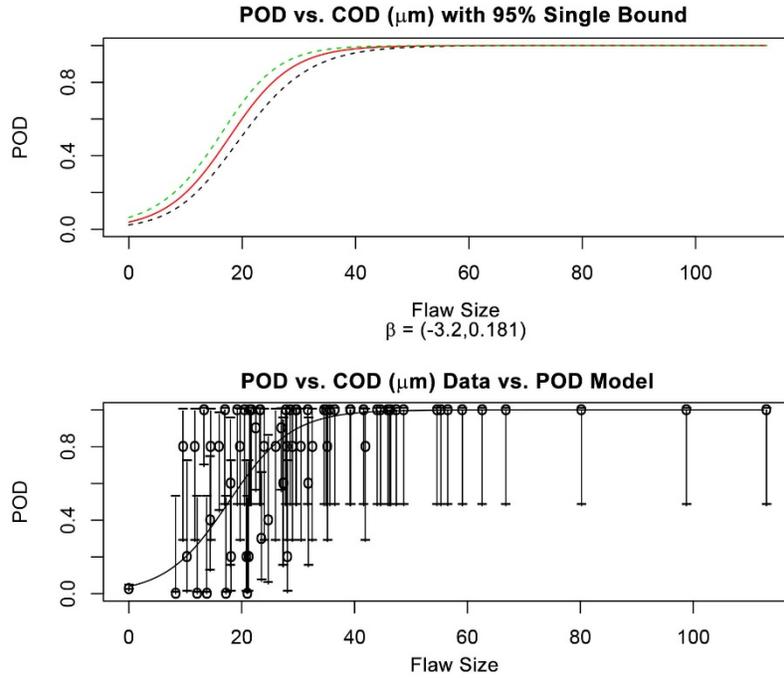
Figure 6-3 POD vs. COD

As a result, using the logistic regression model, the average POD curve as a function of COD, along with 95% confidence bounds and diagnostic plots, are presented in Figure 6-3 and may be compared to Phase II results. Similar results, as a function of crack length, are shown in Figure 6-4.

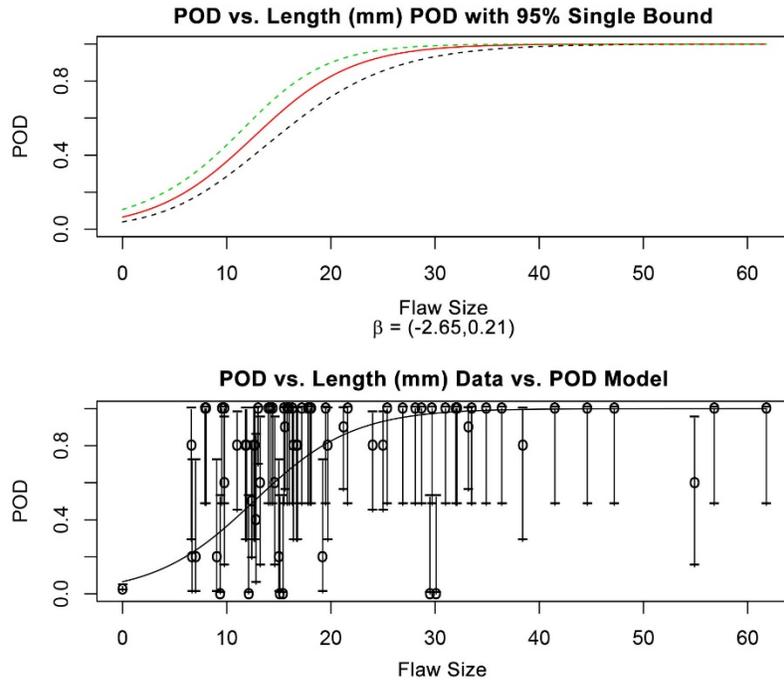
Figure 6-4 POD vs. Flaw Length

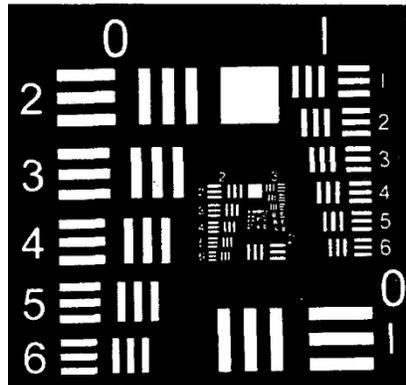
Figure 6-5 Sample Image of a 1951 U.S. Air Force Resolving Power Target (Cumblidge et al. 2007)

Phase III included a resolution check step where the inspection teams were asked to record video of an Air Force Resolving Power Test target (Figure 6-5) (DoD 1959). Simultaneously, an independent analyst from EPRI was asked to review the live data and quantify the resolution in both the horizontal and vertical directions, by identifying the smallest line pair that could be resolved. The same analyst was then asked to review the recorded data from this test target and identify the smallest line pair that could be resolved.

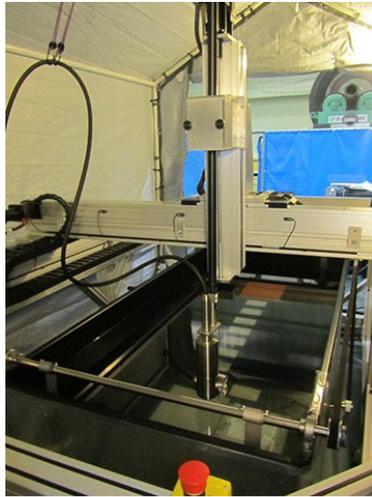
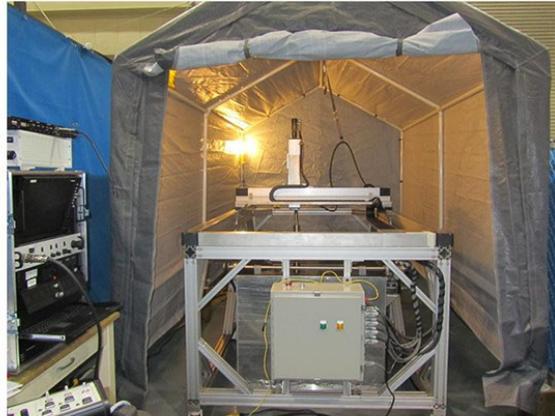
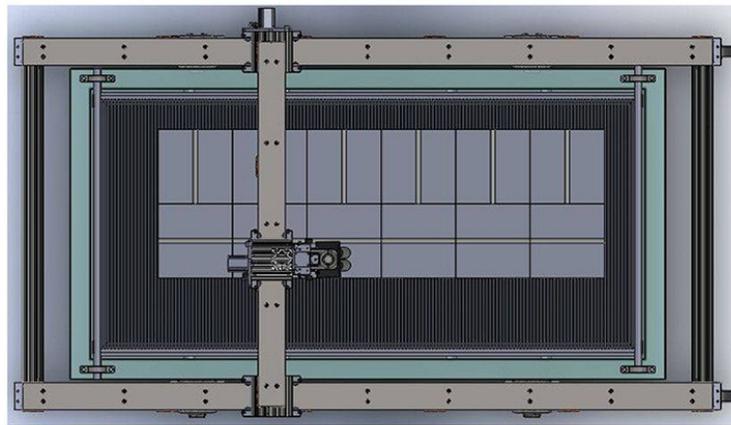
All tests will be conducted with the specimens located underwater in a tank, with a blackout tent used to exclude external (or ambient) lighting to the extent possible (Figure A-2). The camera will be mounted on an X-Y-Z- Θ scanner controlled by a joystick. In addition, the scanner has the ability to tilt the camera in a controlled fashion. The scanner is designed to hold a 25.4 mm to 43.2 mm (1 in. to 1.7 in.) camera handling pole. This scanner allows for precise control.

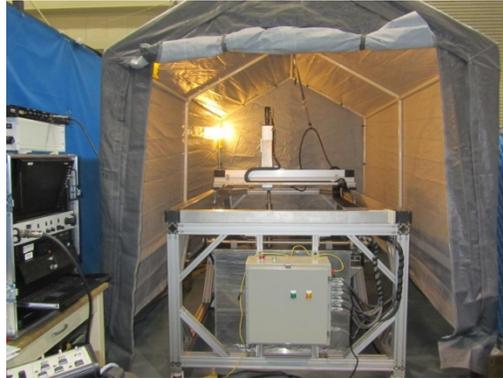
Figure B-1 Black-out Tent with Tank and Scanner

camera in a controlled fashion. The scanner is designed to hold a 25.4 mm to 43.2 mm (1 in. to 1.7 in.) camera handling pole. This scanner allows for precise control of examination cameras.

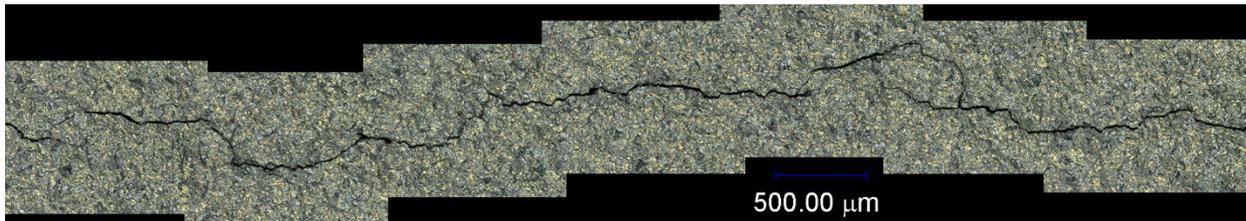
Figure C-1 Crack Segment File with Multiple Photos Stitched Automatically by the Stream Motion Software

1. The cracks were imaged using an Olympus BX51 with Stream Motion software. Depending on the length and tortuosity of the crack and the magnification used, several overlapping images may be required to image the crack from end-to-end. Because of limitations on file size (to maintain very high-resolution images), the image sets were often broken up into multiple files, with each file containing several images stitched together by the software. An example of a file with several images already stitched is shown in Figure C-1. Note this is just one of several similar files that constitute the entire crack.

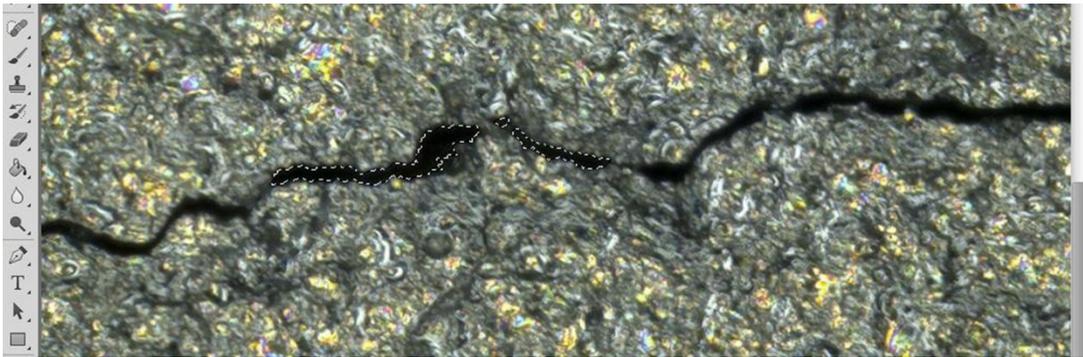
Figure C-2 Selection of the Crack Using the Magic Wand Tool in Photoshop

- a. Outline crack(s) within each section of the microscopy file set for a crack using the *magic wand* tool in Photoshop (and touching it up manually as necessary). The general wand tolerance used was between 5 and 10 (unit-less). Once satisfied with the crack selection, fill in the region as solid black on a new layer (Figures C-2 and C-3).

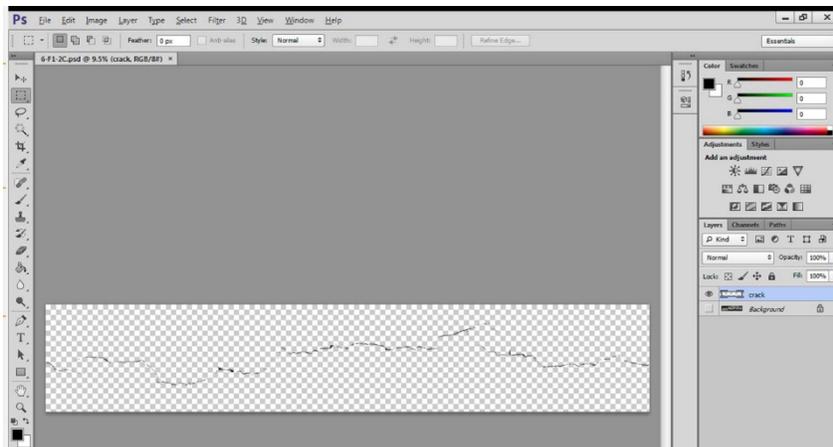
Figure C-3 New Layer Containing a Solid-Black Crack without Anything Else

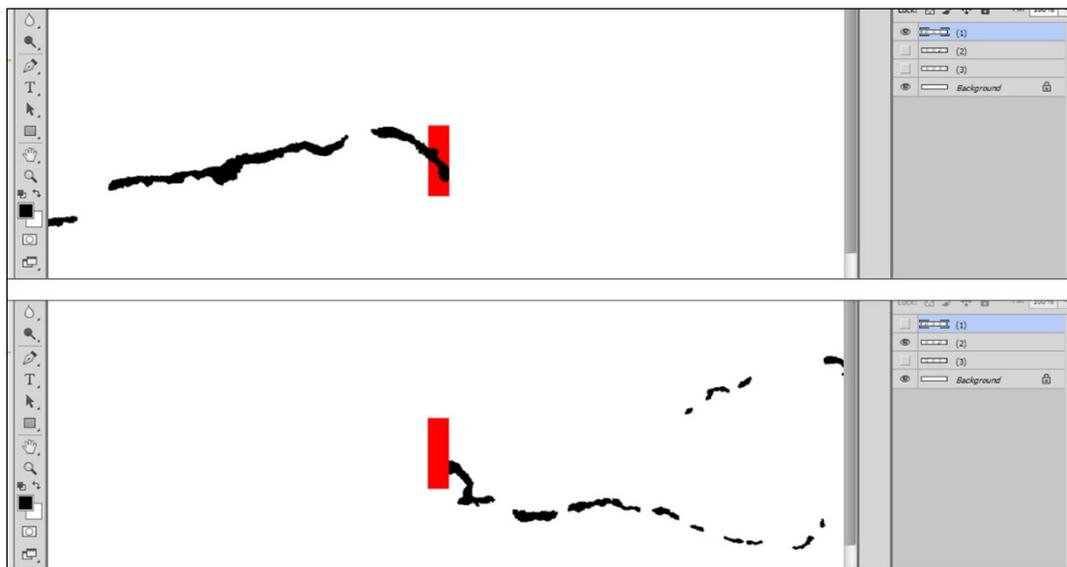
Figure C-4 Example of Two Overlapping Segments of a Crack with the Fiducial Mark (red box) Identified

3. Manual stitching of the black and white (B&W) crack images was done in Adobe Photoshop and MATLAB. Each crack segment layer created in the previous step was pulled into a new Photoshop file (containing all the other crack segment layers), with each B&W crack segment image contained within its own layer in the new file. The segments were then marked with paired-fiducials so that automatic crack-reconstruction would be simple for MATLAB when loading in the segment images.
 - a. Once two crack segments were aligned, the cracks were trimmed to have a flush edge with each other. A red box was drawn with the right side along the seam of those two crack segments. This box was then attached to each crack segment as an identical, fiducial mark for automatic stitching of the later crack-segments (Figure C-4).

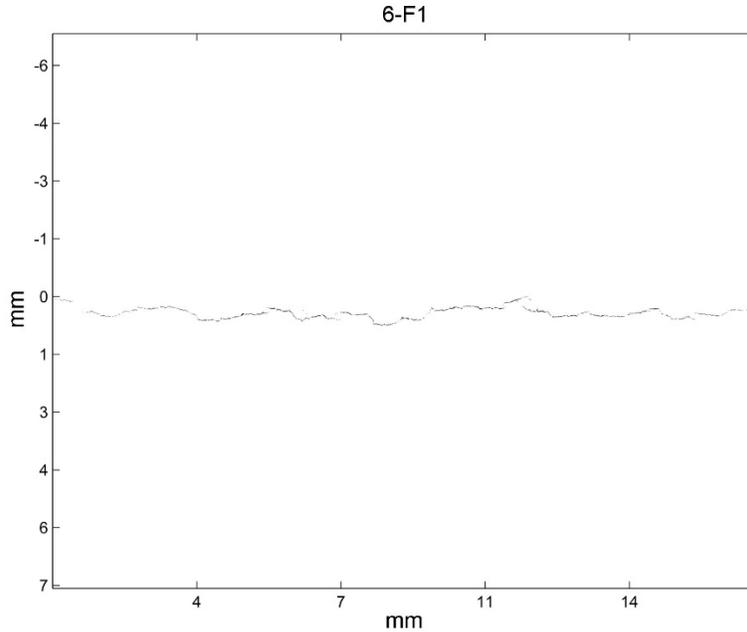
Figure C-5 MATLAB-generated Crack Matrix (from segment images)

- b. Center and save each overlapping segment image individually with the attached red box(es) as a jpeg image, numbering the segments from left-to-right (or top-to-bottom).
 - c. Using MATLAB, each set of B&W crack segments were incrementally loaded in as color matrices for each crack. By identifying the matching red box pair across each incrementing file, the crack segments were then stitched together as a binary matrix with black representing a “1” and everything else being assigned a “0” (Figure C-5). These crack matrices were then saved as a MATLAB data file for ease in processing.

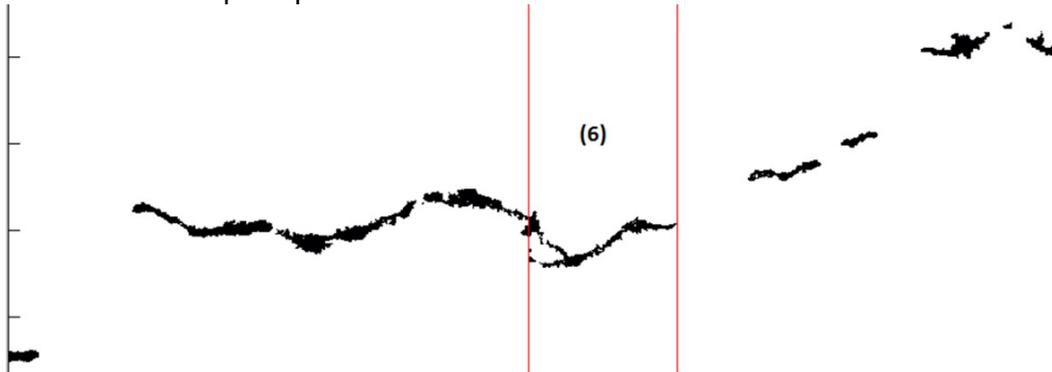
Figure C-7 Zoomed in View on Crack Branch Not Included in Automatic Building

- c. Visually verify and identify connected segments. Add/connect other segments manually as needed and approve the connected segments (Figure C-7). The result is an image of the crack from tip to tip.

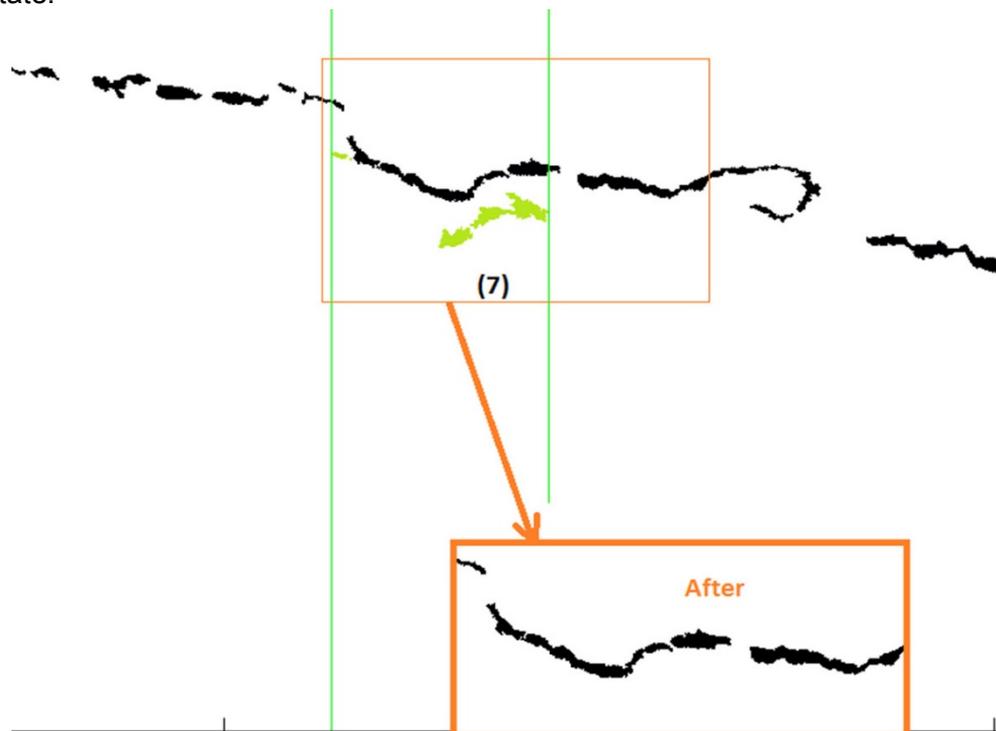
Figure C-8 Example of an Excluded Segment

- d. Remove all ligaments not declared as being part of the crack from the crack-matrix (Figure C-8). The final crack is then ready to be processed for length and COD true state.

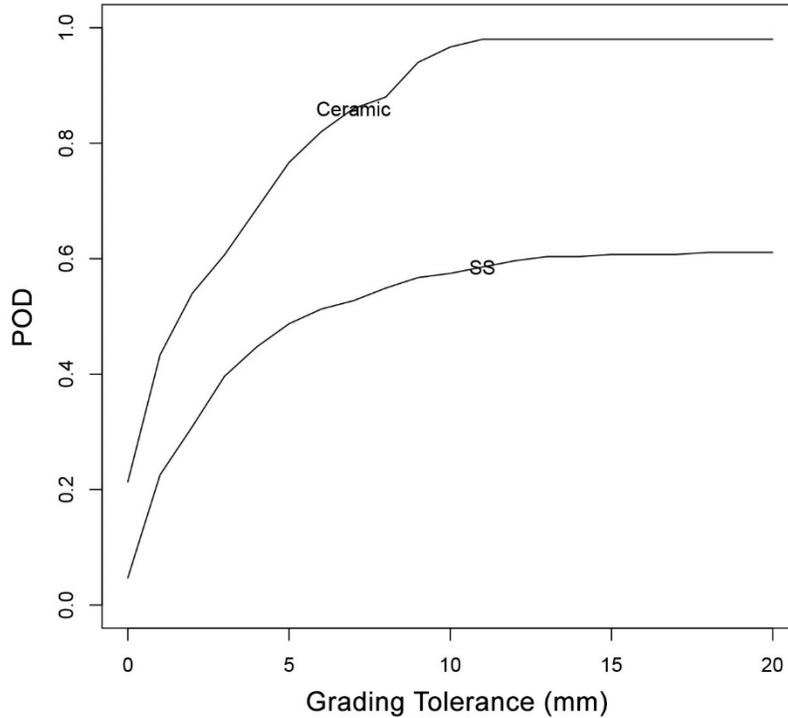
Figure D-1 Plot of POD vs. Grading Tolerance

Figure D-1 displays the relationship between grading tolerance and POD (using data from Phase II of this study). In ceramic specimens, the POD reaches an asymptote close to 1, while SS seems to be more difficult to inspect, reaching an asymptote of 60%. This analysis indicates that a grading tolerance of 10 mm (0.39 in.) accounts for most of the location errors in the data, and choosing the tolerance to be any higher does not significantly change the POD results.

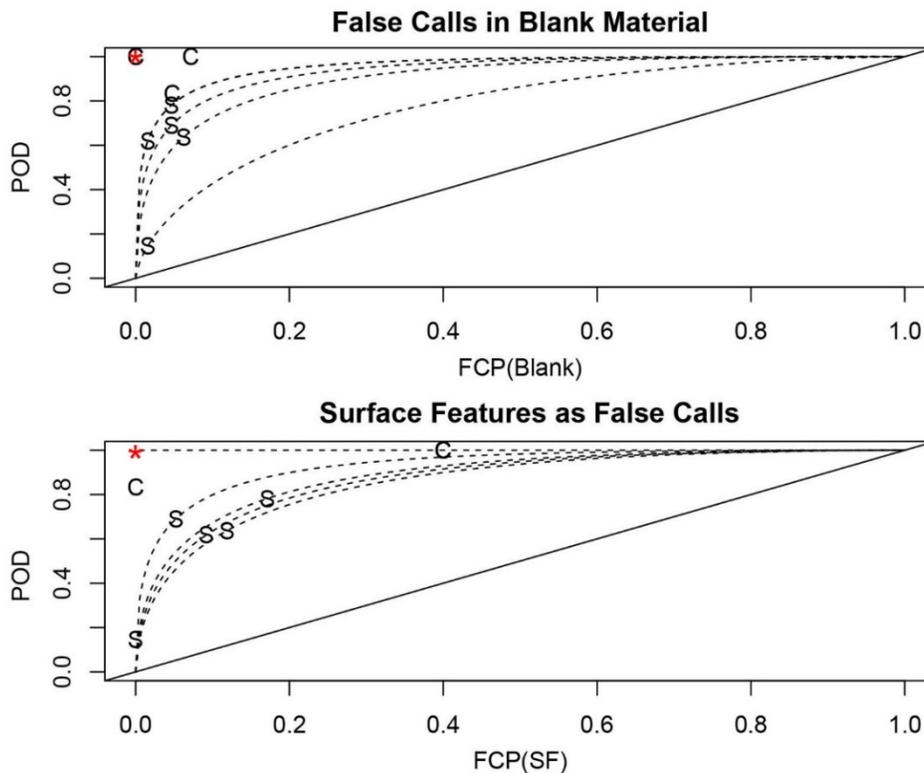
Figure E-1 ROC Plot of (FCP,POD) Estimates in Table E-1. “C”: POD and FCP of individual teams on ceramic specimens; “S”: POD and FCP of individual teams on stainless steel specimens; *: Ideal inspection system performance.

To allow one to compare team performance visually, we have constructed receiver operating characteristic (ROC) plots of the detection data provided in Table E-1. The two plots shown in Figure E-1 present detection performance in “blank” material and in material with surface features. The individual curves (labelled “C” and “S”) show the POD and FCP by individual teams on ceramic (“C”) and stainless steel (“S”) specimens. An ideal inspection would result in a POD 100% with no false calls. For comparison, the diagonal line on these plots represents the case if one were to simply guess at whether a crack were present or not. As one can see, the presence of surface features makes the detection problem harder. In “blank material” (i.e., material without surface features), detection performance is better in ceramic than SS. However, when discrimination of cracks from surface features is considered, SS and ceramic performance are less distinct.

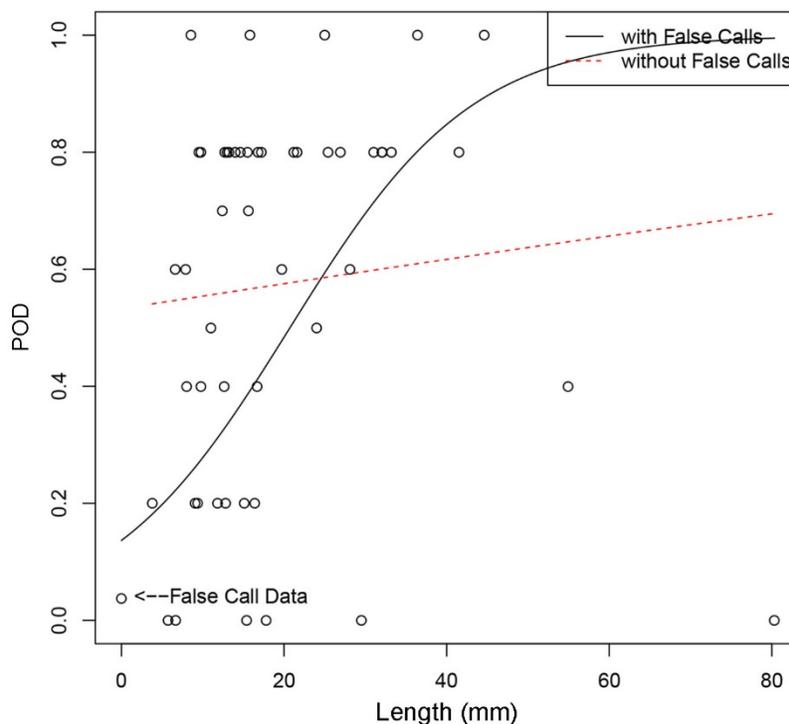
Figure E-2 POD Regression with and without False Calls

More specifically, Figure E-2 shows that there is a weak relationship between POD and flaw size in the range of 5 to 80 mm (0.2 to 3.15 in.), but a strong relationship in the 0 to 5 mm (0 to 0.2 in.) range.

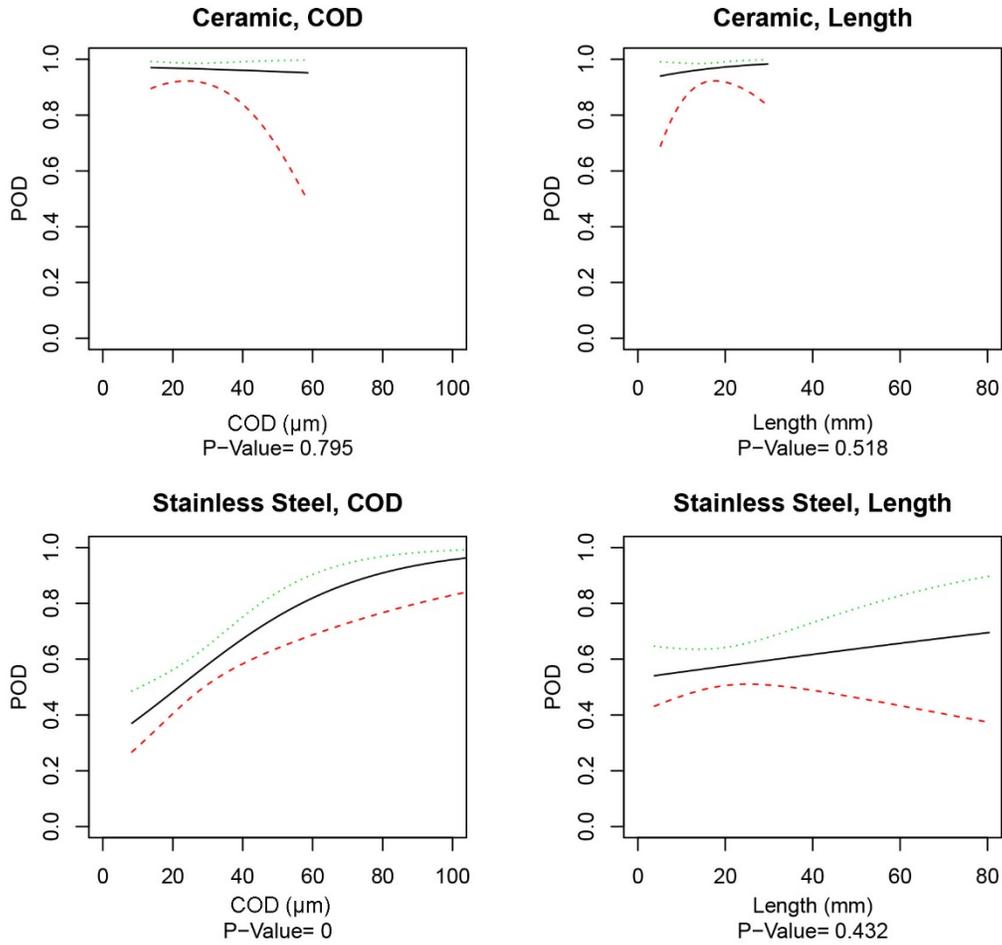
Figure E-3 POD Regression Using the Explanatory Variable COD vs. Flaw Length. The figures show the POD on ceramic specimens as a function of COD (*top left*) and crack length (*top right*), and in stainless steel specimens as a function of COD (*bottom left*) and crack length (*bottom right*).

Which explanatory variable has a stronger effect on POD, COD or flaw length? To answer this question, a logistic model was fit to detection data (without false calls) and with the results plotted in Figure E-3. It appears that only COD affects POD in this data set, and COD is only significant for stainless steel. From the FCPs we have tabulated, we know that both explanatory variables would be important if their ranges were broader.
