NUREG/CR-7246
PNNL-27003

Reliability Assessment of Remote Visual Examination

Remote visual testing (RVT) is a commonly used nondestructive examination method for inservice inspection (ISI) of reactor internals to detect cracking and gross component failures. Despite widespread use, the detection reliability of RVT and the factors that impact overall RVT performance have been unresolved issues. This report describes the results from an assessment sponsored by the U.S. Nuclear Regulatory Commission and conducted by the Pacific Northwest National Laboratory, in cooperation with the Electric Power Research Institute, for evaluating the reliability of RVT methods currently being used for [reactor] in-vessel visual inspection.

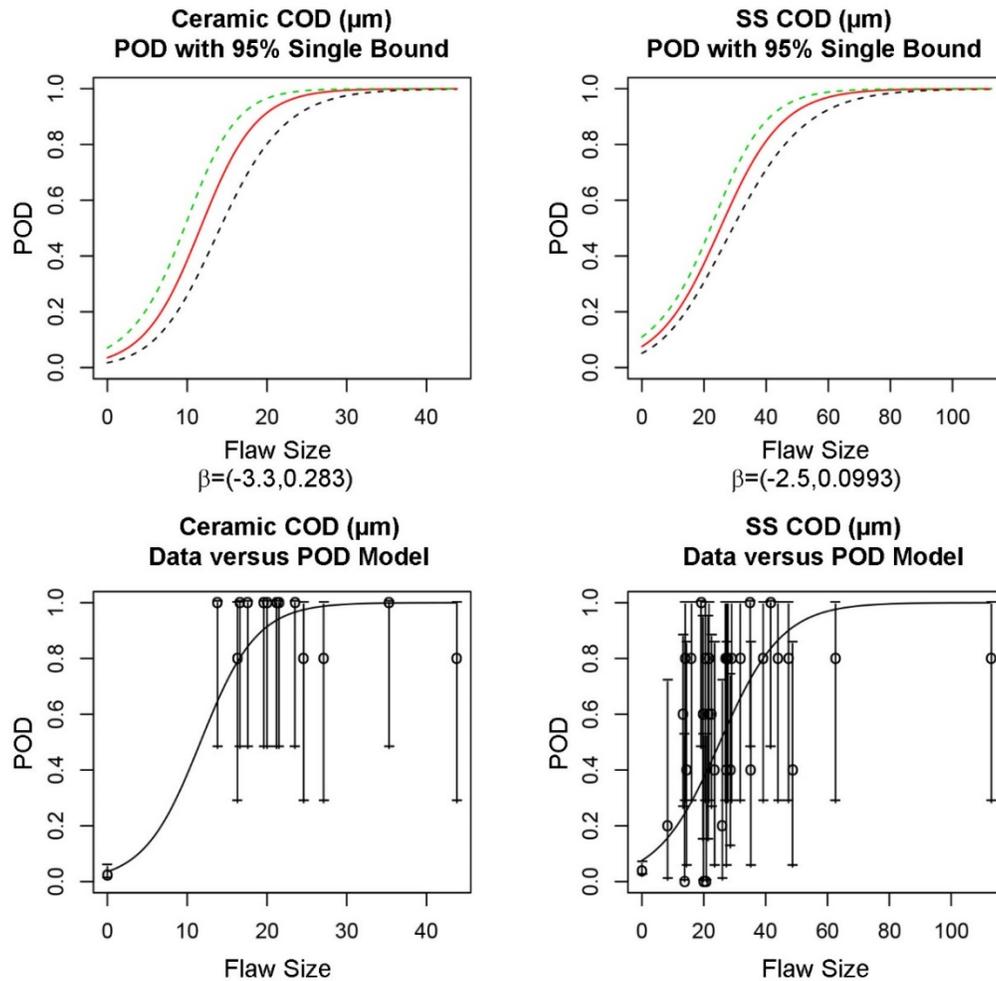
Figure E-4 POD vs. COD

This section displays POD curves for COD to be most realistic. Figure E-4 provides an average POD, using the data from all five participating teams. The false call data used in these fits are that produced by “blank” material, not surface features. In the Figure, the top two plots display the estimated curves surrounded by 95% confidence bounds, while the bottom two plots show the fit with data. The bottom two “diagnostic” plots can be used to evaluate how well the regression model fits the data.

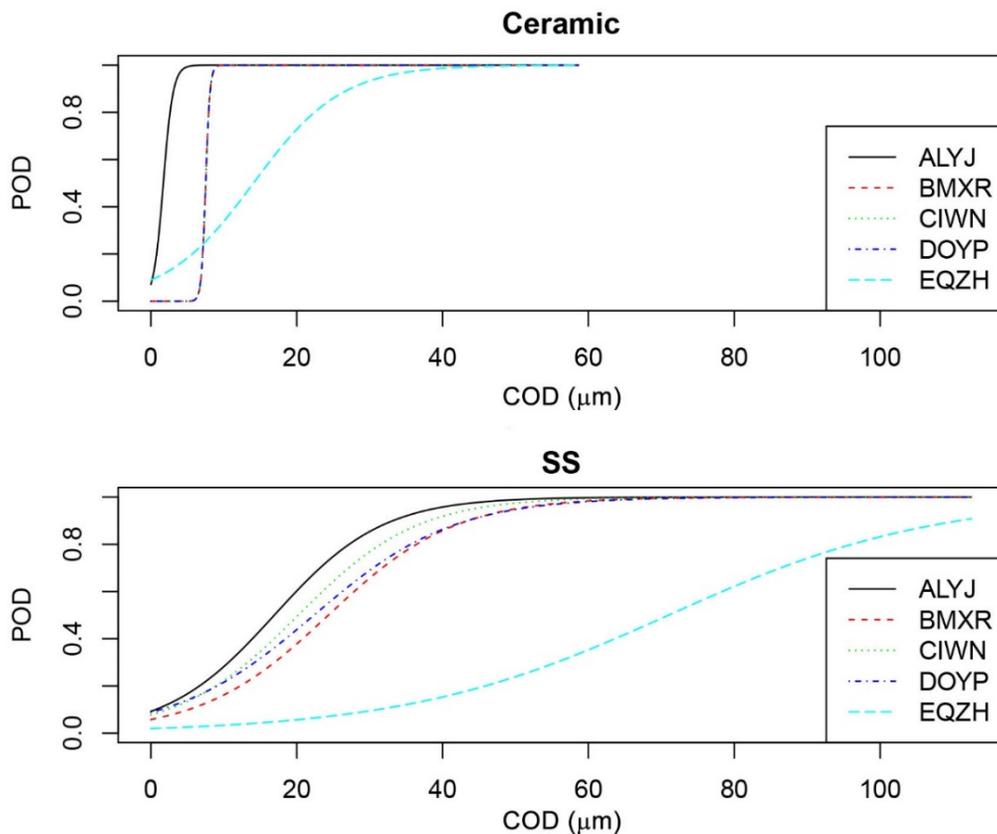
Figure E-5 POD vs. COD for Each Team

In SS specimens, we see a similar grouping—EQZH forms one group, ALYJ another, and the other three teams form the third. Again, EQZH exhibits the worst detection performance while ALYJ exhibits the best.

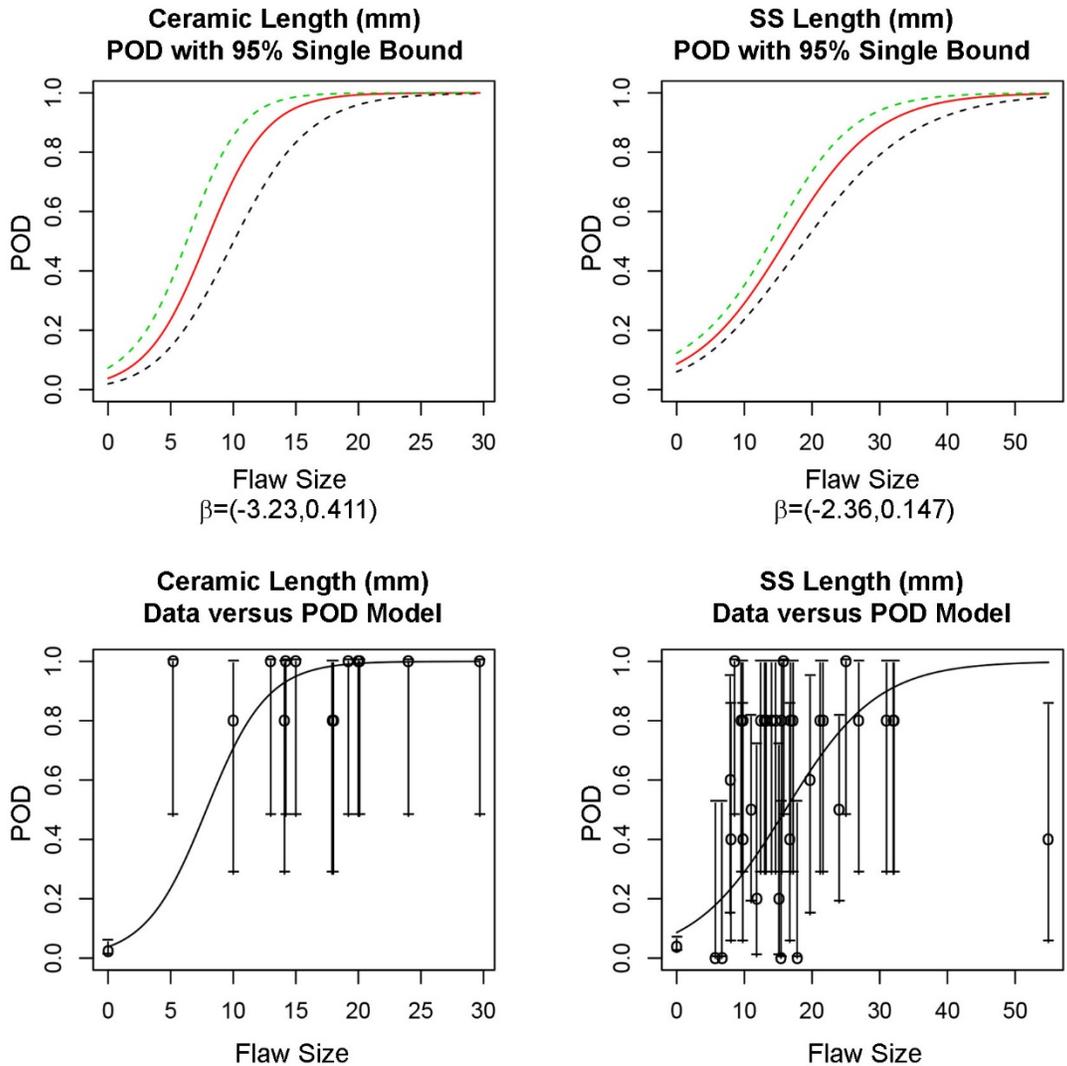
Figure E-6 POD vs. Length Using All Detections and False Calls in Clean Material. Flaw F29.1 excluded.

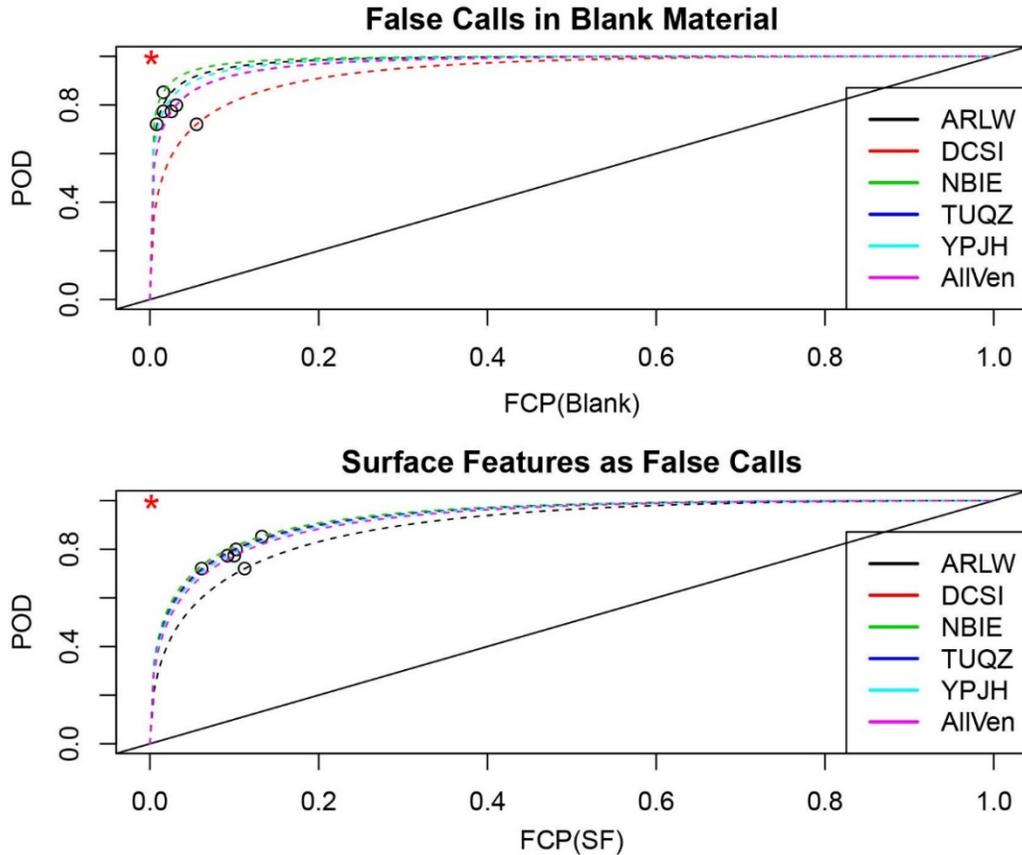
Figure F-1 ROC Plot of (FCP,POD) Estimates in Table F-3. “o”: POD and FCP of individual teams on stainless steel specimens; *: Ideal inspection system performance.

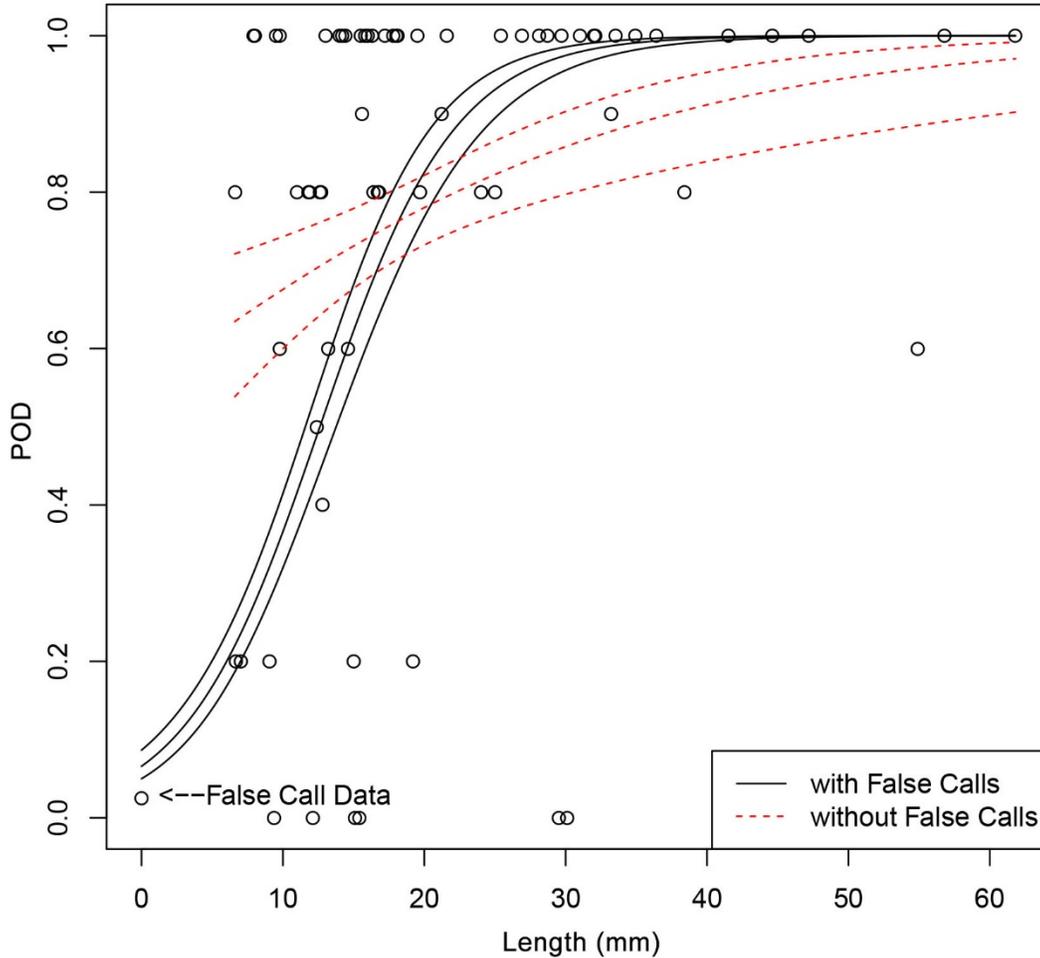
Figure F-2 POD Regression with and without False Calls

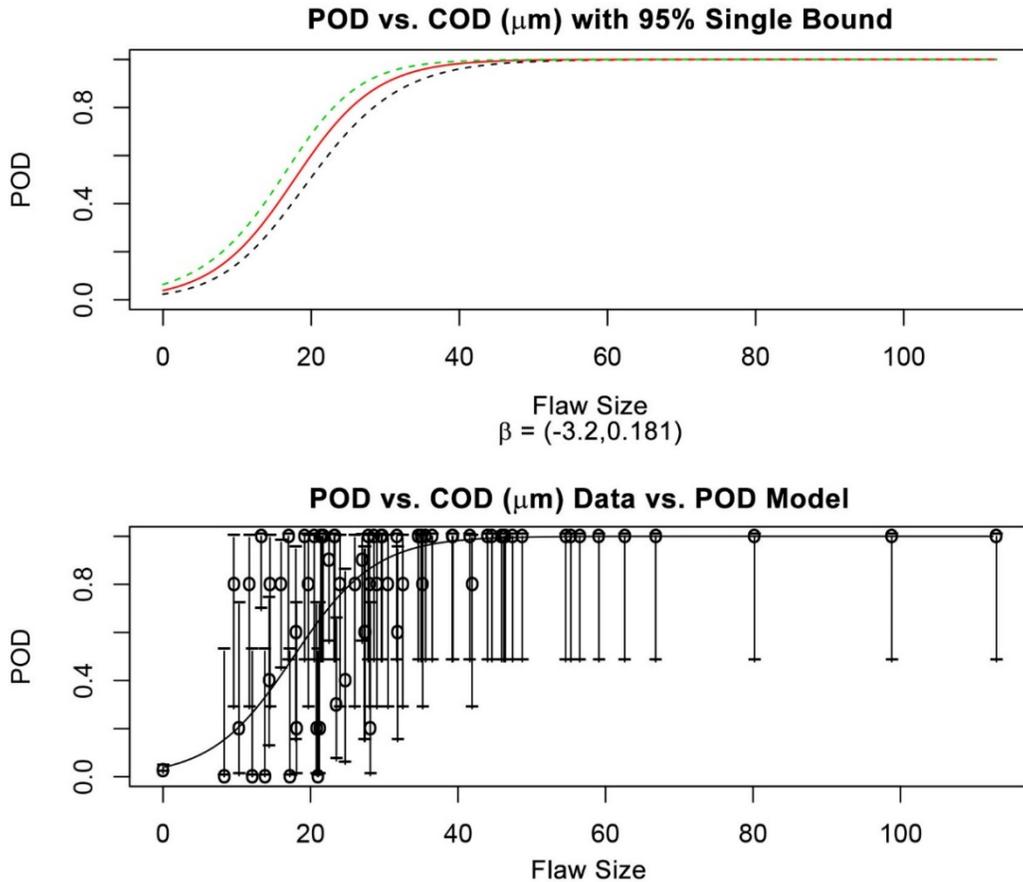
Figure F-3 POD vs. COD

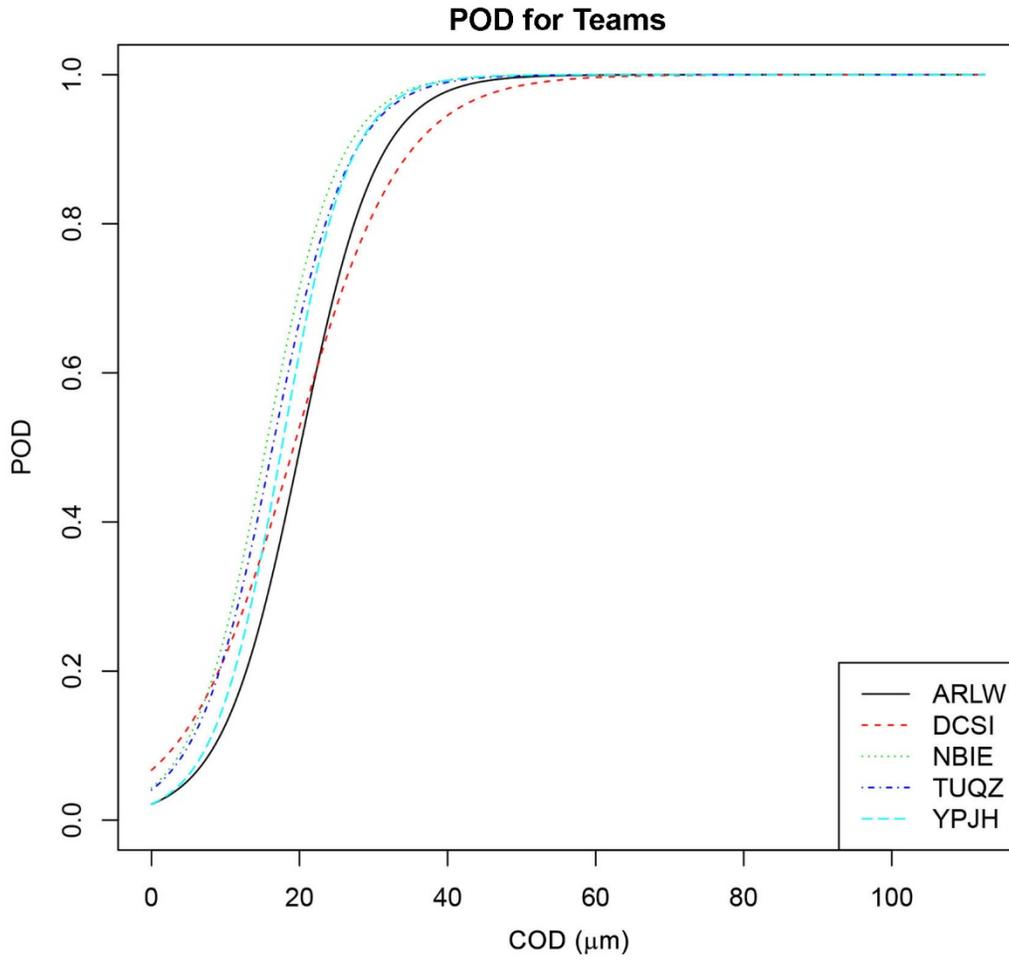
Figure F-4 POD vs. COD for Each Team

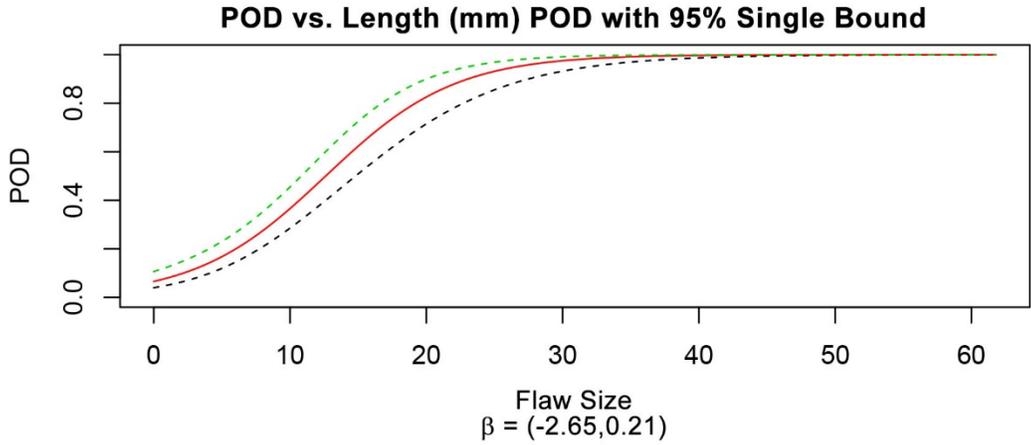
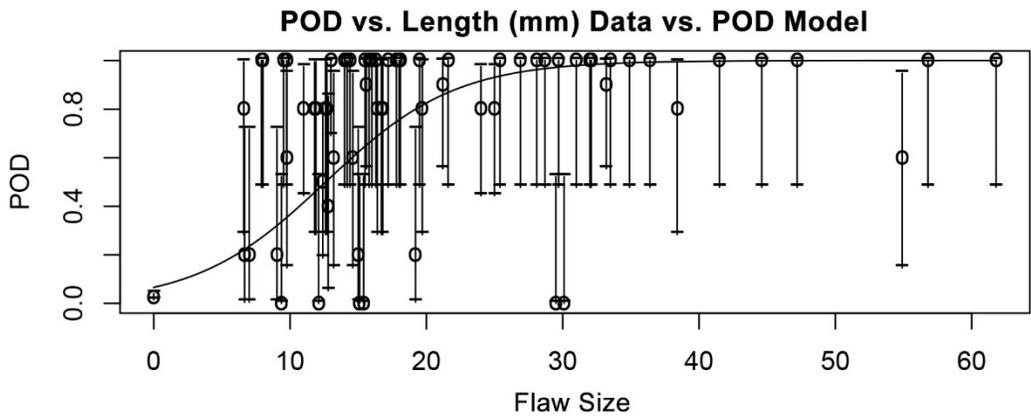
Figure F-5 POD vs. Flaw Length

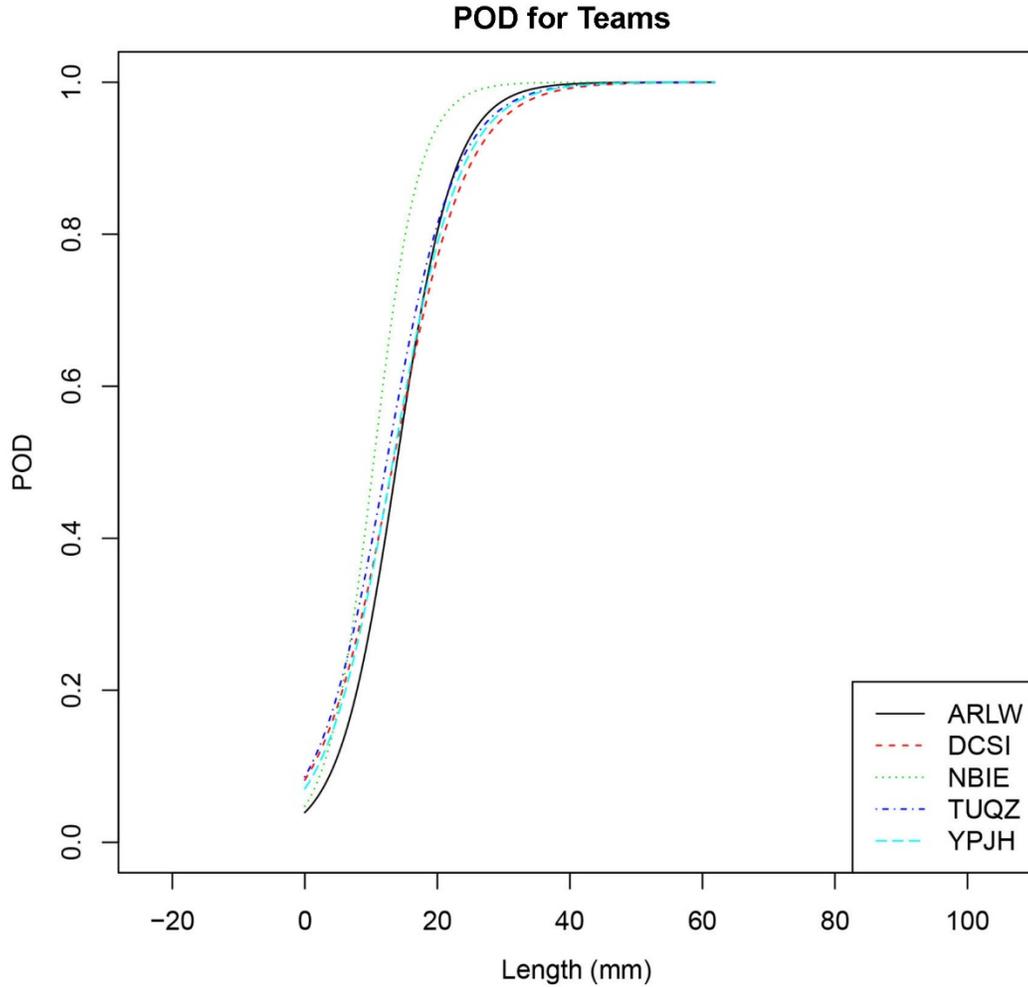
Figure F-6 POD vs. Length for Each Team

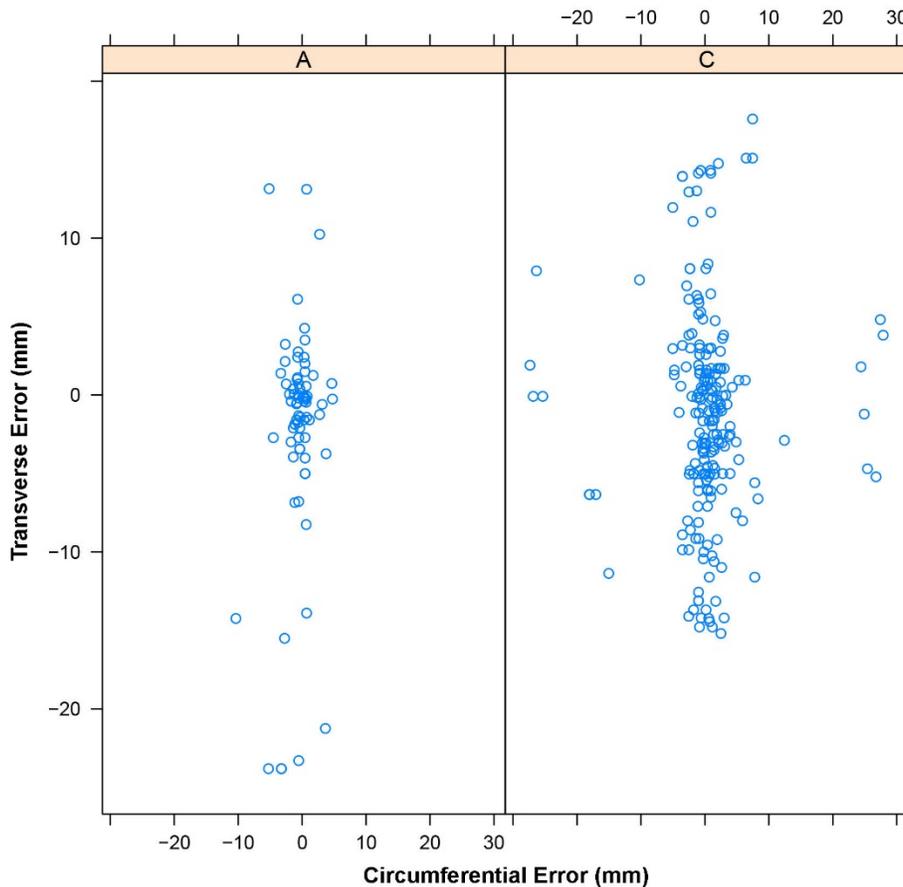
Figure F-7 Plot of Location Errors of Axial and Circumferential Flaws

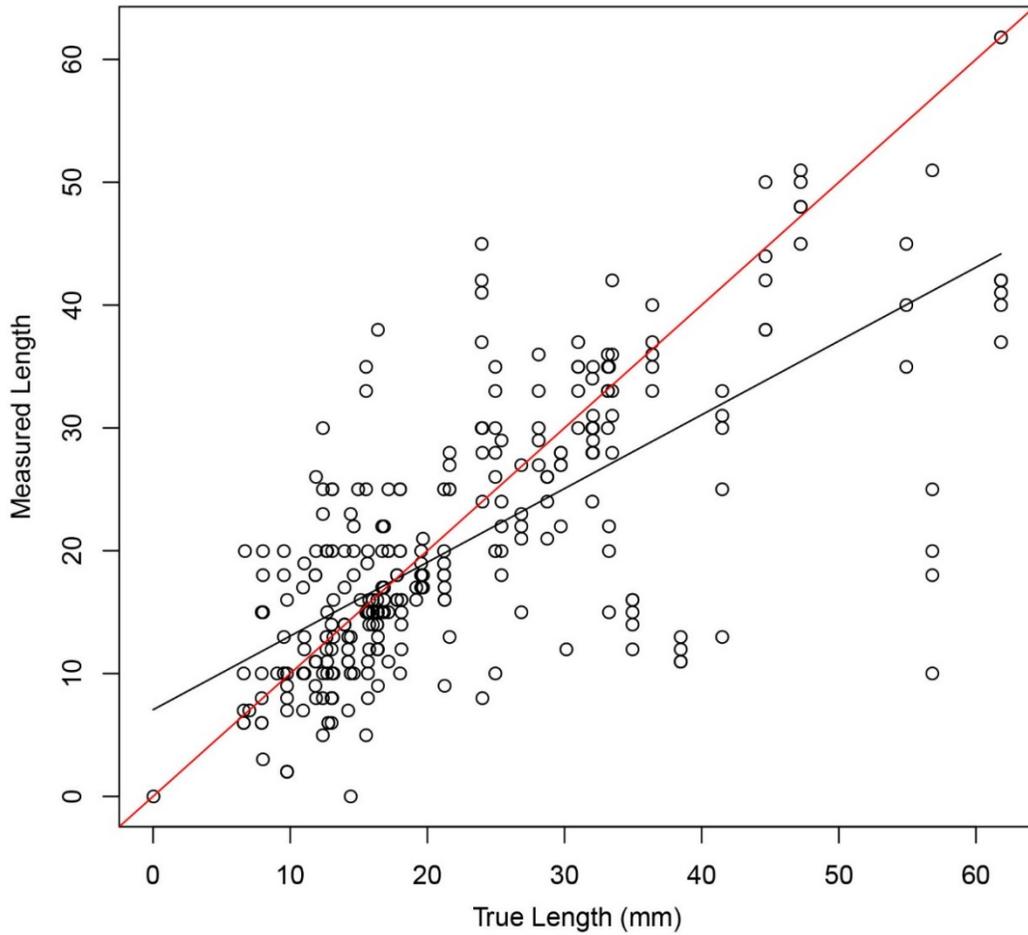
Figure F-8 Measured Lengths vs. True Lengths. Black line is regression fit; red line is measured=true.

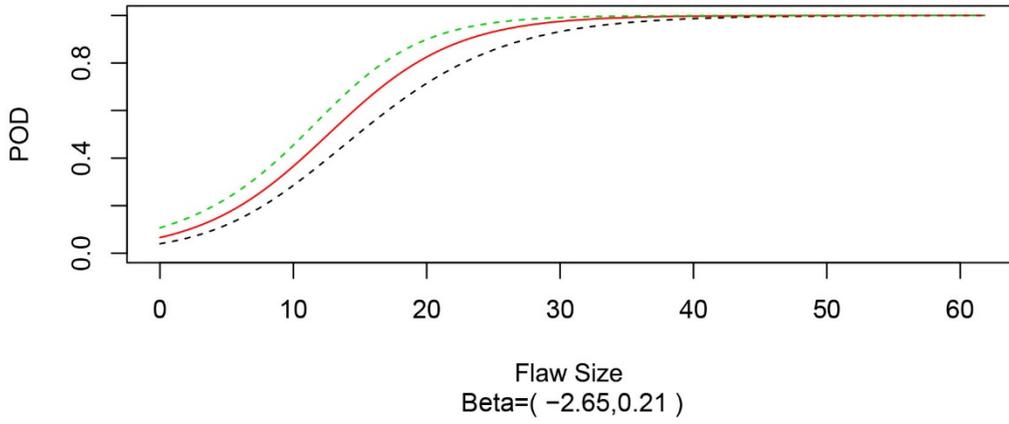
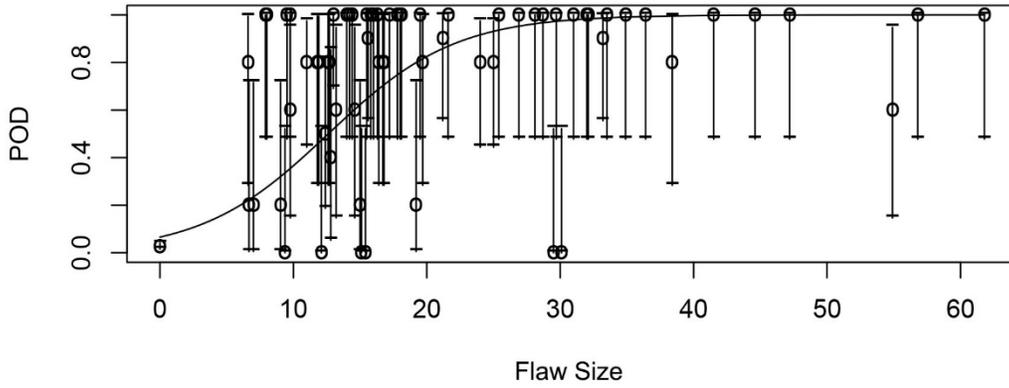
Figure G-1 POD vs. Length using Linear Model

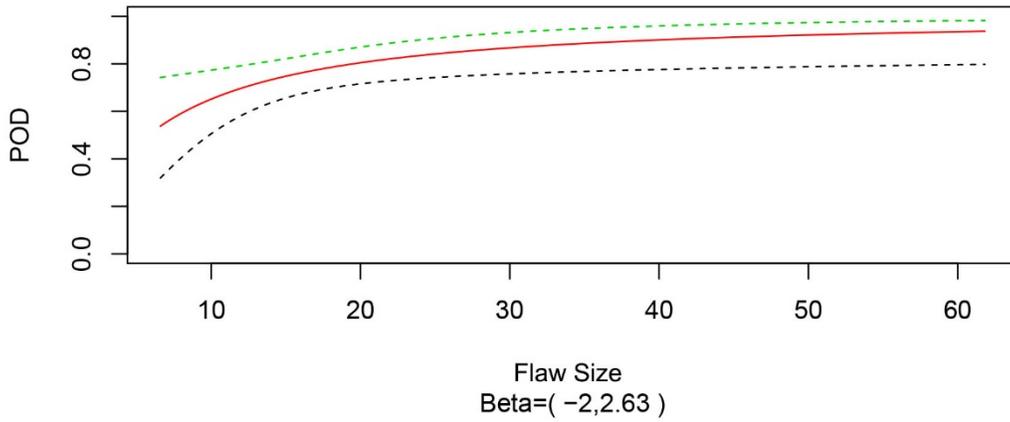
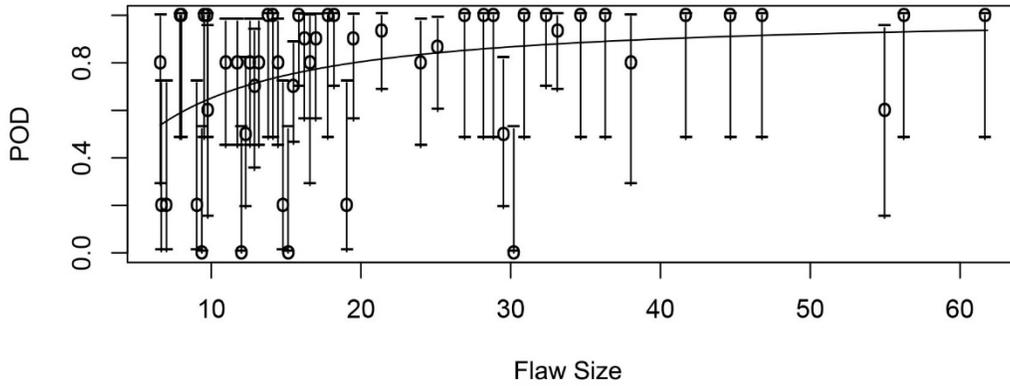
Figure G-2 POD vs. Length Using Log Model

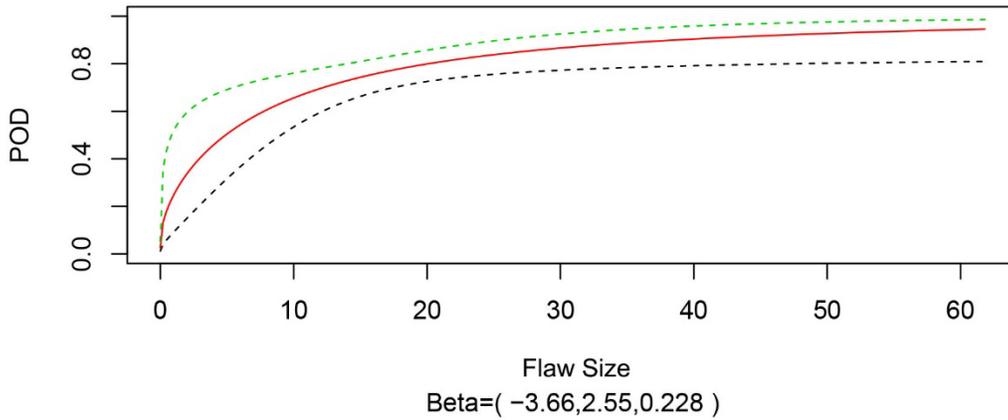
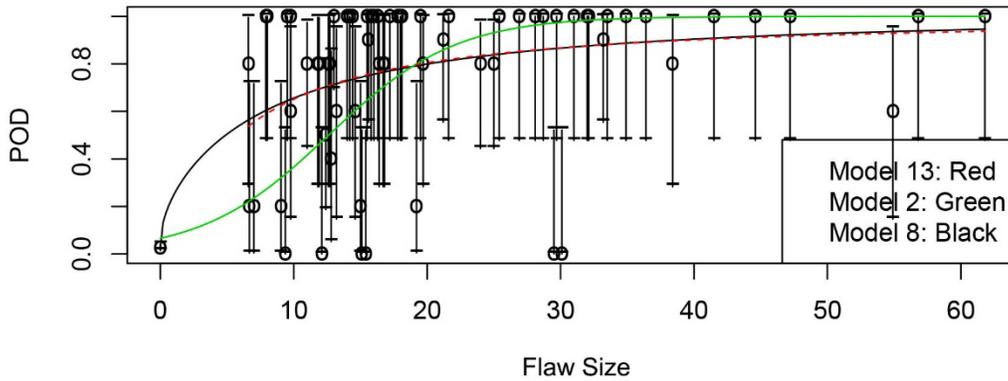
Figure G-3 POD vs. Flaw Length with Box-Cox Model

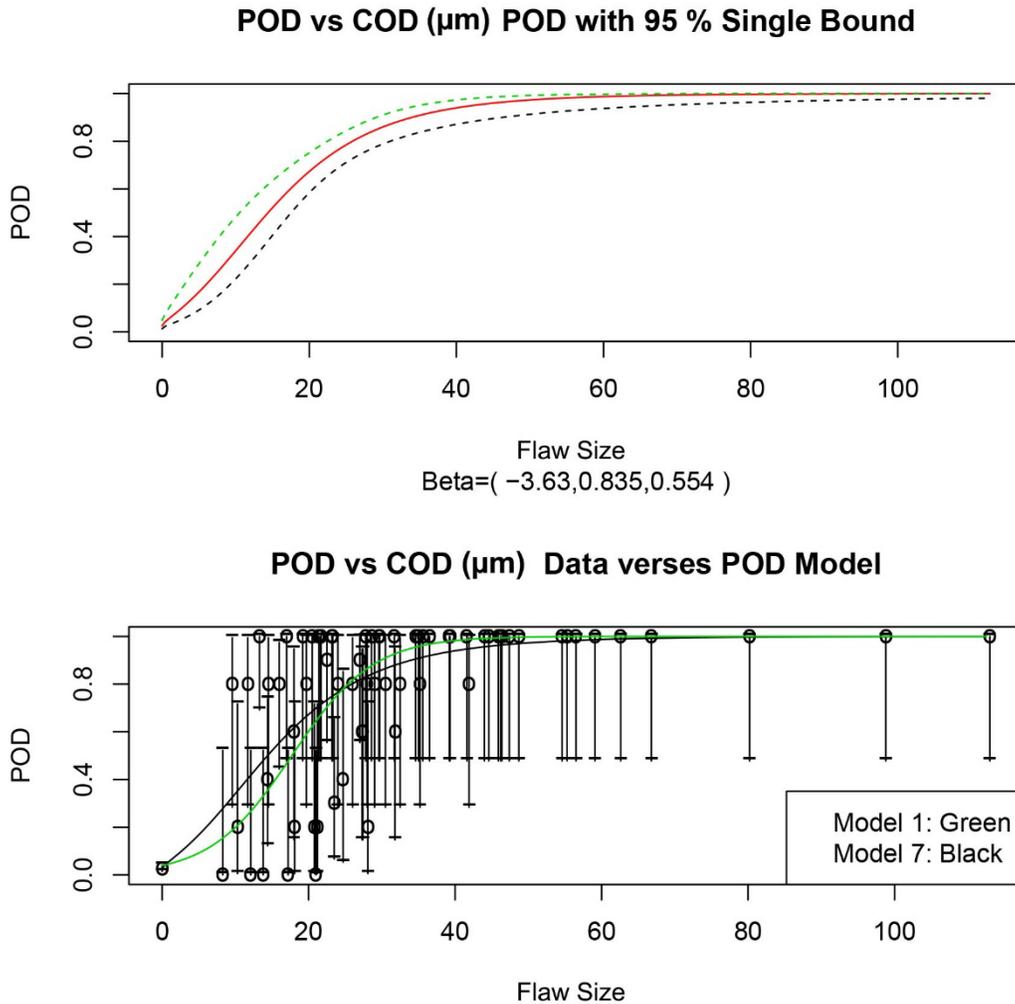
Figure G-4 POD vs. COD Using Box-Cox Model

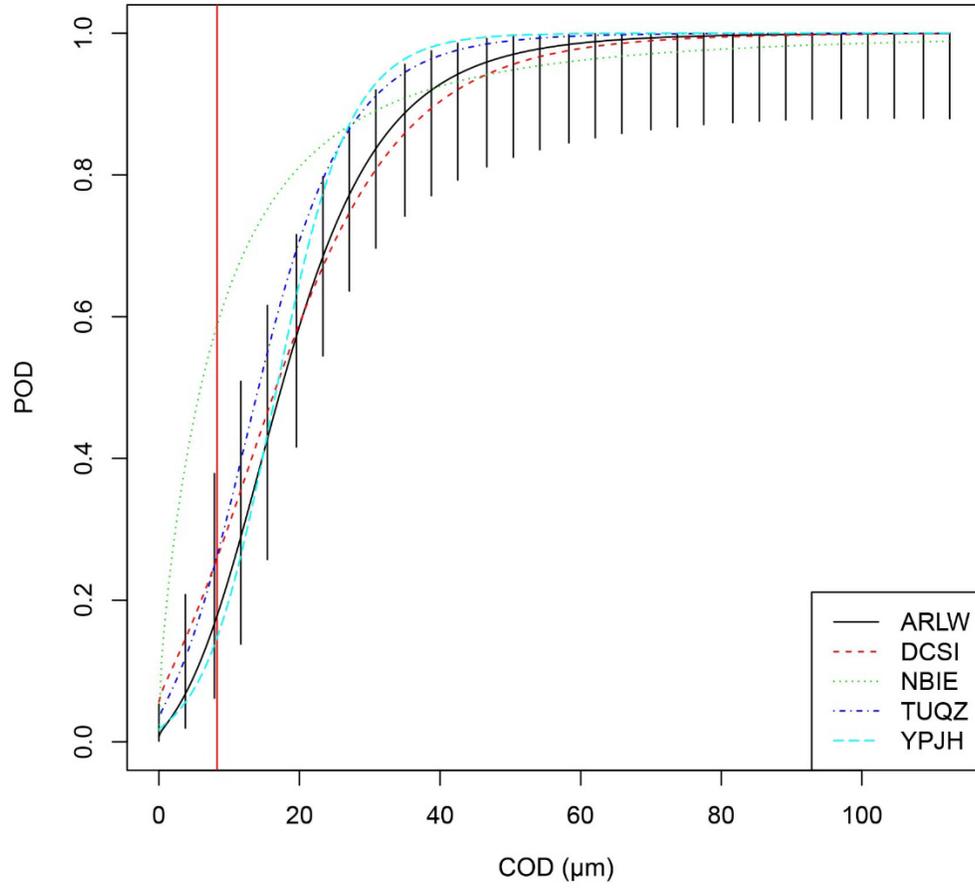
Figure G-5 POD vs. COD for Each Team

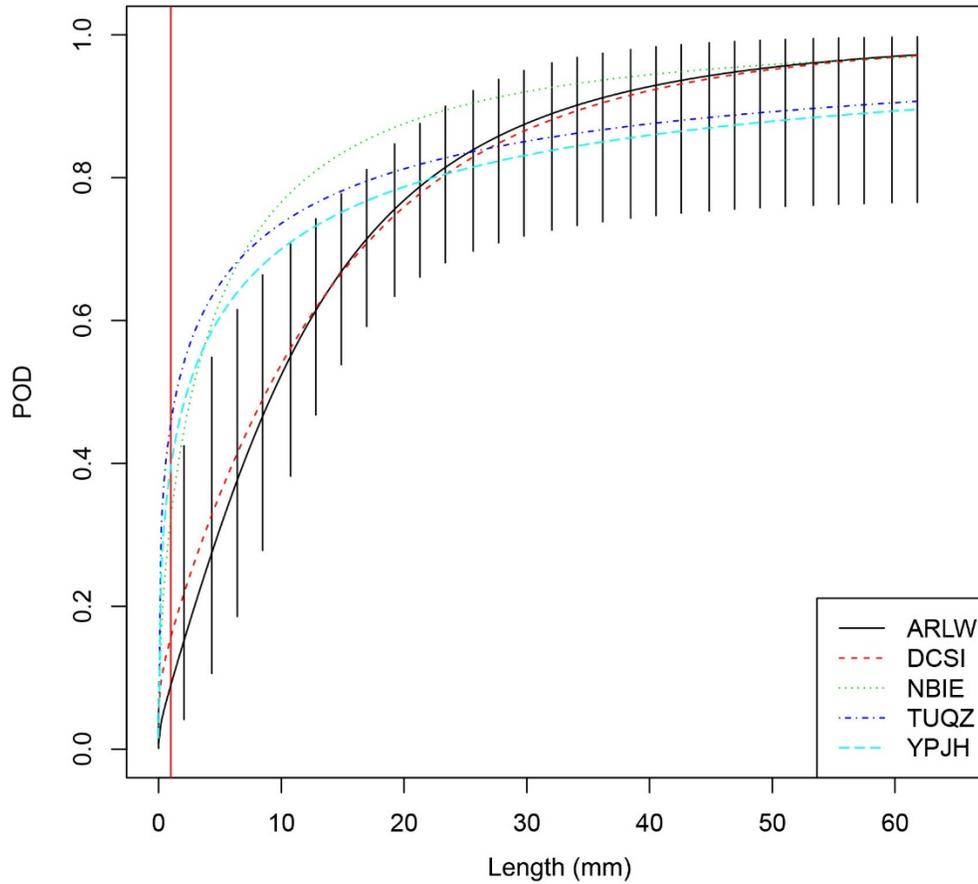
Figure G-6 POD vs. Length for Each Team
