### Evaluation of Halite Dissolution in the Vicinity of Waste Control Specialists Disposal Site, Andrews County, TX

## EVALUATION OF HALITE DISSOLUTION IN THE VICINITY OF WASTE CONTROL SPECIALISTS DISPOSAL SITE, ANDREWS COUNTY, TX

Robert M. Holt

March 2007

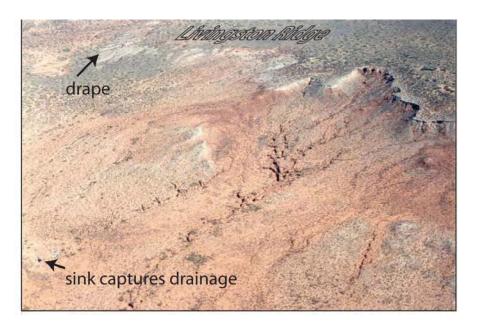
Figure 5 – Mescalero caliche drapes the Livingston Ridge escarpment in response to local subsidence since the caliche formed beginning  $\sim 0.5$  Ma.

At the surface, a retreating escarpment (Livingston Ridge) has developed that shows local subsidence in the last 0.5 Ma because a pedogenic calcrete ("Mescalero caliche") of that age drapes the surface (Figure 5). The Livingston Ridge escarpment directly overlies dramatic changes in the surface on the "top of Salado halite" (Figure 6). Subsidence creates fractures parallel to the escarpment that can enhance vertical infiltration (Figure 7).

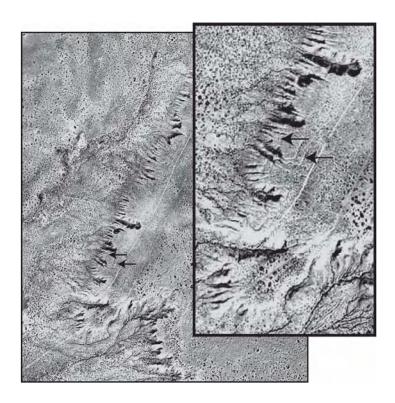
Figure 7 – An aerial photo (dated 10/24/1957) showing fractures (arrows) paralleling the Livingston Ridge escarpment along Nash Draw in response to subsidence over a dissolution margin. This photo covers the ridge in the right center portion of Figure 6 and predates the drilling used as a basis for Figure 6.

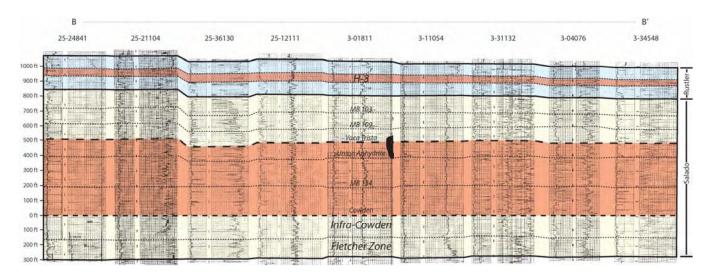
Figure 21 – South to north stratigraphic relationships across the study area and WCS facility from geophysical logs (not spaced to horizontal scale). See Figure 13 for locations. Different intervals are color coded for easier tracking. The black spot near the center is from the original scanned log.

A series of isopach maps (Figures 17-19), a west to east stratigraphic section (Figure 20), and a south to north stratigraphic section (Figure 21) were constructed to evaluate rapid thinning or thickening due to dissolution and collapse and to illustrate important stratigraphic relationships. Salado and Rustler stratigraphic units are easily identifiable in most geophysical logs and readily traceable from the Delaware Basin to the WCS site area. A stratigraphic sections hung on the base of the Cowden Anhydrite illustrates the remarkable continuity of these units in the WCS area (Figure 20). Elevation changes along these stratigraphic sections at small vertical exaggerations illustrate the limited structural deformation (Figure 22). Geophysical log crosssections (Figures 23 and 24) from the application (originally designated A-A' and B-B' and here called C-C' and D-D', respectively) have been re-interpreted and included here for comparison. They reveal that there are generally only minor differences between our interpretation of stratigraphic contacts within the evaporites and the original stratigraphic picks.

The Rustler contains the uppermost halite unit present at the site (H-3 from Holt and Powers, 1988). H-3 shows little thickness variation across the site area, and appears to thicken in the easternmost part of the study area (Figures 20 and 21). The Rustler is thickest in the area south of the site and generally thins to the north and northeast (Figures 16 and 21). Marked thinning in the upper Salado with accompanying thickening of the Rustler is observed in boreholes 3-31589 and 3-03756 (over 11 mi. from the WCS site) along the eastern margin of the study area.

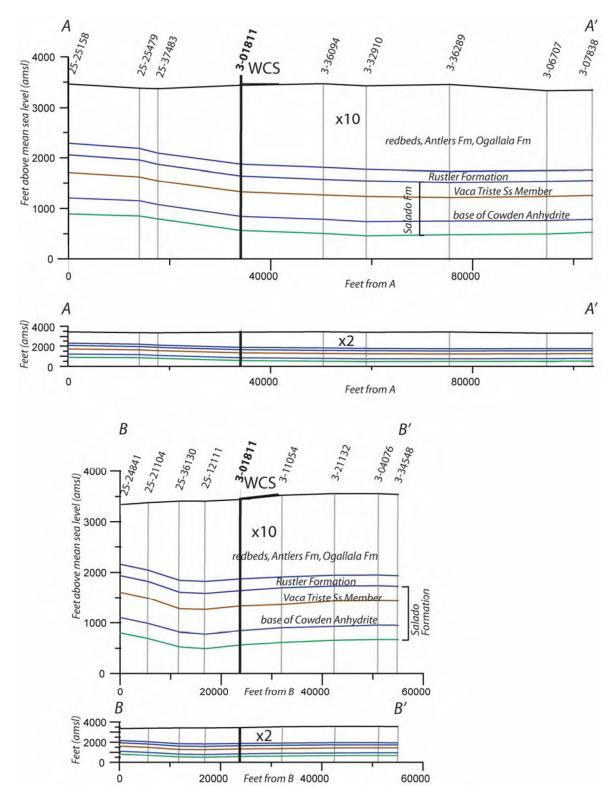
Figure 22 – Line drawings of elevation changes along cross-section A-A' (Figure 20) and B-B' (Figure 21) showing vertical exaggerations of 2 (lower graphics) and 10 (upper graphics). Horizontal scale is in feet measured from one end of the cross-section.

Because some sedimentary information is not available from geophysical logs (e.g., brecciation, etc), we focused on identifying broad-scale features associated with collapse and upward stoping, including abrupt thinning of the evaporite section with accompanying thickening of overlying rocks, complicated contours of elevation on stratigraphic units or of unit thicknesses, or complete stratigraphic disruption. To aid our interpretation of dissolution, we constructed structure contour maps on the tops of the Tansill, Salado, and Rustler Formations (Figures 14-16); isopach maps of the top of Tansill to Cowden interval, the Salado, and the Rustler (Figures 17-19; and east to west (Figure 20) and north to south (Figure 21) stratigraphic sections and cross-sections (Figures 22) across the WCS site area.

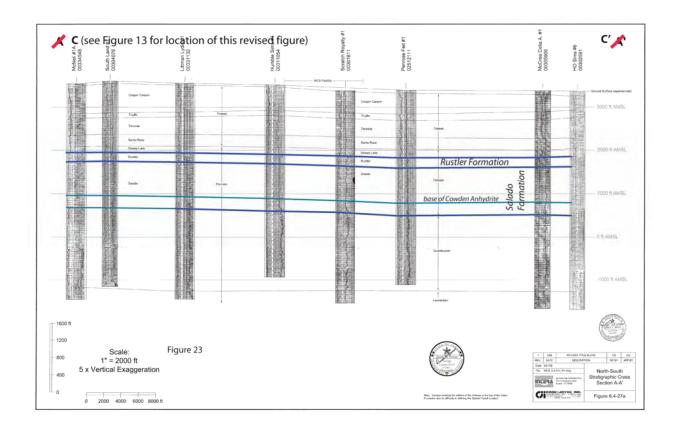
Figure 23 – Re-interpreted stratigraphic contacts (blue) for the Rustler and Salado Formations and base of Cowden Anhydrite (green) on cross-section (A-A') originally included in the application. A larger paper print of this figure is included in a pocket for this report.

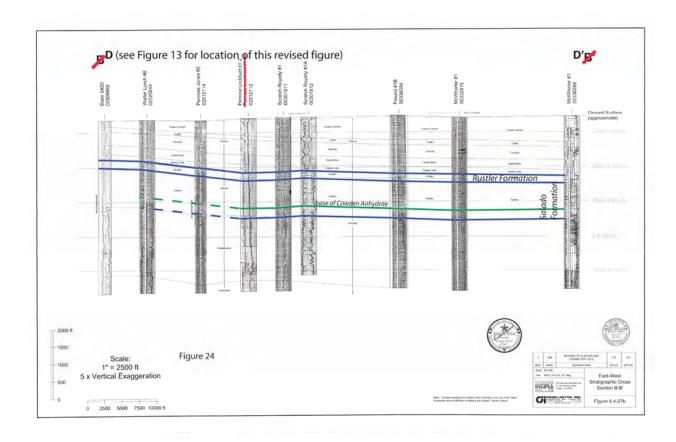
Figure 24 – Re-interpreted stratigraphic contacts (blue) for the Rustler and Salado Formations and base of Cowden Anhydrite (green) on cross-section (B-B') originally included in the application. A larger paper print of this figure is included in a pocket for this report.

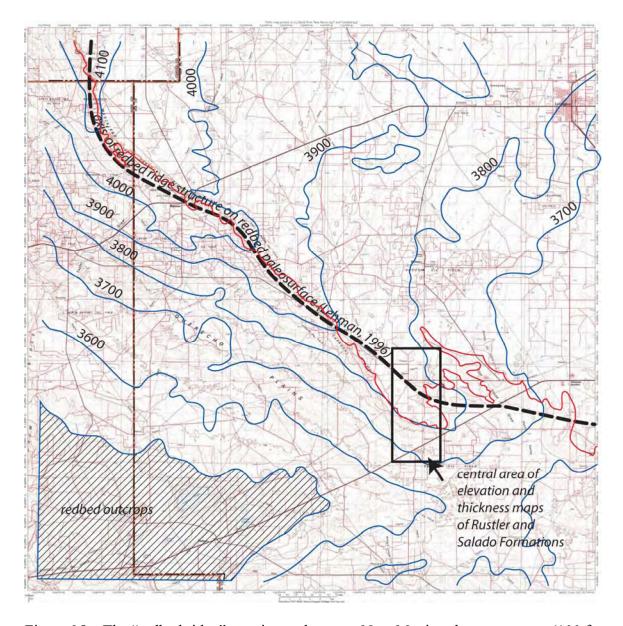
Figure 25 – The "redbed ridge" area in southeastern New Mexico shows contours (100 ft interval) of the elevation of the top of pre-Cretaceous redbeds and the axis (dashed line) of the "folding" based on Lehman (1996). The redbed ridge has been interpreted as a feature developed in response to dissolution of halite. The rectangle near the center identifies the central area of elevation and isopach maps (Figures 23-25) used to compare Rustler stratigraphic and isopach data with the elevation on the redbed paleosurface.

To further examine this proposition at another location, we chose to examine the upper evaporite section (Rustler Formation) along the Mescalero Ridge (Figure 25), an escarpment northwest of the WCS site area, where drillhole control is dense and the redbed ridge has been defined in the past (e.g., Nicholson and Clebsch, 1961; Lehman, 1996).

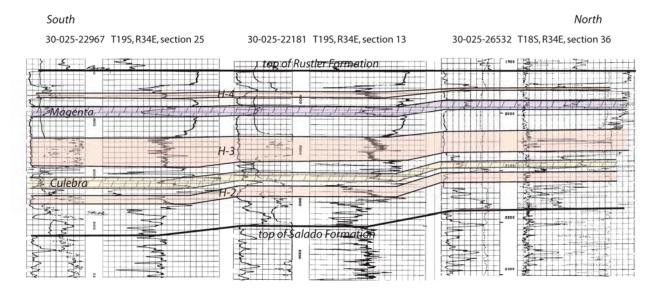
Figure 26 – Three geophysical logs illustrate persistent stratigraphic relationships of the Rustler Formation perpendicular to the trend of the redbed ridge. The formation thins consistently to the northeast (Figure 29).

A few drillhole geophysical logs (Figure 26) at this ancillary study site illustrate the relationships between Rustler stratigraphic units that are similar to that at WCS. There is limited salt in the uppermost member (Forty-niner) of the Rustler and thicker halite within the middle member (Tamarisk). Halite is also present in the lower part of the Rustler. The geophysical log signatures of the top of Rustler and top of Salado are straightforward to interpret throughout this small study area crossing the "redbed ridge."

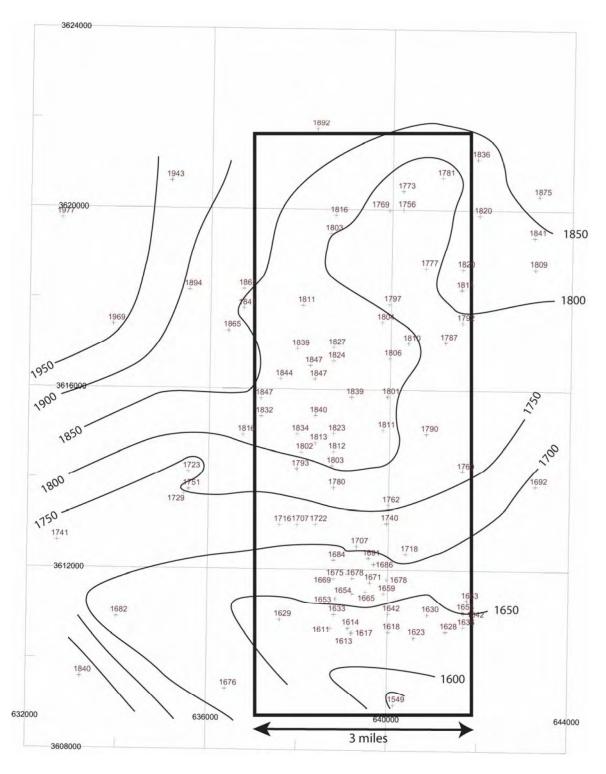
Figure 27 – Elevation (ft amsl) for the top of the Salado across the trend of the redbed ridge. Gridlines are UTM coordinates (m; Zone 13). Rectangle is shown in Figure 25.

To illustrate the structure and thickness relationships, we mapped the elevation of the top of the Salado (Figure 27; Appendix C), the top of the Rustler (Figure 28), and the thickness of the Rustler (Figure 29). The topography of the escarpment and area are included for reference, as is the general trend of the "redbed ridge" as shown by Lehman (1996).

The evidence is straightforward that both the top of Salado and top of Rustler show some structure broadly similar to that of the redbed ridge, with a flank to the southwest parallel to the Mescalero Ridge escarpment and a slight flank to the northeast. These structure contours show rising elevations to the northwest, similar to the redbed ridge. The top of both formations show some closure to the northeast, in contrast to the contours shown by Lehman (1996).

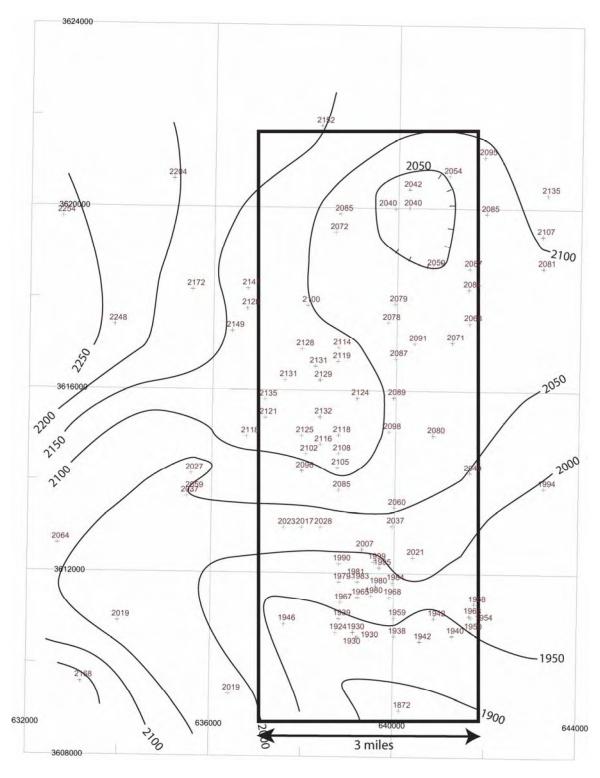
Figure 28 – Elevation (ft amsl) for the top of the Rustler across the trend of the redbed ridge. Gridlines are UTM coordinates (m; Zone 13). Rectangle is shown in Figure 25.

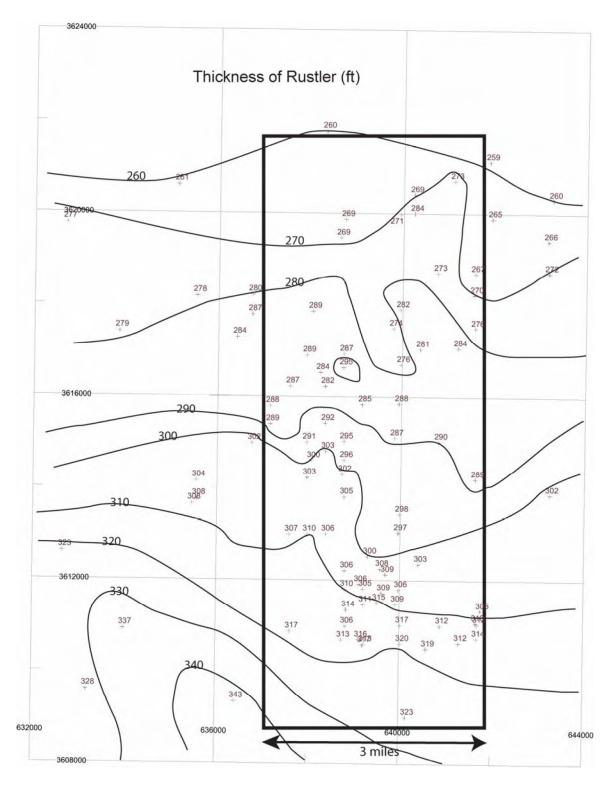
Figure 29 – Thickness (ft) of the Rustler across the trend of the redbed ridge. Gridlines are UTM coordinates (m; Zone 13). Rectangle is shown in Figure 25.

The thickness of the Rustler, however, contrasts singularly with the elevation contours. The Rustler is generally thinning to the north-northeast across the area with structure, showing no changes that parallel the structure contours that would be clear if dissolution of upper Permian evaporites were the cause of the trend and general southeast plunge of the redbed ridge. This is completely consistent with the evidence from the WCS site and surroundings that indicate no relationship between evaporite bed thicknesses and the elevation of the redbed ridge.

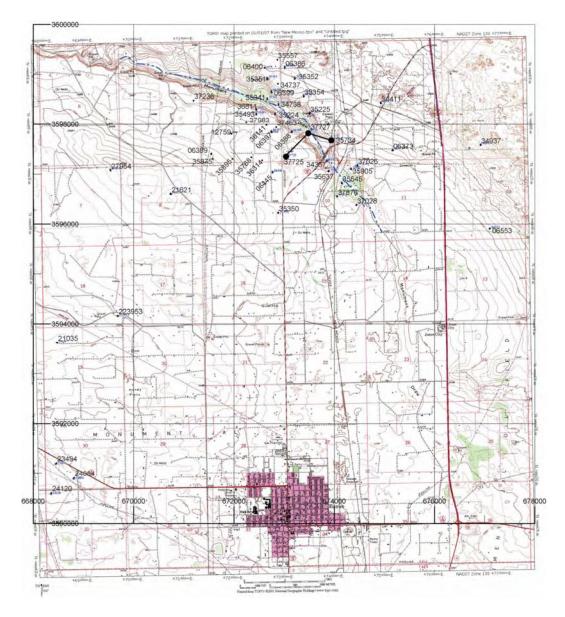
Figure 30 – Topographic base (T21S, R37E) with abbreviated API numbers (add 30-025- to the number) for drillholes for which geophysical logs were interpreted at and around section 3 and the carbon black plant. The dashed blue line indicates the topographic location of the Monument Draw drainage and is repeated in subsequent contour maps. Black overlay lines and values are UTM (NAD27; Zone 13) coordinates in meters with a 2000-m spacing. Three black dots connected by a line is the location of a log section into the draw (Figure 34).

Nicholson and Clebsch (1961, p. 44-45) reviewed the limited shallow data from drillholes across Monument Draw, New Mexico, in the immediate vicinity of the carbon black plant (section 3, T21S, R37E) (Figure 30). The redbed surface under the draw is shown to be depressed in their data, with fill of Quaternary sediments they interpreted to be derived from erosion of the Ogallala. Although Nicholson and Clebsch inferred that the surface on the redbeds resembled an erosional feature, they also considered that such a depression could have a dissolution origin. They also noted that dissolution features are not normally as linear as the trends of Monument Draw, NM. We examined drillhole geophysical logs of the uppermost halite-bearing formation, the Rustler, in the vicinity of the carbon black plant to resolve this modest ambiguity.

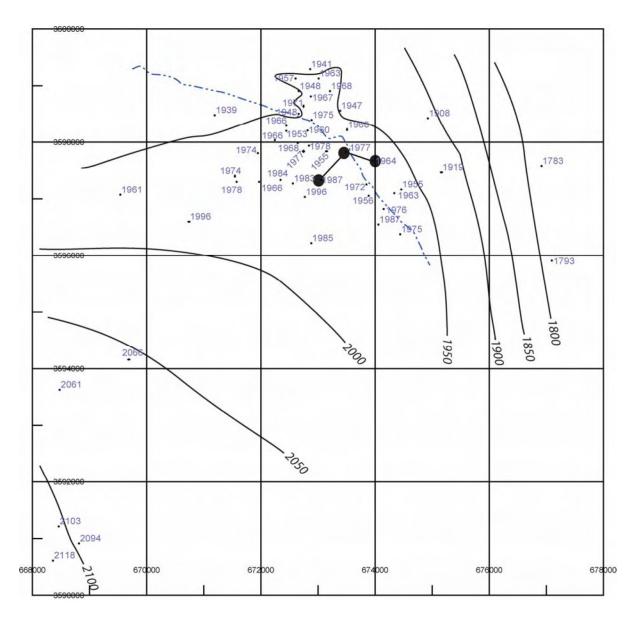
Figure 31 – Elevation (ft amsl) of the top of the Salado Formation in the vicinity of this segment of Monument Draw, NM. Only a few wells were selected at greater distances from section 3 to provide more control on contours. Grid lines show UTM coordinates (m; Zone 13).

Geophysical logs from 49 wells within and across Monument Draw in this area were interpreted to obtain data on the elevation of the top of the Salado (Figure 31; Appendix D), top of the Rustler (Figure 32), and the thickness of the Rustler (Figure 33). The majority of the logs are from drillholes in section 3 and immediate adjacent sections; data from a few logs to the northeast and southwest were added to provide some extra control on contour trends. Dissolving halite from the Rustler or Salado should be revealed as structural features and as localized changes in thickness; thus these maps were developed to try to reveal such features along this section of Monument Draw, NM.

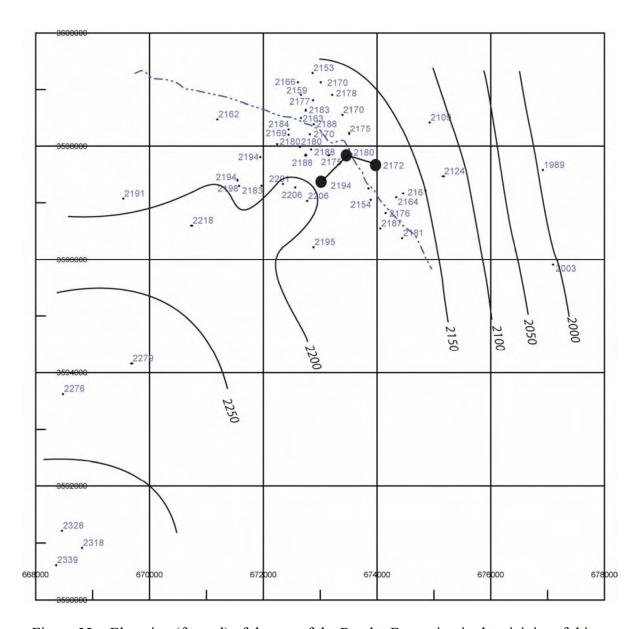
Figure 32 – Elevation (ft amsl) of the top of the Rustler Formation in the vicinity of this segment of Monument Draw, NM. Only a few wells were selected at greater distances from section 3 to provide more control on contours. Grid lines show UTM coordinates (m; Zone 13).

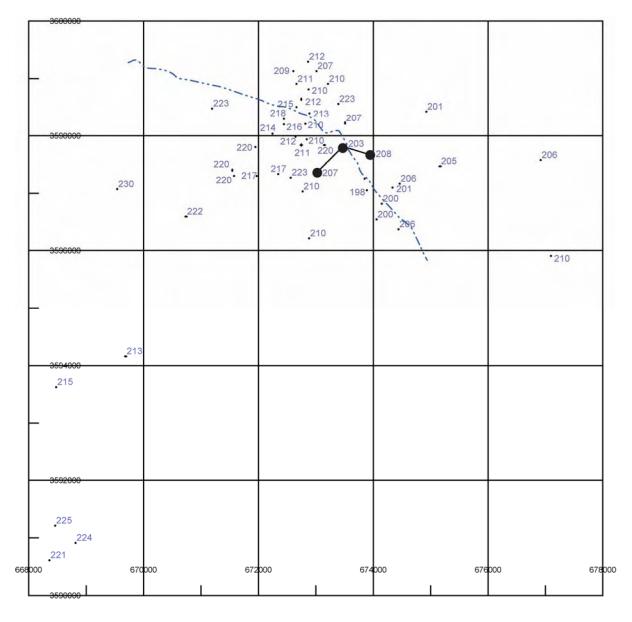
Figure 33 – Thickness (ft) of the Rustler in the vicinity of this segment of Monument Draw, NM. No contours were drawn because of the limited variation. Grid lines show UTM coordinates (m; Zone 13).

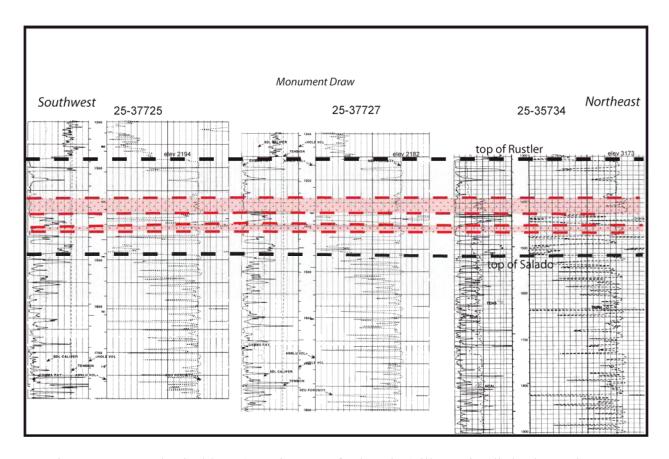
Figure 34 – Geophysical logs (see Figure 30 for location) illustrating little change in thickness for the Rustler and upper Salado from outside Monument Draw to the center and eastern side of the draw. Light red shows halitic zones, the uppermost in this area, are persistent and little changed. The Draw did not develop at its present location in response to solution of this halite and subsequent subsidence.
